## 1.0 Assignment 4: Critical Reflection of Roles and Responsibilities

- 1.0.1 In 2019, MSDS Marine were commissioned by the National Museum of the Royal Navy (NMRN) to produce a Conservation Management Plan (CMP) for three Coastal Forces vessels that the museum had recently acquired; Motor Torpedo Boat (MTB) 331, MTB 71, and Rescue Motor Launch (RML) 497. The Coastal Forces division of the Royal Navy was established during World War I and was re-instated during World War II. The division was principally developed for the protection of the coast of Britain and comprised around 2,000 craft that were mainly crewed by wartime sailors and volunteers. These vessels were responsible for a great variety of tasks including minesweeping, larger vessel support, submarine chasing, and torpedo launching. The Coastal Forces vessels collectively fought over 1,000 actions during both World War I and II.

## 4.0 Appendix 3: RML 497 CMP

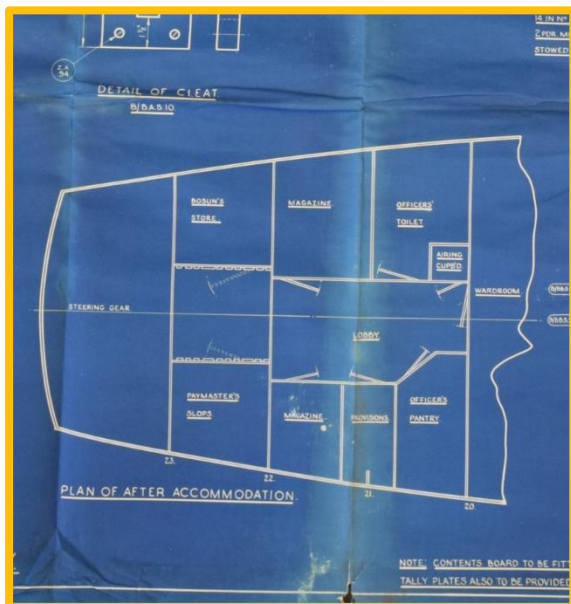
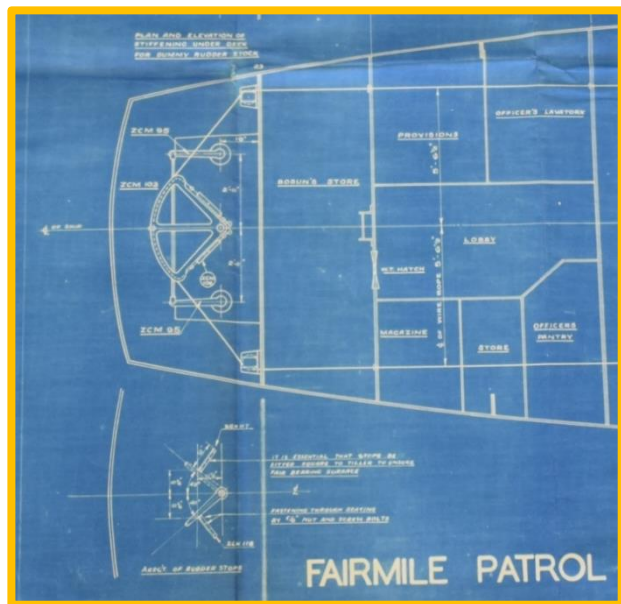
Figure 27: Original and alternate layout for the stern section of a Fairmile. RML 497 has features from two different layouts.

- 3.5.14 The stern section beyond the bulkhead at frame 22 was originally made up of a bosun's store from frame 22 to 23 and then aft of frame 23 was the steering gear (Drg B173). The vessel appears to have been built in this manner, according to the plan shown in Figure 27. There is, however, another plan which shows a different form of steering gear associated with a different stern layout. In this plan the Bosun's store was sectioned off to leave a central lobby with storage on the port and starboard sides (L/S/238). Interestingly there are the remains of internal divisions within the vessel which cut across the patched-up door to the Bosun's store, suggesting that the internal divisions from the second plan were installed possibly at a later date, resulting in the aft section of the vessel having a layout which is a combination of both plans (see Figure 27 for comparison).

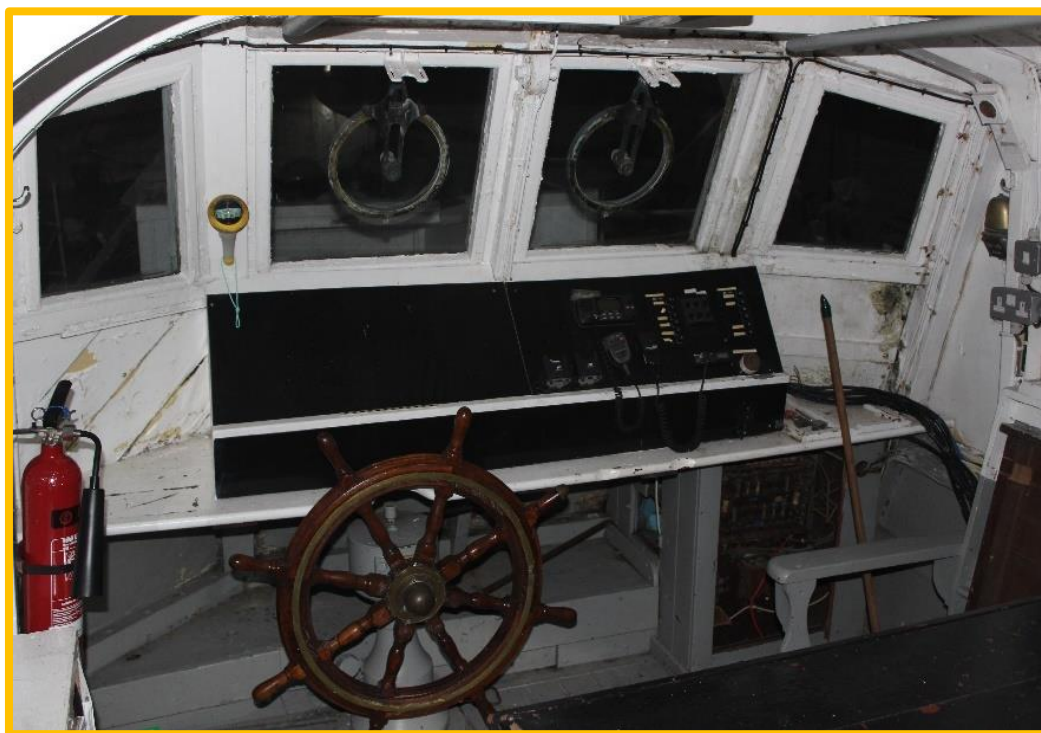
Figure 30 Interior of the wheelhouse, forward section

to just aft of the funnel at frame 15. The wheelhouse was constructed of a series of timbers including vertical stiffeners, beams, an aft bulkhead, knees and planking (see Figure 30) (Drg B97). The wheelhouse floor was accessed from the main accommodation, where the floor is set down into the ceiling of the compartment, lowering its height in the footprint of the wheelhouse. It is made up of a lattice of mostly pine timbers. The wheelhouse has largely retained its original fabric, both internally and externally.

- 3.5.17 Access to the wheelhouse is via the original timber-framed and double-diagonal planked door in the aft face of the wheelhouse (Drg B97). Once inside it is clear that many of the original internal features and fittings have been retained, though there are also clear modern additions. The wheel is positioned toward the forward face, to the port side of the dash, and was originally surrounded by engine room telegraphs and the compass binnacle (see Figure 30). A series of voice pipes were also installed running below decks and the fuse box for the electrics was positioned below the dash (Drg B150). A chart case and document box were located to port, below the window and a rack for the Lewis guns was by the door. The phone and starter switch were positioned on the starboard side wall. On the aft wall a barometer, bookshelf and telescope rack were located, in addition to the steering column for the bridge wheel, and on the floor to the starboard side was a hatch to allow communications with crew in the radio room (Drg B150). The wheelhouse also has eight Perspex double-pane windows which may be original or of an early date, four on the forward face and two each on the port and starboard sides, some of which contain copper alloy components and iron fastenings. Those facing forward have Kent screens fitted. The windows and the majority of the surrounding timber frames are likely original except for the timber above the starboard window which is a plywood replacement.

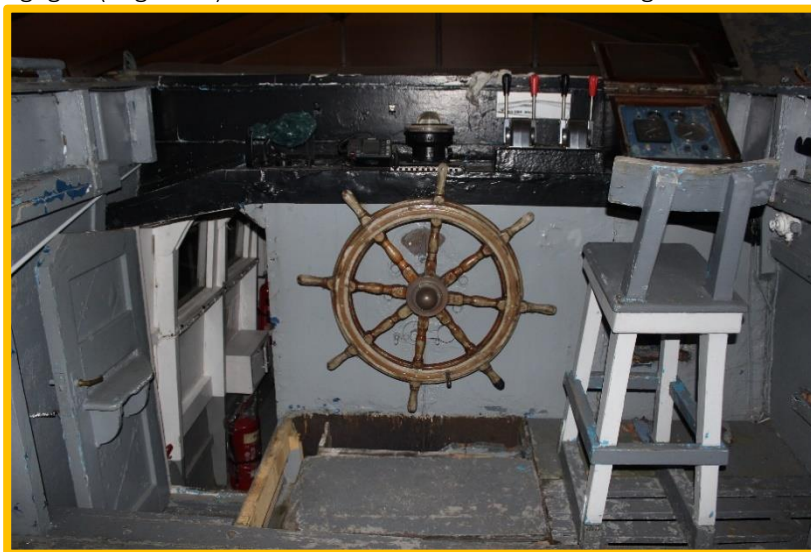
*Figure 31 The bridge, facing forward*

- 3.5.18 Aft of the wheelhouse was the bridge, which formed a raised steering platform (see Figure 31). The sides of the bridge and the additional windshield structure were originally protected with armour plating which no longer survives (Drg B246). The floor of the steering platform was formed of slat-laid planks, arranged on a transverse orientation, and with spacing between. Sunk in to the deck on the port side of the steering position was the well for the wheelhouse door. To the starboard of this was a step locker positioned on the floor. The aft edge of the bridge decking was cut into by the mast and the square mounting bracket that attached to the deck. The forward windscreen which was constructed on the forward face of the bridge protected the dash, where the compass was positioned on the centreline. A voice pipe ran from the dash in to the wheelhouse. The external ship's wheel was positioned on the centreline, and the steering arm for this ran through into the wheelhouse at an angle to join the line of the internal wheel. A clutch assembly on each wheel allowed each wheel to be individually engaged and disengaged (Drg B298). There are numerous modern fittings on the dash.

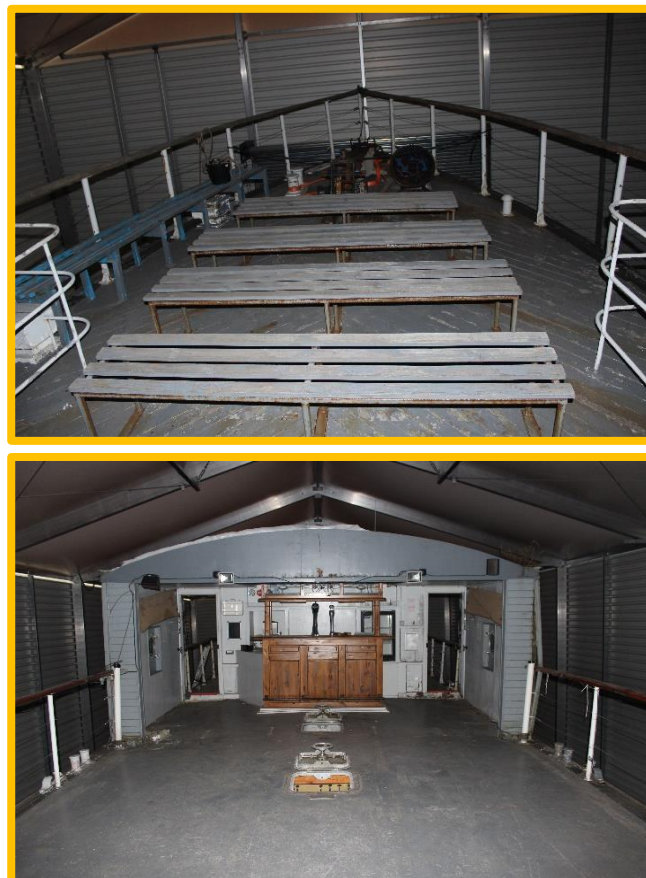
- 3.5.20 Instead, the top deck of the vessel now largely has the character of a ferry. There are now handrails around the deck, and other modern fixtures include benches and bar equipment (Figure 32).

*Figure 32 Ferry features of the top deck include seating (bow depicted) and the sick-bay themed bar*

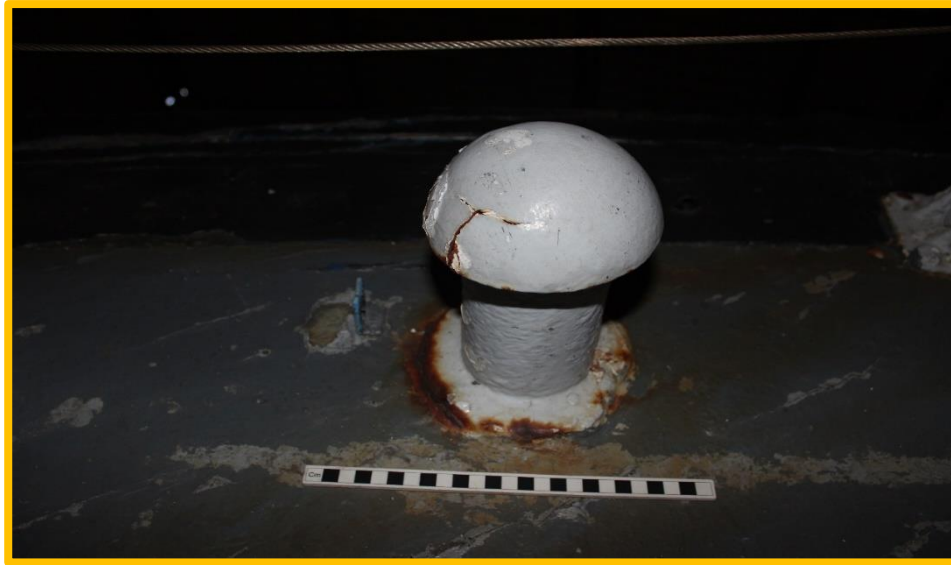
*Figure 33: Mushroom vent*

- 3.5.21 The vessel was fitted with numerous types of ventilation, including ventilation boxes, cowl vents and mushroom vents (L/S/238), (see Figure 33). Vents and ventilation ductwork remain present throughout the vessel to form the ventilation system.

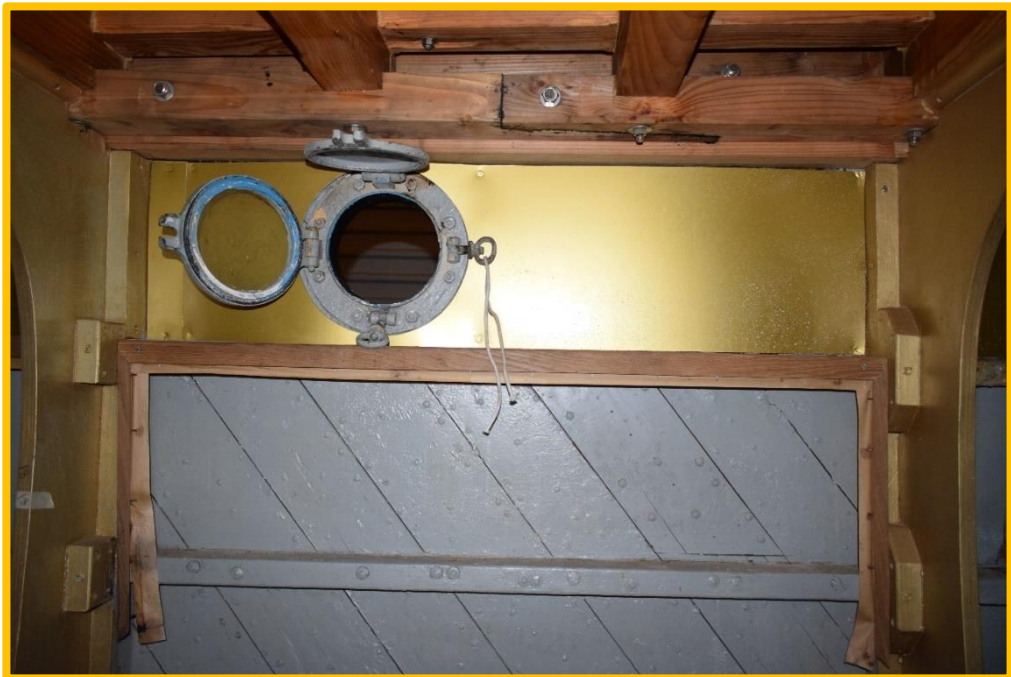
*Figure 34: Porthole in the Ward Room*

3.5.22 There are 30 original, composite portholes present throughout the vessel (see Figure 34). There are two in the forward heads, nine in the main accommodation (one is missing and has been patched over), four in the Officer's Quarters, six in the engine room, six in the ward room, and three in the aft ancillary area (L/S/238).

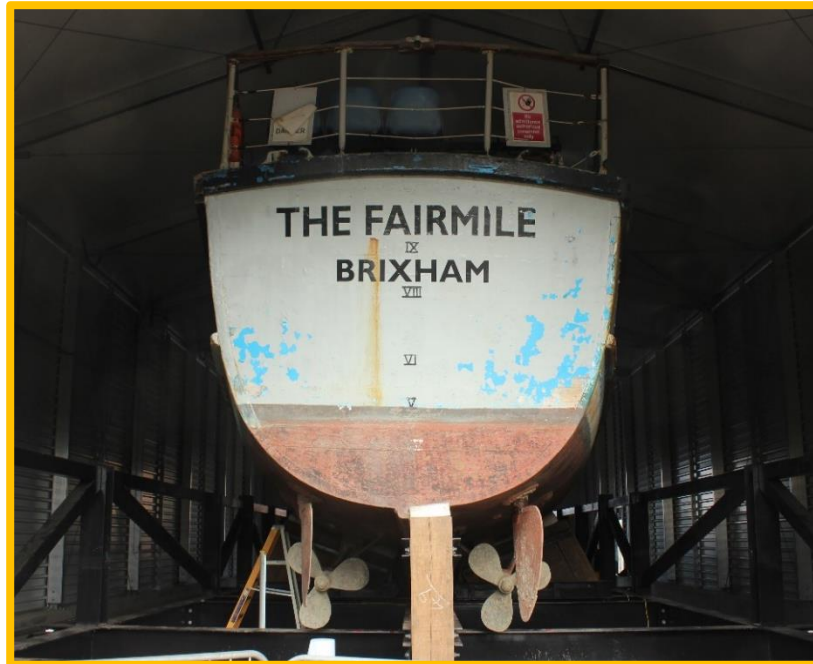
*Figure 35: Stern of the vessel*

3.5.23 The stern tubes for the propeller shafts were 11 ½ inches wide and exited the underside of the hull between frames 18 and 20 (see Figure 35). The steel propeller shafts were constructed with a diameter of 2 ¼ inches. The brackets for the propellers were mounted on the underside of the hull below frame 22. The vessel was originally fitted with two three-bladed bronze propellers, with a diameter of 33" (Drg BE22). Two propellers survive today, though it is not certain whether these are original.

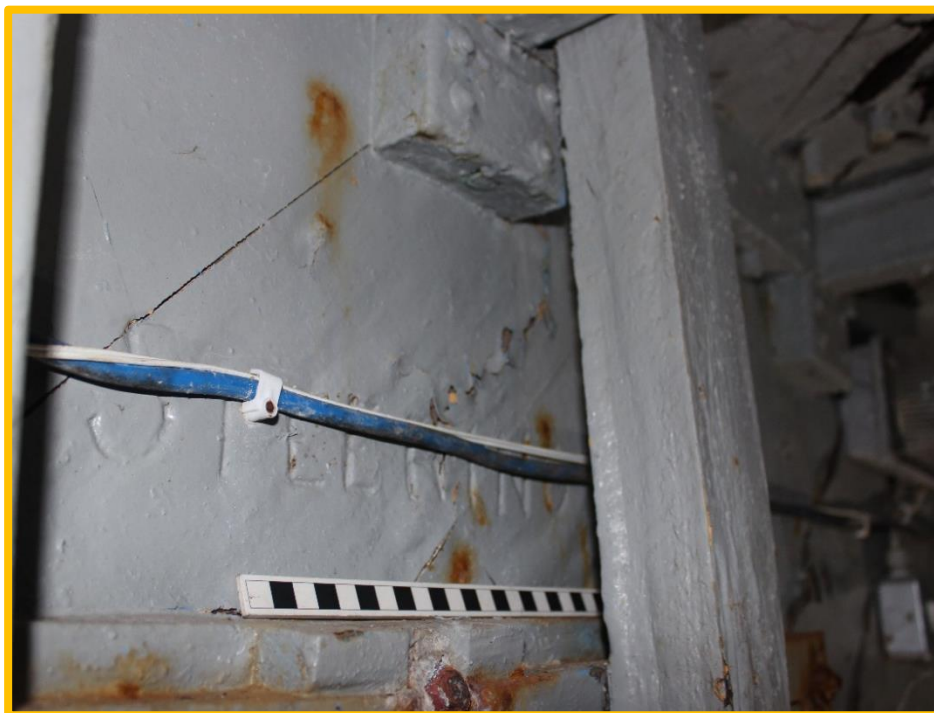
- Original features are at risk associated with the degradation of bulkhead 22. These include lettering indicating the original position of the bosun's store;

- 4.4.4 In addition to these original areas, enigmatic clues to the former presence of lost internal divisions and compartments survive. These include packing pieces for internal divisions which no longer survive, the patched-up hole in the funnel marking the location of the former flue for the stove in the galley, and more legible evidence such as inscriptions marking the location of the Bosuns Store or Steering Compartment (Figure 36). Unfortunately, the bulkhead on which these inscriptions are located (at frame 22) has suffered heavily from rot, and it is likely that the letter itself is preserved only within the paint layers rather than the timber which has deteriorated badly due to the effects of the rot. The steering compartment lettering has been further affected by the installation of wiring running across the text.

*Figure 36: Lettering marking the location of the steering gear on bulkhead 22*

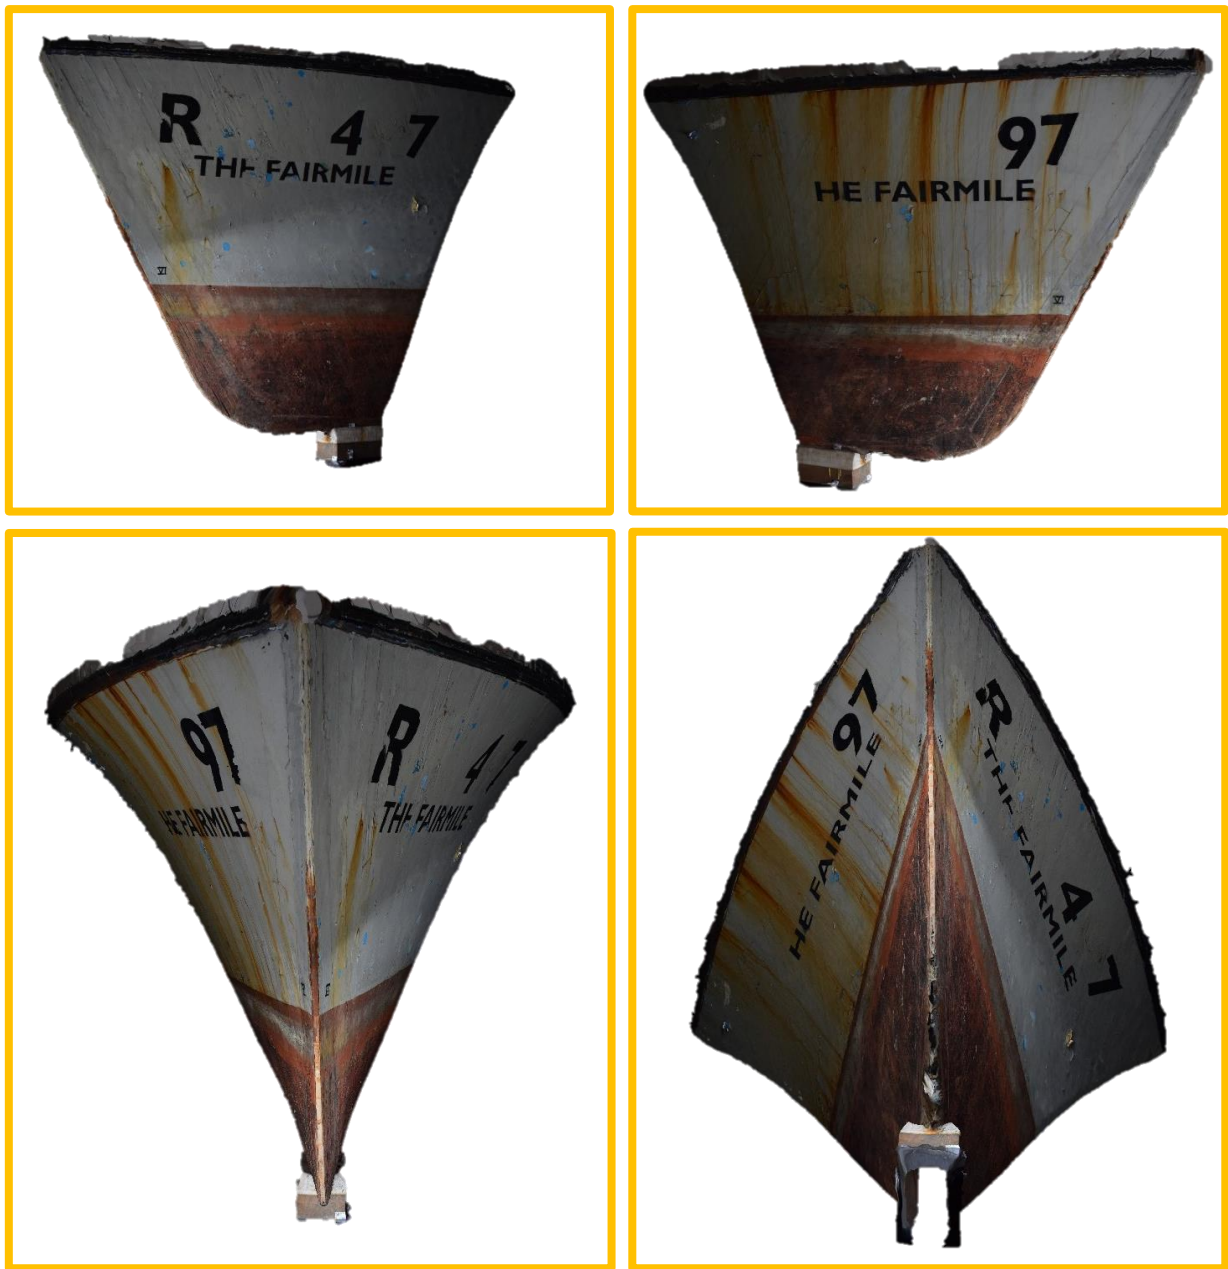
*Figure 40: Extracts from photogrammetry model of the bow*

13.1.4 Measurements were taken at the time of the surveys conducted for this CMP to establish monitoring points for the bow of the vessel (Figure 39), and a photogrammetry survey of this area, and the stern, was completed (Figure 39 and Figure 40). Repeat measurements can be taken with reference to the positions and details given below, and repeat photogrammetry surveys or collection of laser scan data would provide additional means of monitoring this critical area.
