## SWANSEA FORESHORE ICE CREAM PARLOUR

#### 1. BRIEF

##### 2.1 SITE WALKOVER

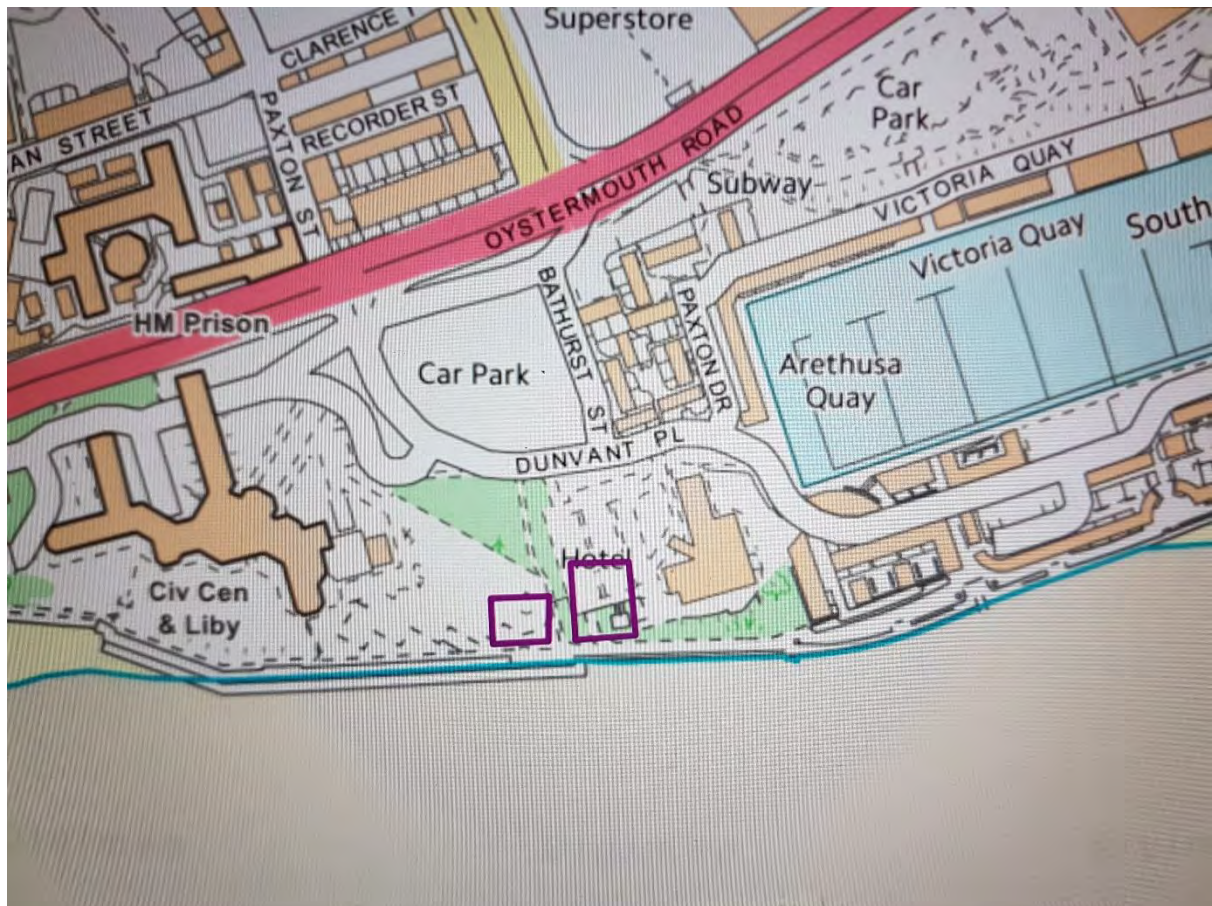
## APPENDIX A

A site walkover was undertaken by Emilie Driscoll on 12 Dec 2018. The weather was overcast but dry. During the walkover, manhole covers were found along the site and some mounds. No other issues were noted. More site photographs in Appendix A.
