# Coastal regeneration at Llanelli, South Wales, **UK: lessons not learned.**

International Coastal Symposium (ICS) 2009.

**Mike Phillips<sup>\*</sup>, Victoria Powell<sup>#</sup>  
and Robert Duck<sup>#</sup>**

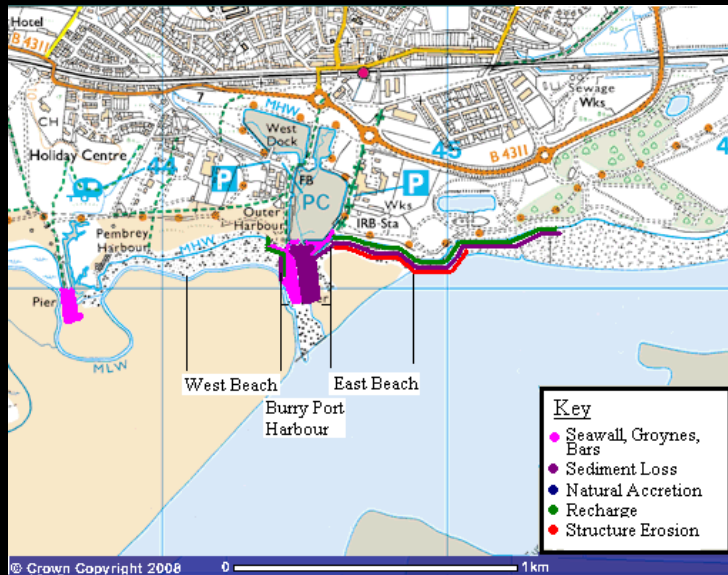
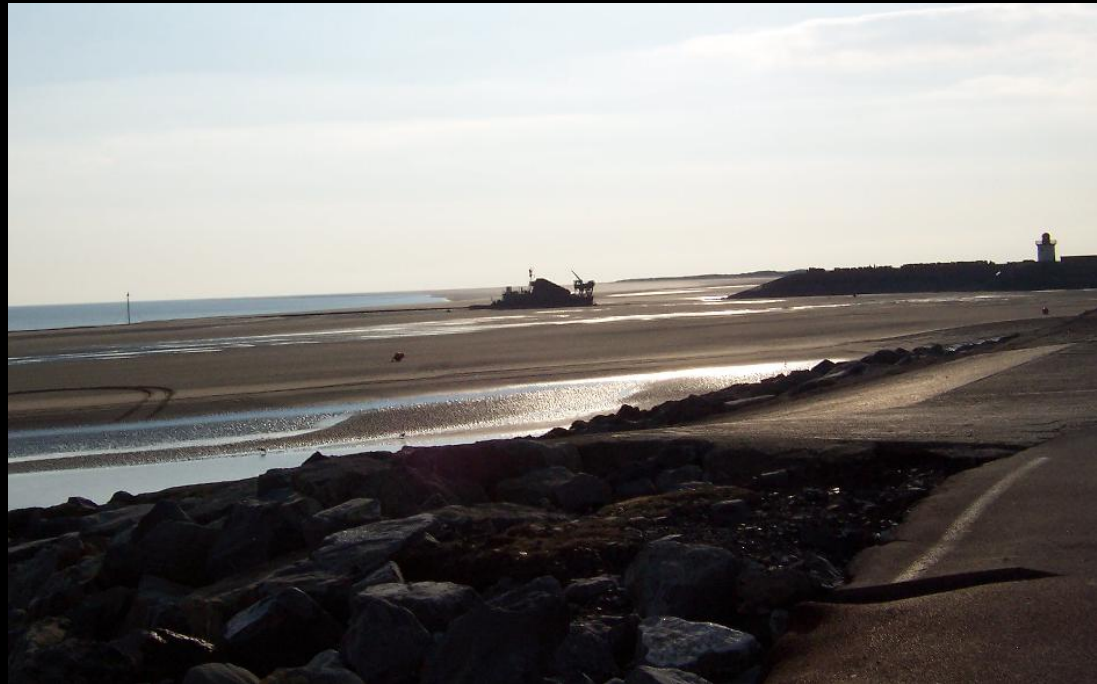
**Burry Port Harbour has been restored during the Millennium Path development. It has a new harbour gate and is now a busy leisure boat facility. There are two beaches either side of the harbour, with the east beach being down stream from the harbour defences. Damage to coastal path started within 3 years of completion (CCC, 2007).**

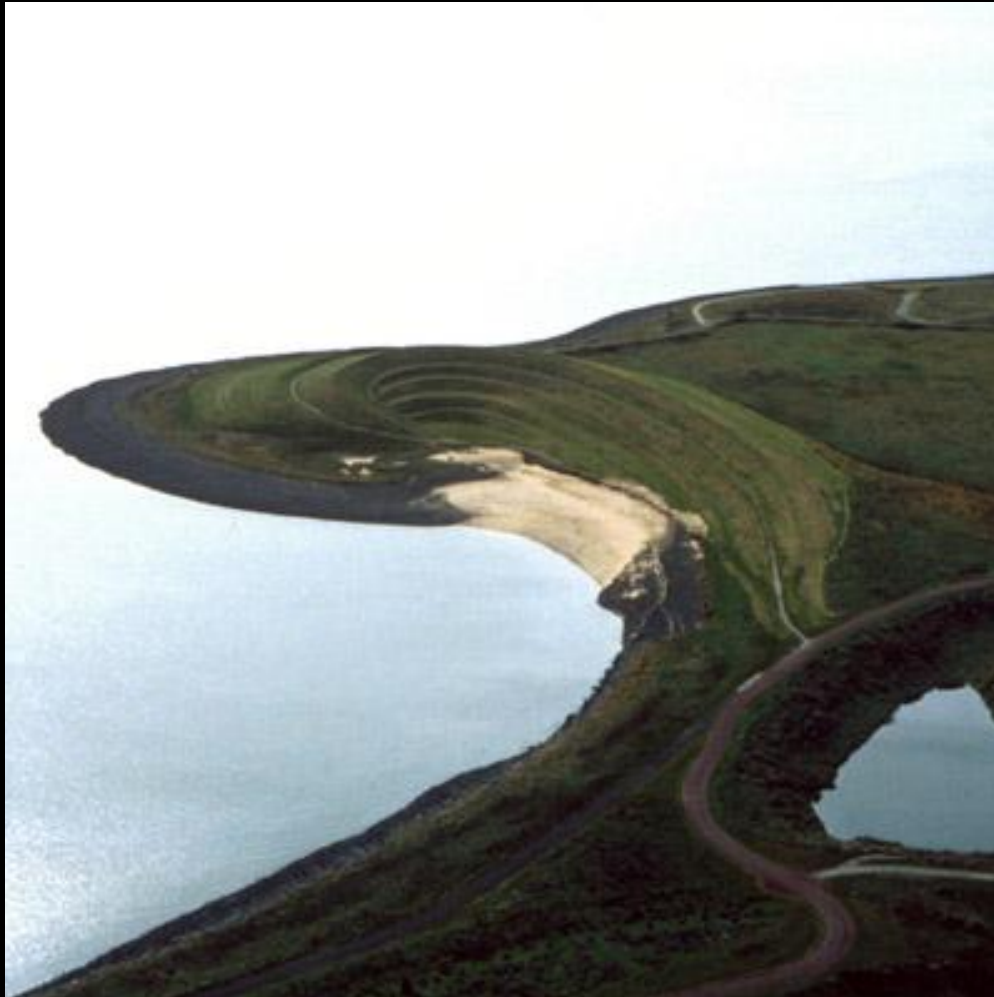
**The Earth Sculpture lies off the main path and is built into the sea to create an artistic feature that can be seen from Llanelli, the Gower and the sea (Richard Harris).**

**Its design incorporated the use of materials taken from the old power station spoils, Pulverised Fuel Ash being one of the main construction materials.**

**The design included a beach inset into the curl of the sculpture.**

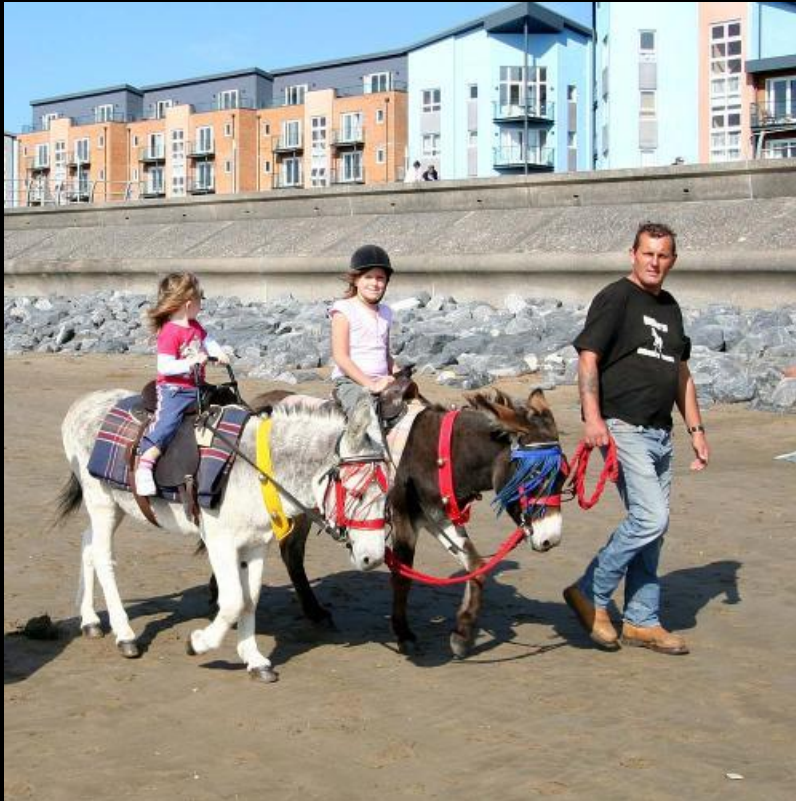
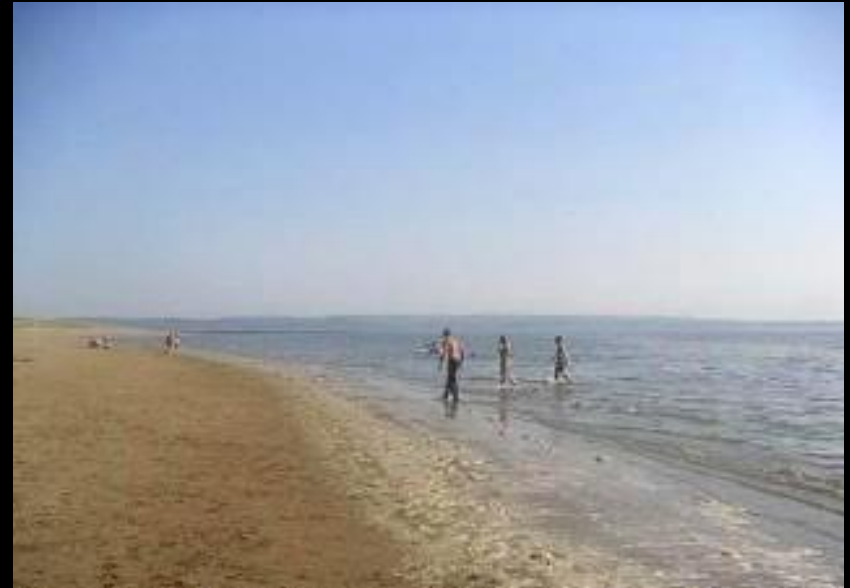
**Llanelli Beach is surrounded by decommissioned industrial sites, docklands and part of Llanelli town which had Objective One status. The redevelopment removed industrial ruins and provided a flat complex behind the beach as well as a cultural arts centre nearby. Residential development was positioned between the beach seawall and North Dock, the nearest lying within 8m (25ft) of the seawall.**

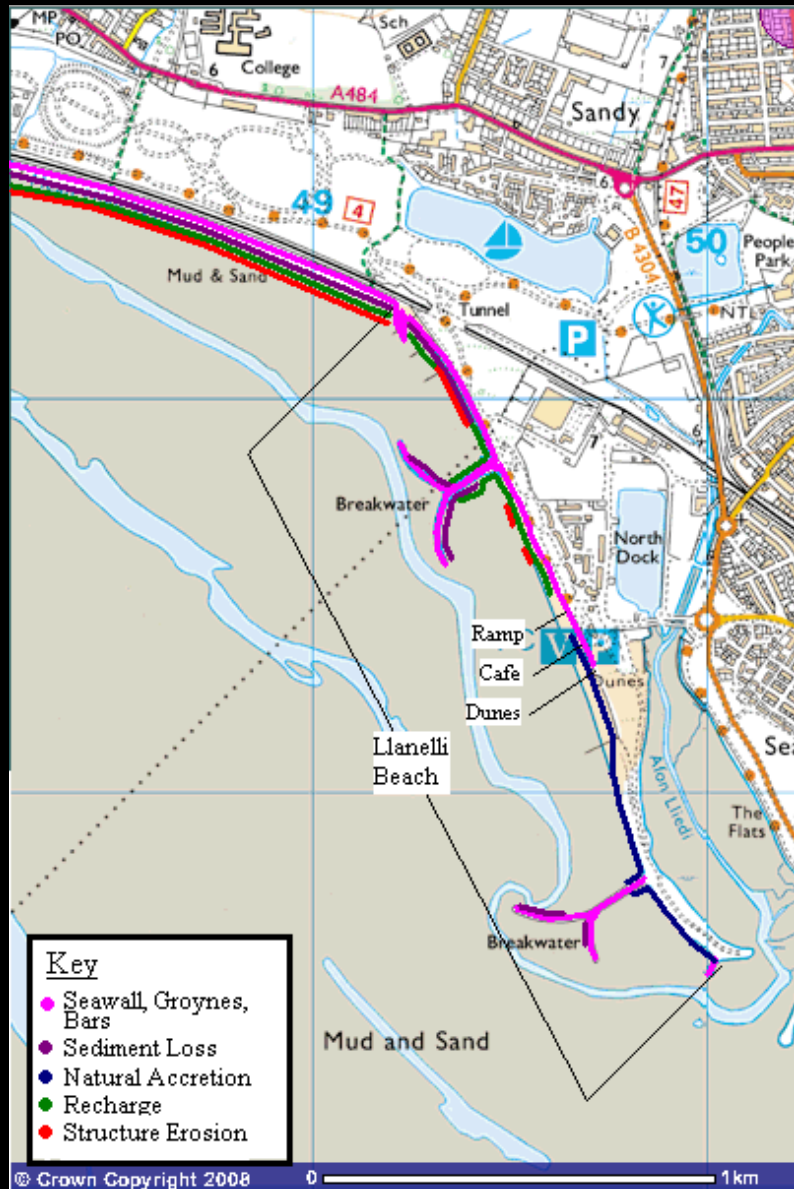
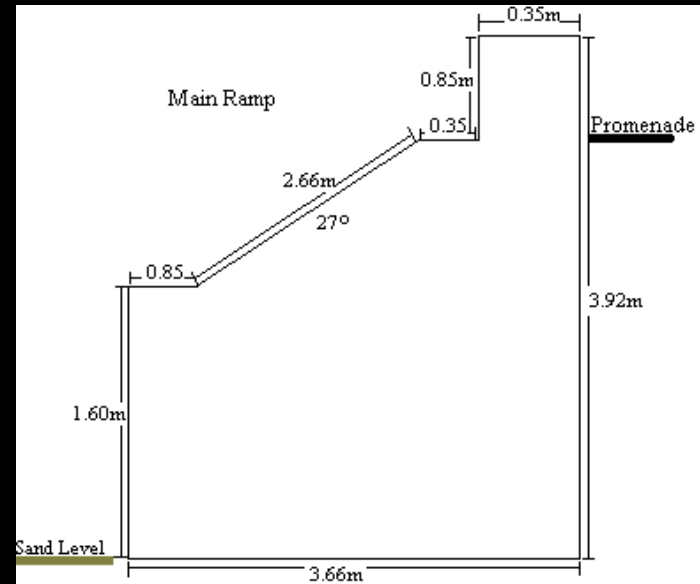
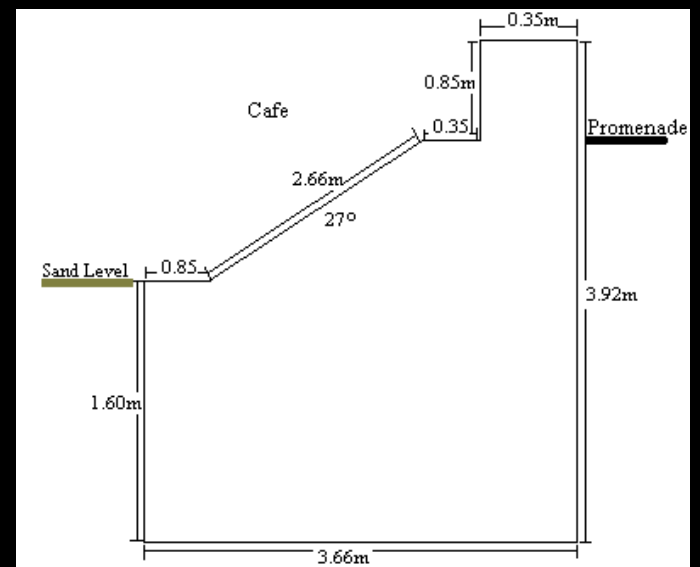
- **Beach depletion adjacent to dune system;**
- **Hard engineering structures do not fully protect shoreline;**
- **Rock armour and beach nourishment supplement hard defences but greater volumes needed;**
- **In 2001 coastal defences protected £5M assets but risk/costs are significantly increasing with new development.**

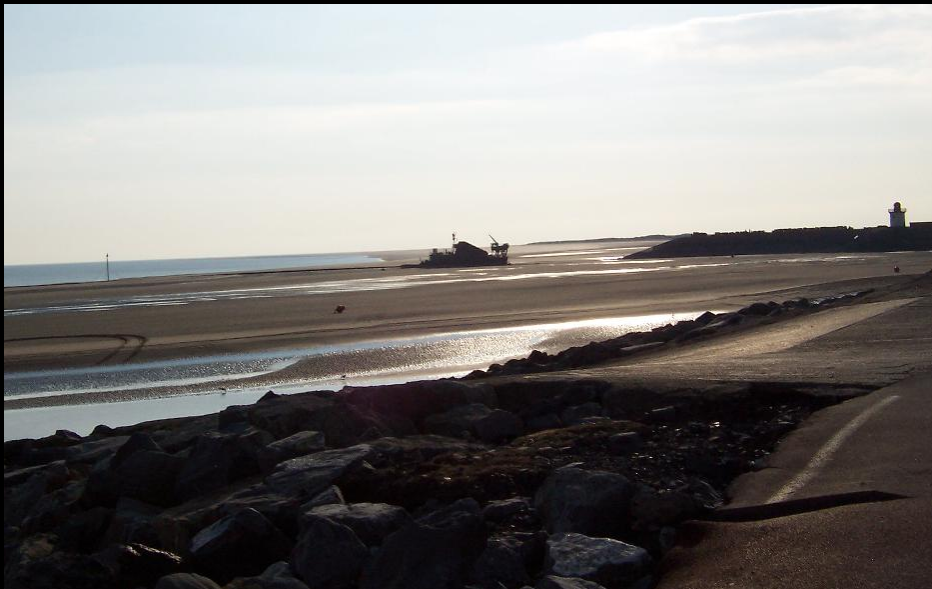
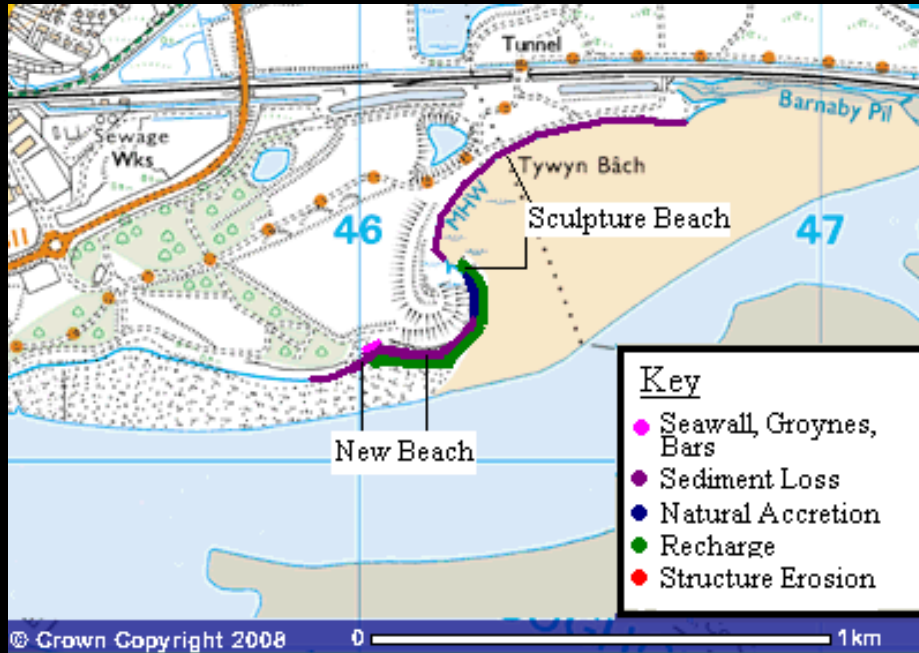
## EARTH SCULPTURE

- Low-lying coastal path is inappropriately located;
- Erosion caused by storms, and over a tidal cycle by westward flowing river currents and eastward sea currents;
- Allow the site to degrade naturally with minor protection points,
- Investigate the impact of a submerged breakwater
