***Risk Management and Root Cause Analysis  
regarding a Manufacturing Defect in the  
Automotive Manufacturing Sector***

**Engineering Applications and Study Skills  
(ACMA 4039)**

Benjamin Cole

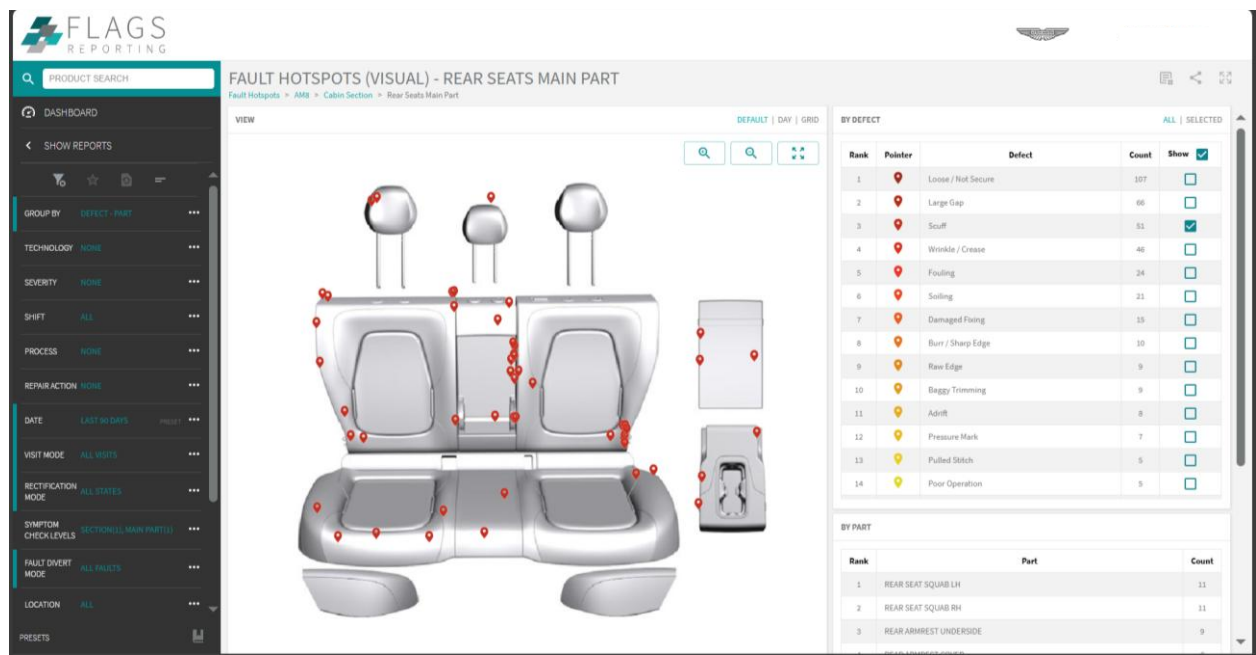
Figure 2 - Flags Reporting System (Flags Aston Martin, 2025)

Aston Martin uses a system called ‘FLAGS’ to report damage to vehicle parts. From examining the Flags data, it is apparent that the issue is called at End of Line (EOL). EOL is the final quality checks within the Trim department, before the vehicle enters the next segment of production.

Within the last 30 days exclusively, the concentration of scuffs in this area has reached 9 in the 104 vehicles inspected during this time. That is 9% of vehicles produced in this time frame with this exact damage. It has been established that the average rework time for a scuff of this caliber is 40 minutes, equating to £150 in both labor and material. Therefore, a total of 360 minutes and £1,350 in costs just for these 9 established scuffs within 30 days. This issue is going to be rectified as soon as possible.
