# Rotating Equipment Operating Outside Intended Design Life and Usage Parameters

UNIVERSITY OF WALES

BEng Mechanical & Manufacturing  
Engineering

2017

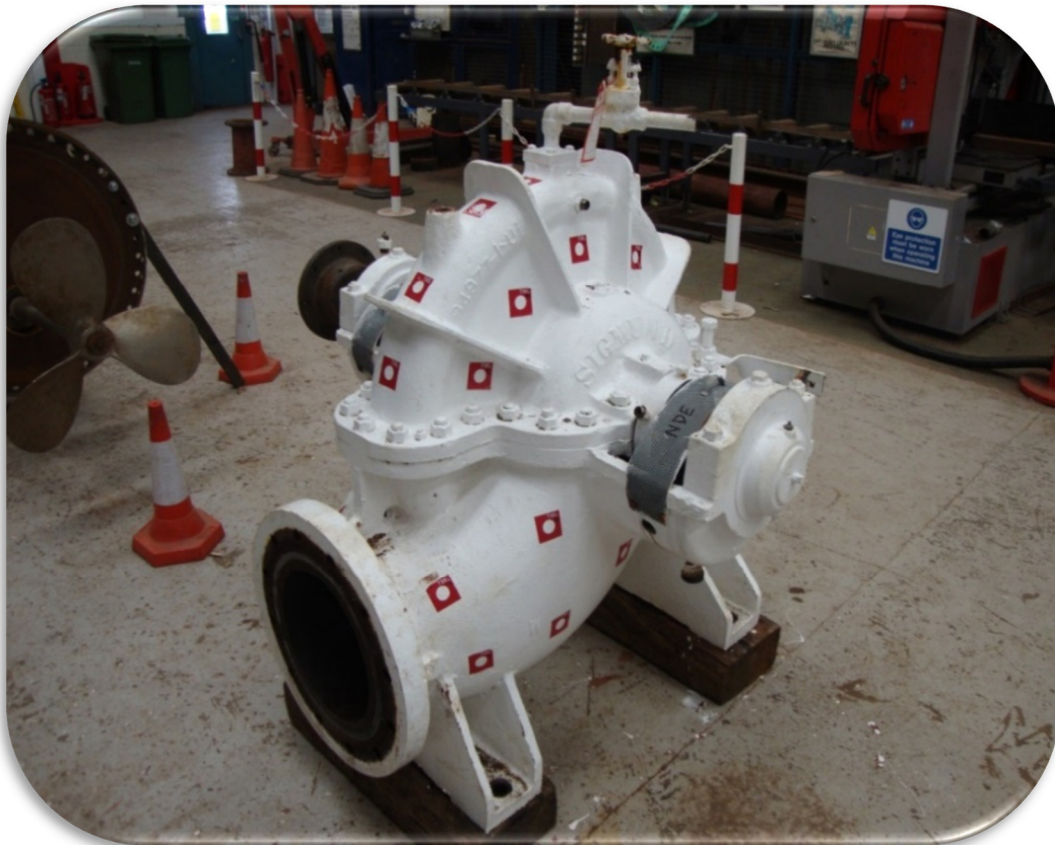
### 1.1.1 - Figure 2 – A Typical Centre Hung Centrifugal Pump Used At Sem Logistics

Centre hung pumps comprise a central shaft mounted impellor, suspended between a bearing race support either end of the shaft, relying on a mechanical seal on both ends of the casing to separate the internal pressure generated within the pump from atmosphere.

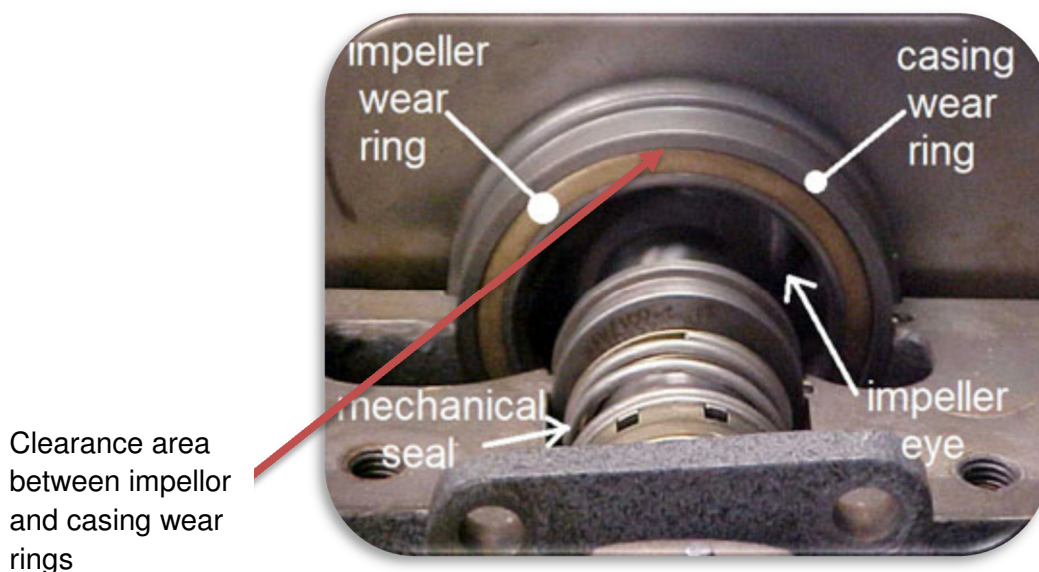
### 1.1.5 - Figure 4 – Closer View of Wear Ring Area

The outer or 'casing wear ring' pictured below is fixed in position within the pump casing, within which the impeller wear ring turns, fixed to the impeller:

Clearance area  
between impellor  
and casing wear  
rings

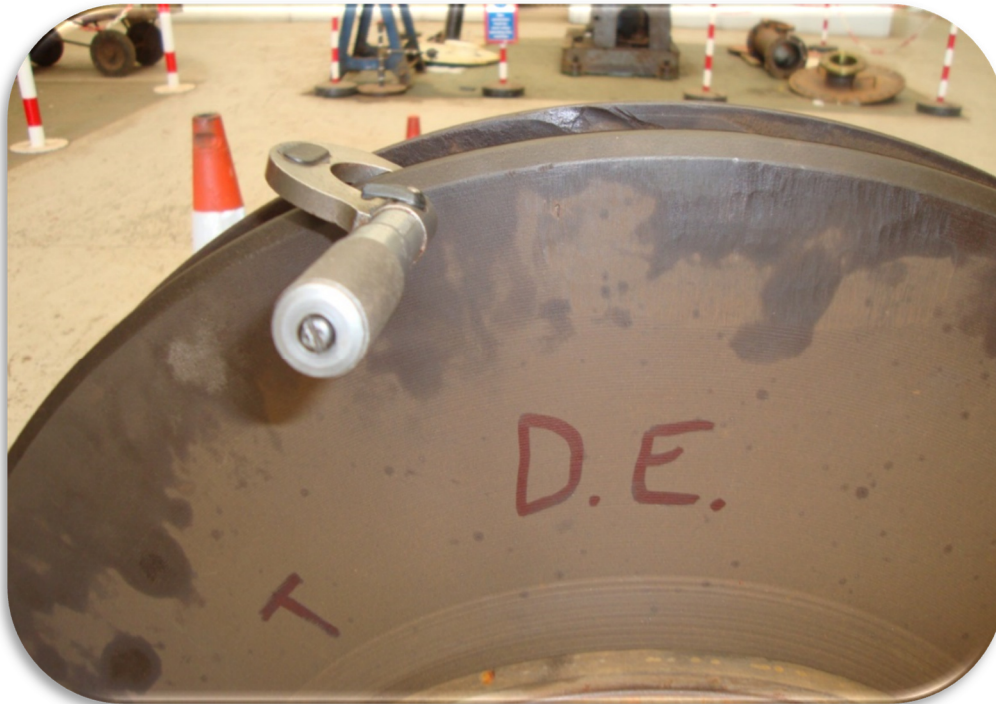
#### 1.1.10 - Figure 6 – Impellor Wall Thickness Measurement in Progress

Thickness readings were taken in the centre of each vein, on either side of the impellor.

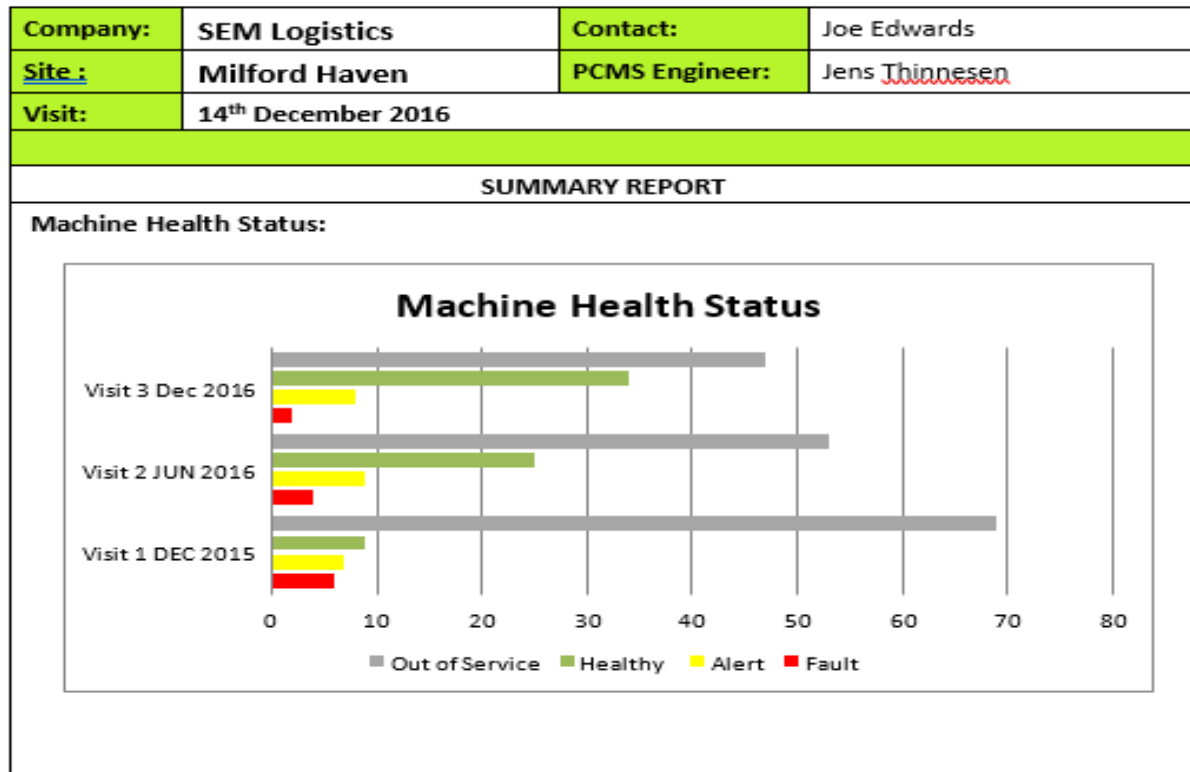
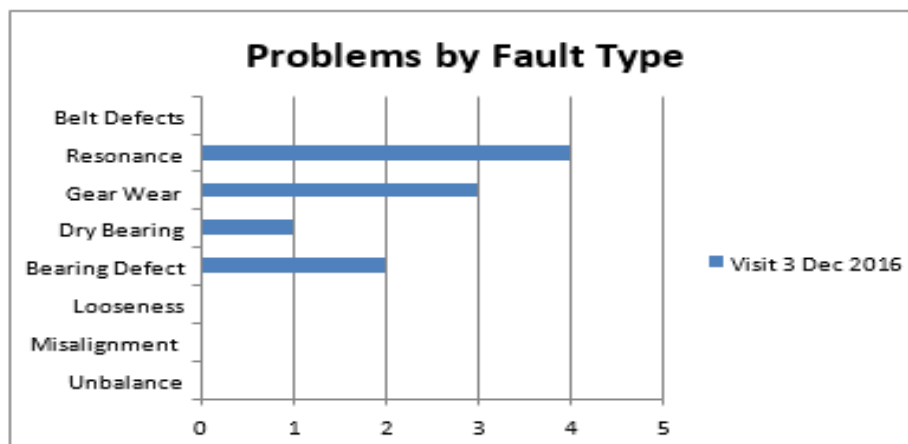
### 1.2.3 - Figure 7 – Condition Monitoring Overview

Due to a large number of the tanks at the site having undergone major refurbishment work, more rotating equipment was available for the data gathering to be performed.

The information gathered and depicted in figure 7 shows an improved percentage of equipment in service versus in alert or fault status. This was attributed to rectification of defects being performed as soon as was reasonably practicable, such as '21G87X Bearing Defect Verification' prompted by this survey.

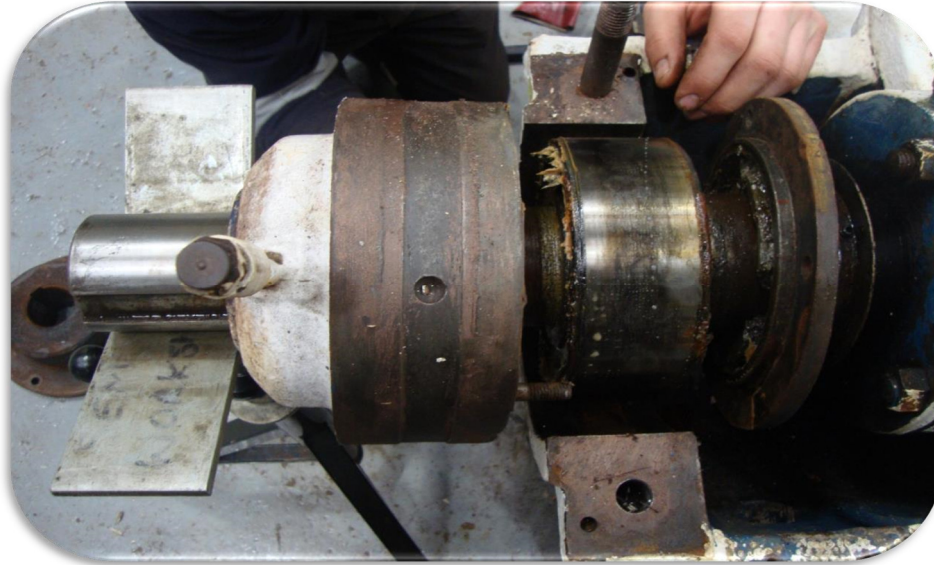
#### 1.2.5 - Figure 8 - Drive End Bearing

The drive end bearing of the unit in question was removed and cut open and cleaned, upon close visual inspection, signs of outer bearing race condition breakdown were found:

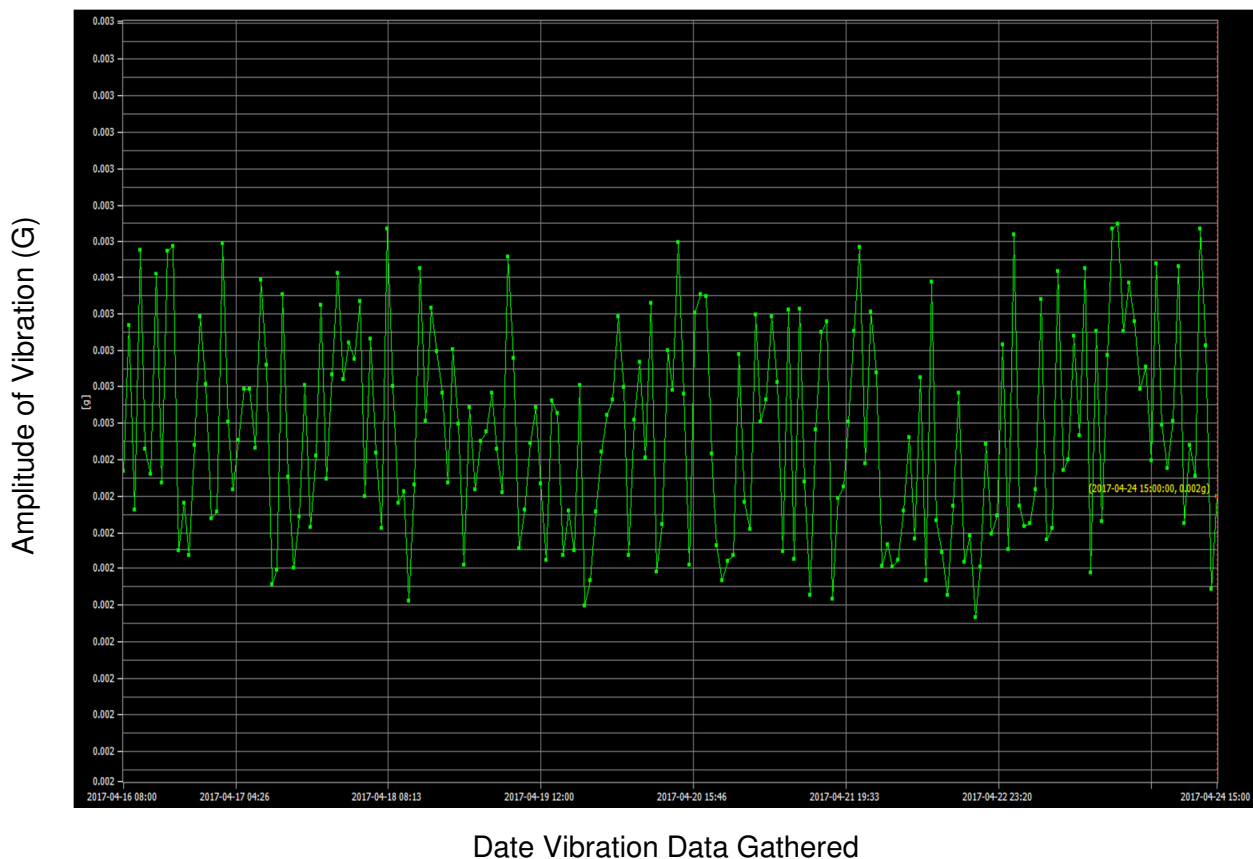
### 1.2.10 - Figure 12 – Remote Vibration Data Transmitted to Web

The below data can now be trended to establish an exact degradation rate.

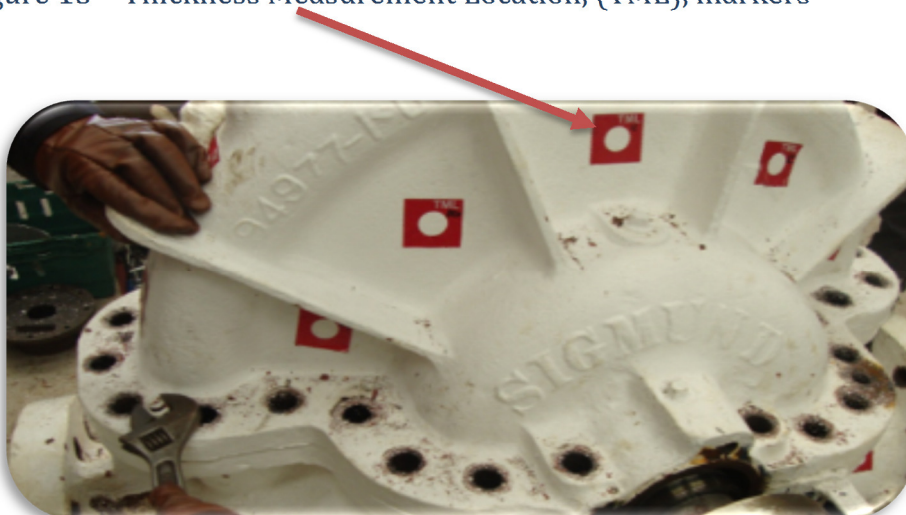
### 1.2.13 - Figure 13 – Thickness Measurement Location, (TML), markers

To rectify such errors, thickness measurement locations markers installed on all units that underwent such inspection, as it would ensure the following inspections provided directly comparable thickness data.

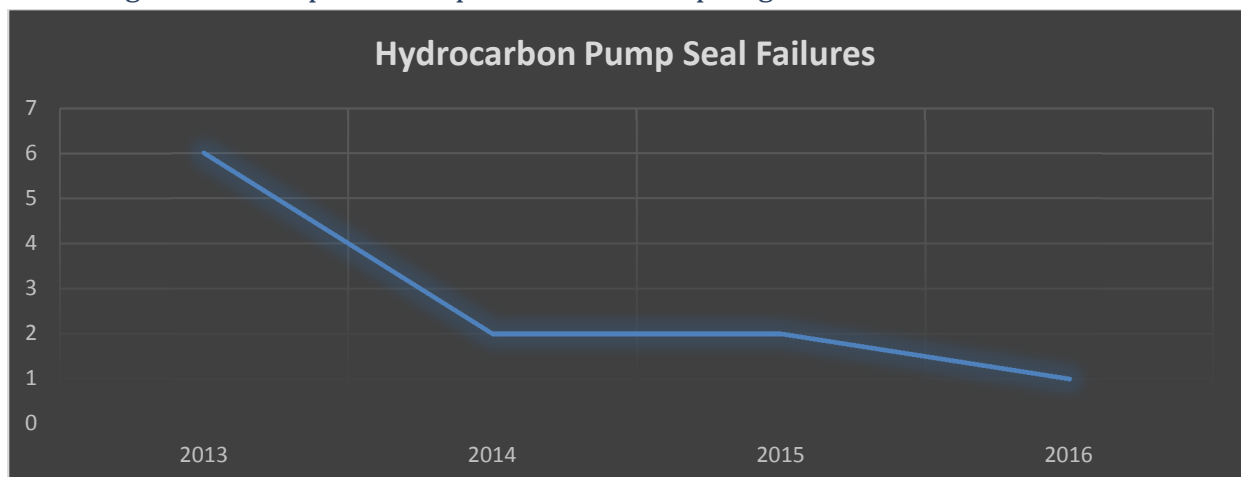
#### 2.1.5 - Figure 22 – Graph 2 - Pump Seal Failure Graphing

Reductions in seal failures have been graphed at the site since 2013 and show a clear downward trend, see figure 22.

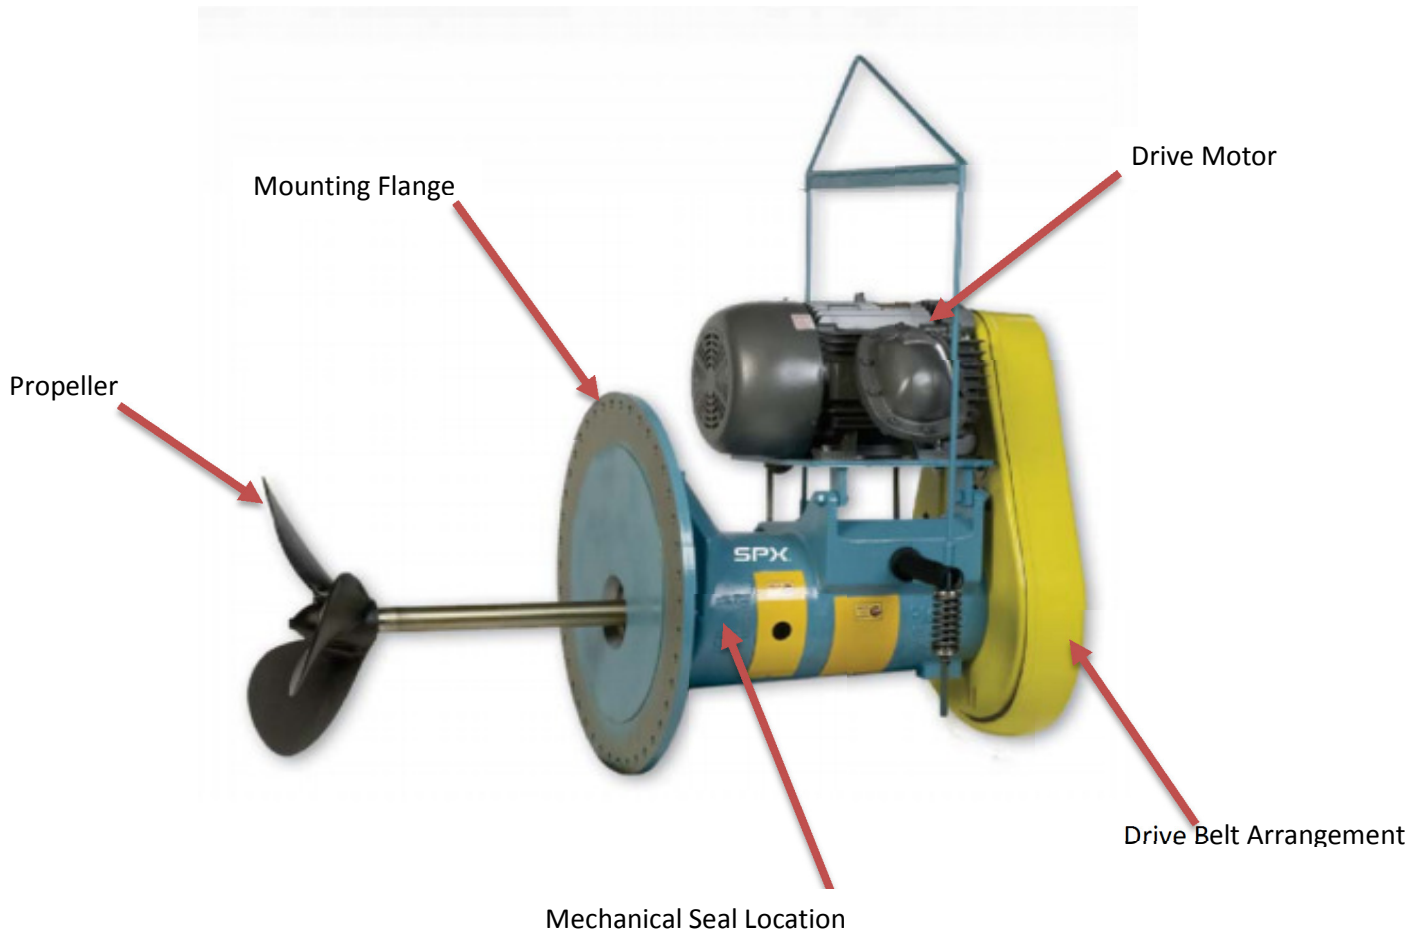
### 2.1.7 - Figure 23 – Belt Driven Tank Agitator GA

As with pumps, the tank agitators were found to have sporadic usage and multi product related issues.

The most problematic aspect was found to be the 'Mitchell Craig' manufactured units sealing arrangements inability to deal with multi product use, and periods of dormancy.

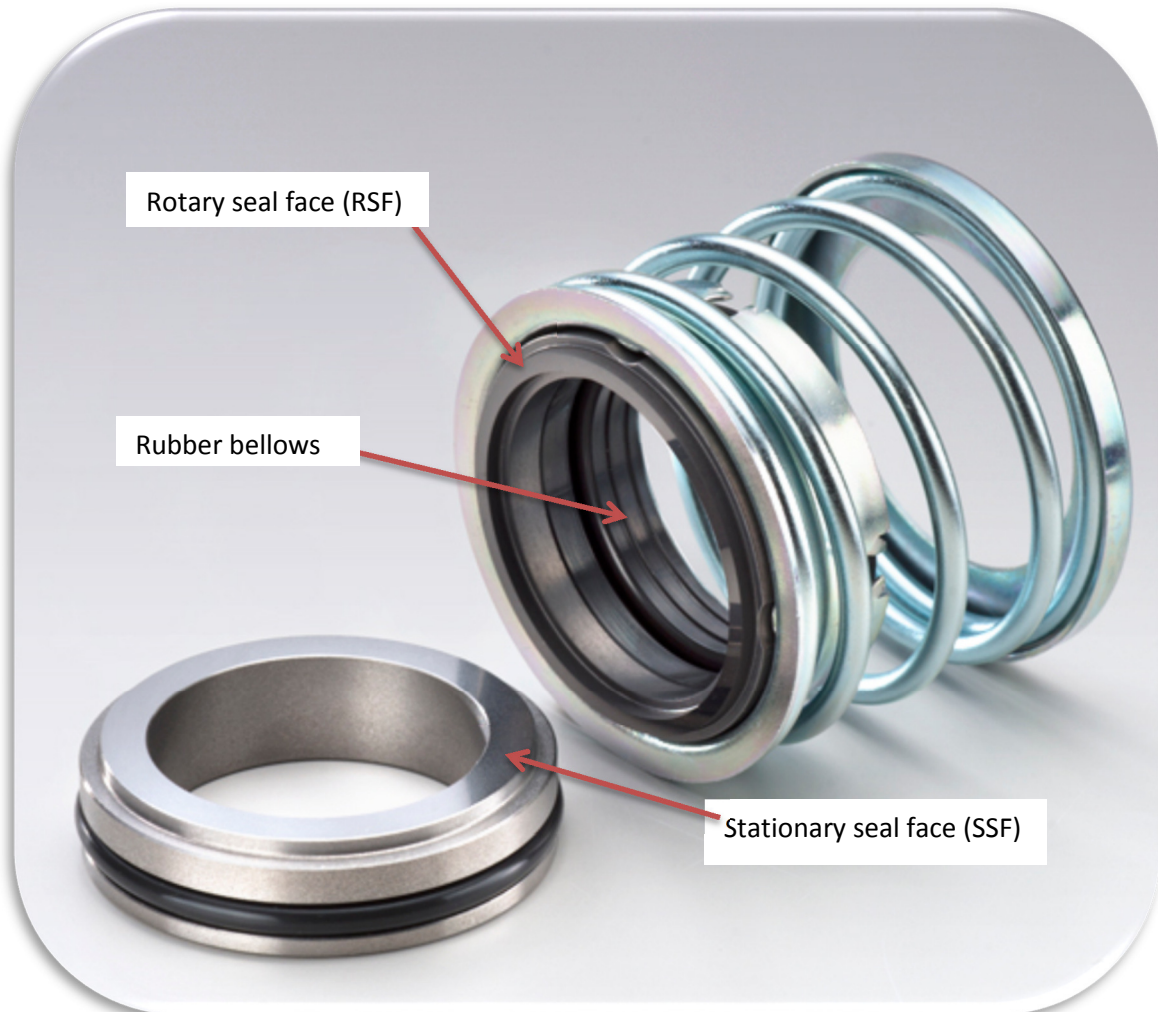
2.1.9 - Figure 24 – Mechanical Seal General Arrangement

A general arrangement of a mechanical seal, similar to that in use on Mitchell Craig agitators, can be seen in Figure 24.

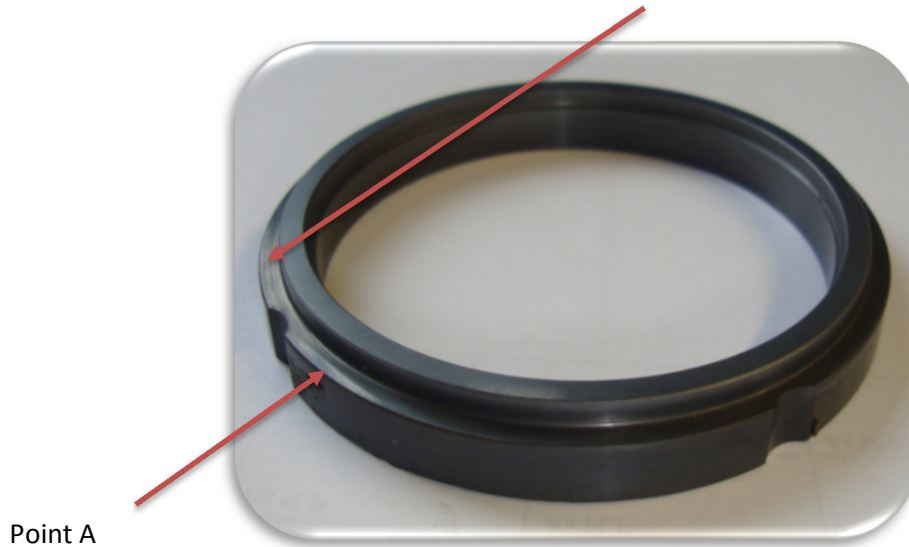
#### 2.1.17 – Figure 27 - Stepped RSR

Force of header pressure of tank now acts on this face

The stepped area of the RSF allows a certain amount of what is known as hydraulic balance within the assembly, the small void, (Point A in figure 27), between the sealing faces causes the fluid to push against the RSF, effectively reducing the force pushing it toward the SSF.

To help counteract wringing, the RSF is now stepped, figure 27.

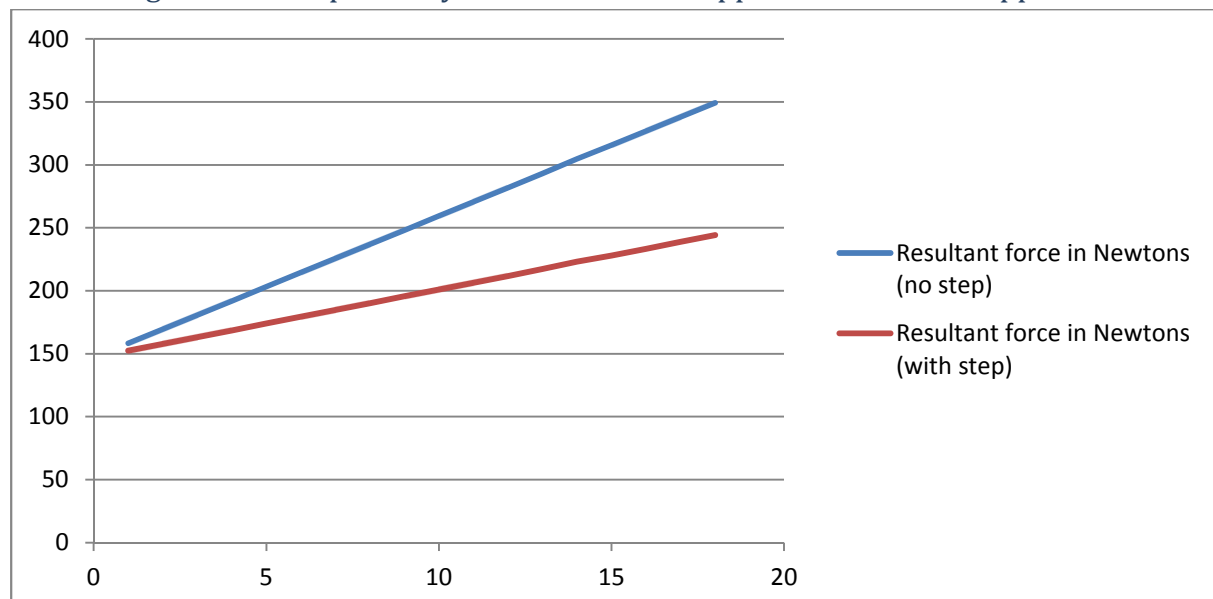
2.1.19 - Figure 28 – Graph 3 – Hydraulic Balance Stepped RSF vs Non-Stepped

- Spring force: 147N
- Force pushing RSF towards SSF due to product head = 202.28N
- Force pushing RSF back due to stepped face = 105.13N
- Resultant force acting on seal arrangement =  $(202.28 + 147) - 105.13 = \underline{\underline{244.15\text{N}}}$
- Repeating the above calculations without the hydraulic balance offered by a stepped sealing face equates to = **349.28N** (43% higher than with a stepped RSF)
- A non-hydraulically balanced seal is subject to higher force, increasing at a much higher direct proportion due to product level than a balanced seal. A graphical representation of this reduction in force can be seen in figure 28.

The closing force acting within the sealing assembly without the benefit of being hydraulically balanced results in a 43% increase, meaning a far higher chance of seal wringing.

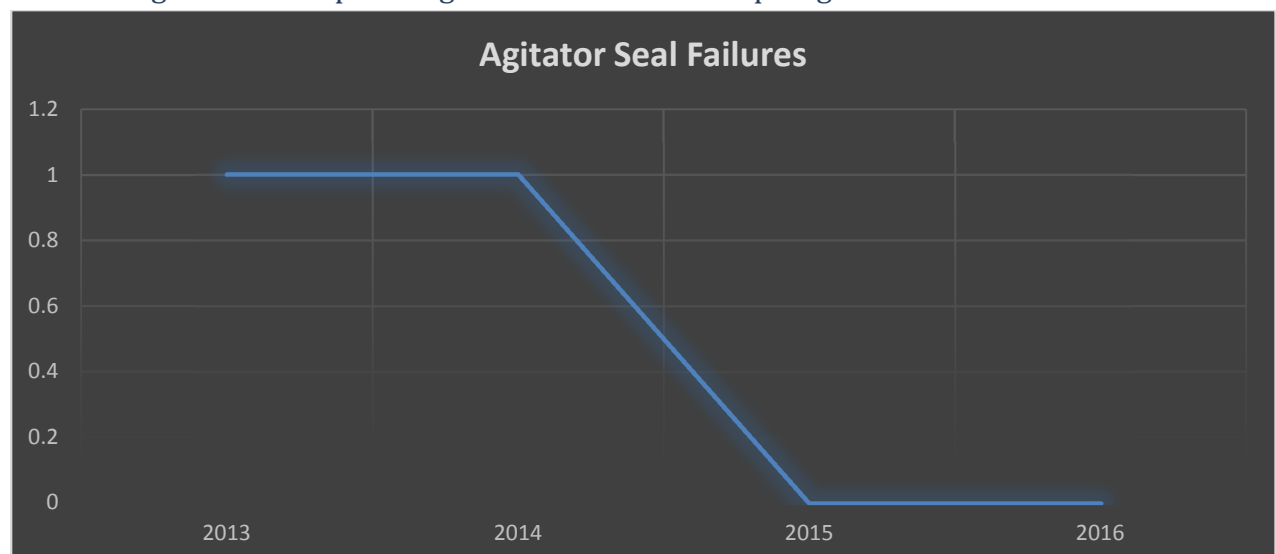
### 2.1.23 – Figure 32 – Graph 4 - Agitator Seal Failure Graphing

As with the pump seal failure logging performed since 2013, the agitator seal failure graphing also shows a clear downward trend, figure 32.

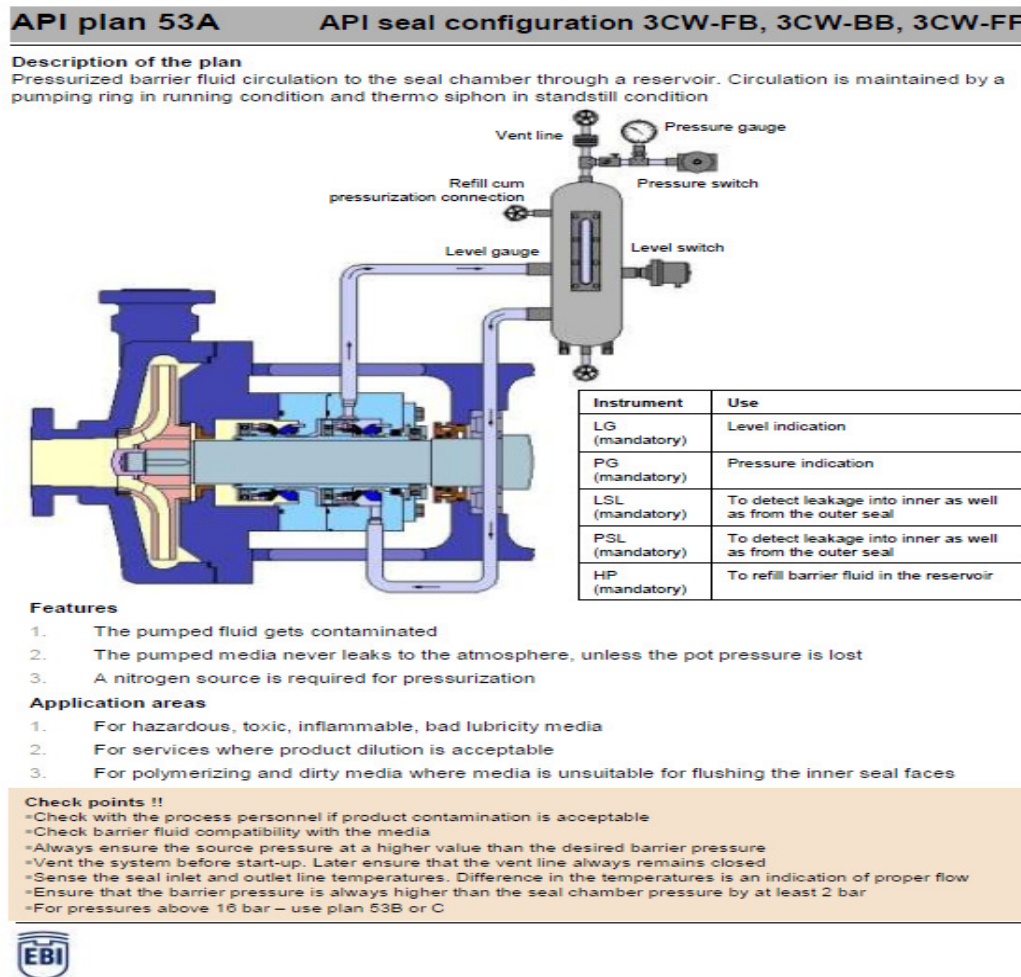
### 3.1.2 – Figure 33 – 53A Design Mechanical Sealing Arrangement

The '53A' design was recommended as the usage conditions met two of the three application guidelines within Figure 33; (1) For hazardous, toxic, inflammable, bad lubricity media, (2) For services where product dilution is acceptable.

Prior to performing of the retrofit of this system a Hazop, or Hazard and Operability analysis, was carried out by a third party, IPDS. The intention of the Hazop was to establish whether there was a need to carry out this alteration, and also assess whether in doing so any further problems could occur.

It was deemed that double mechanical seal fitment on the unit would reduce the chance of incident when compared to the single sealing arrangement currently in use, and was hence installed as depicted below. An extract of the IPDS Hazop can be found as Appendix 10.
