## **BUILDING CONDITION & RETROFITTING SURVEY REPORT**

**Property Address:** 113 Priory Road  
Milford Haven  
Pembrokeshire  
United Kingdom  
SA75 1TU

**Date:** 20<sup>th</sup> December 2025

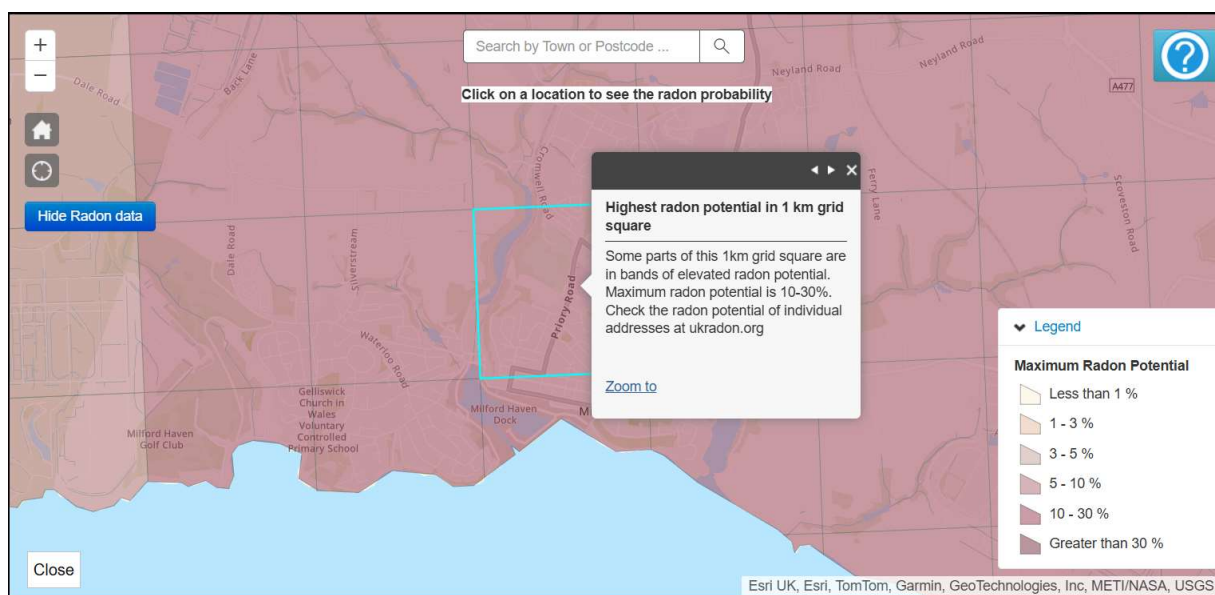
UKradon - UK maps of radon (no date)

Radon is a very high risk in Pembrokeshire, as per the data map below, this property located in Milford Haven as at the maximum percentage. Over 30%, the highest potential of radon gas seeping through the ground. This will have to be included in the proposed works to fit a radon barrier and a suitable escape for radon gases before they become dangerous to the tenants. The new floor detail as detailed below will allow a “void” and vents to allow for any dangerous radon gases to escape externally. The vents enter the cavity, gooseneck upwards and out the external leaf above the external path levels which will have to be dropped 150mm below the DPC line.
