University of Wales Trinity Saint David  
School of Engineering

Undertaking a Green Belt Project

ACMA 5005

| <b>Project Name</b> | <i>DBX rear quarter glass damage and defects</i> | <b>Business / Location</b> | St Athan |

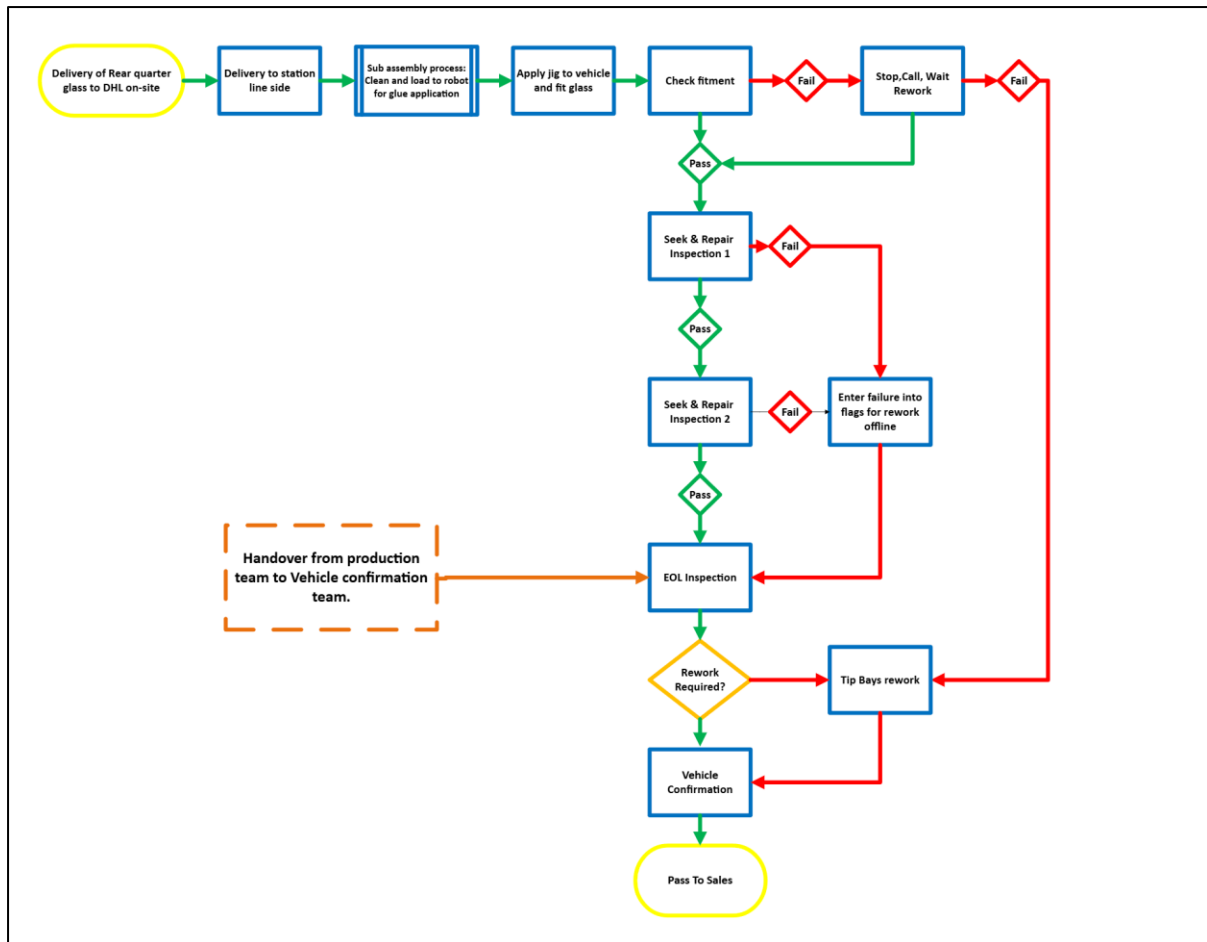
Figure 8-High level process map (Purnell-Whitehead, 2025)

Using the SIPOC study shown in 3.3 a high-level process map has been made (figure 8) to see the current production process that the problem part follows from its arrival into plant to the completed vehicle at pass to sales. Using the process map we can highlight potential areas to capture and/or rectify the issue in hand.

Immediately after mapping out the process, the inspection is at seek and repair station one. This raises concern as the fitted part passes through a significant amount of production stations before being flagged. Looking at Figure 9 there are no detection points for twenty-four stations between the first fit and first inspection. The second immediate concern is that there is no inspection at point of fit leading to the possibility of incoming damage.

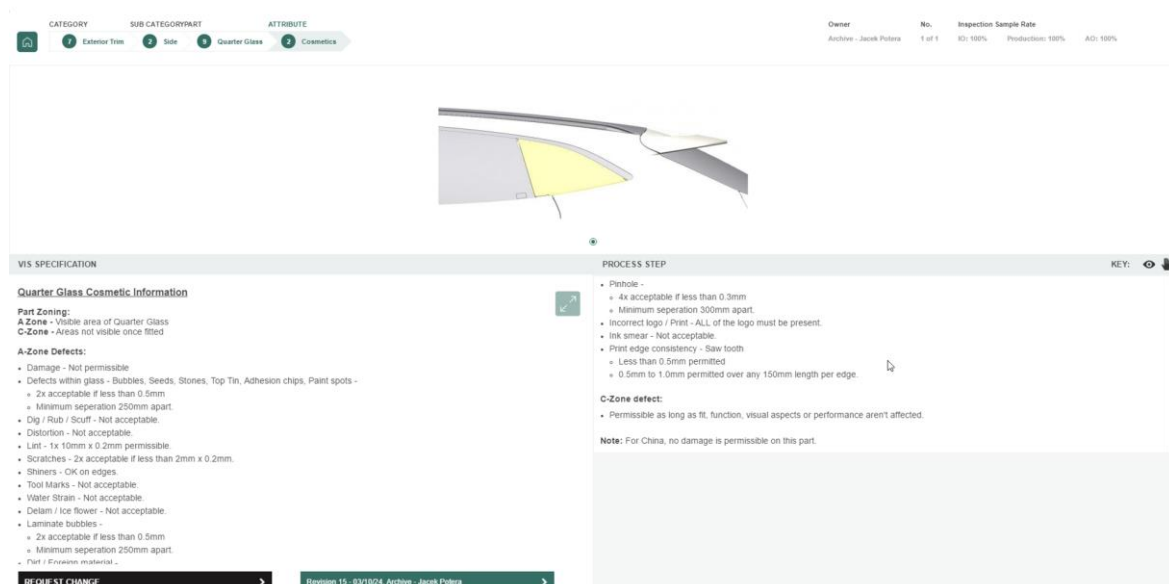
Figure 10: VIS specification for rear quarter glass (Aston Martin, 2025)

**People:** Technicians inspect to VIS (Visual inspection standards) set by the quality department. The specifications in figure 10 lists the defect that would result in defect call into the flags system against that vehicle. Due to the process being a visual operation this means that variation from one inspector to another is possible.

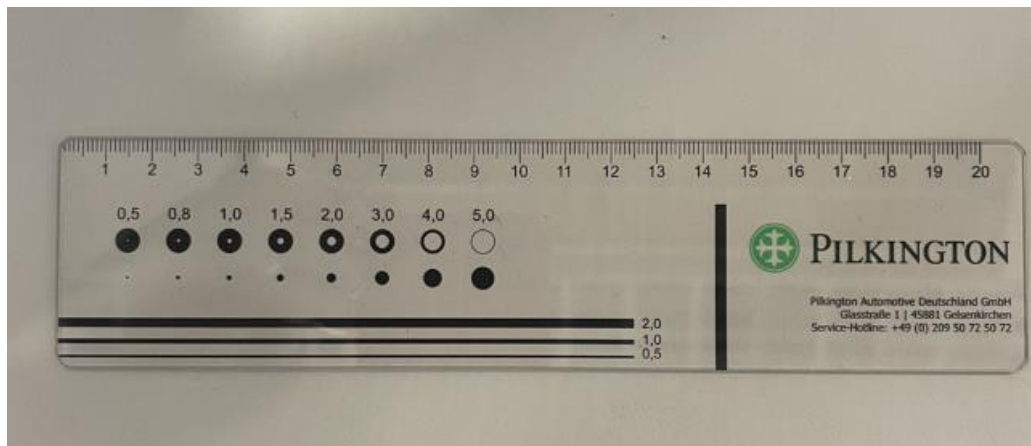
Figure 11: Pilkington glass defect gauge. (Purnell-Whitehead, 2025)

To alleviate the chances of variation, the inspectors are given a measurement gauge supplied direct from the glass manufacturer to help to determine legitimate calls.

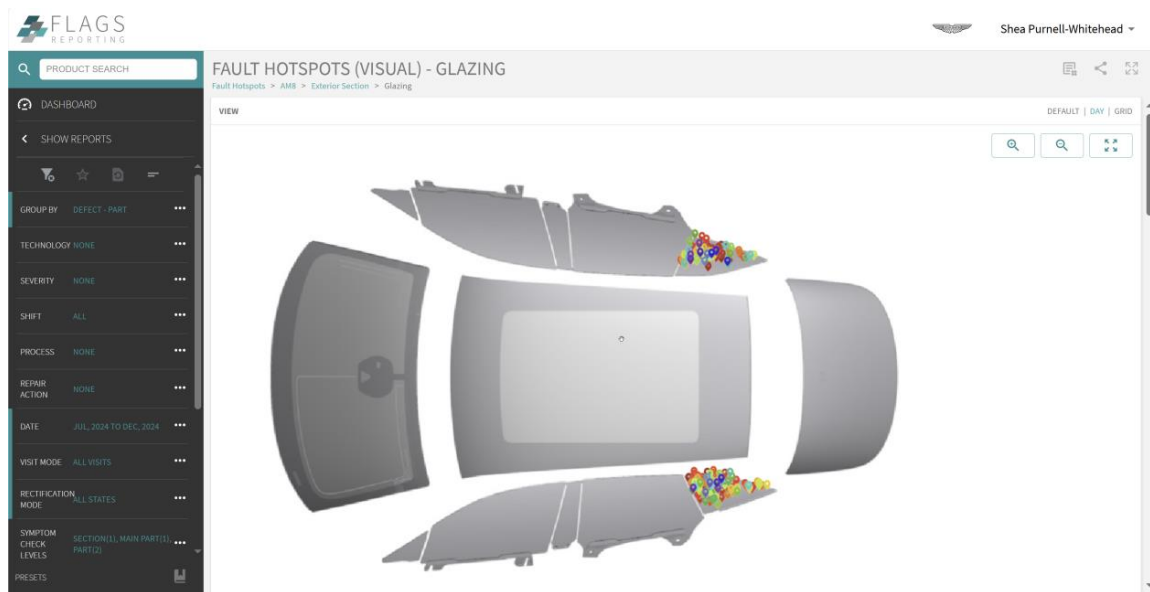
Figure 13:Flags inspection reporting software (Purnell-Whitehead, 2025)

Figure 12 shows that in the six-month period between July 2024 and December 2024 a total of eighty-six defects have been reported across the three-inspection station throughout trim and final. The reporting software also gives the inspector to label the exact location and type of defect that is being reported (Figure 13). The damage reported is in the same proximity of the glass. Repeated damage in the same proximity could be a sign of a process issue.

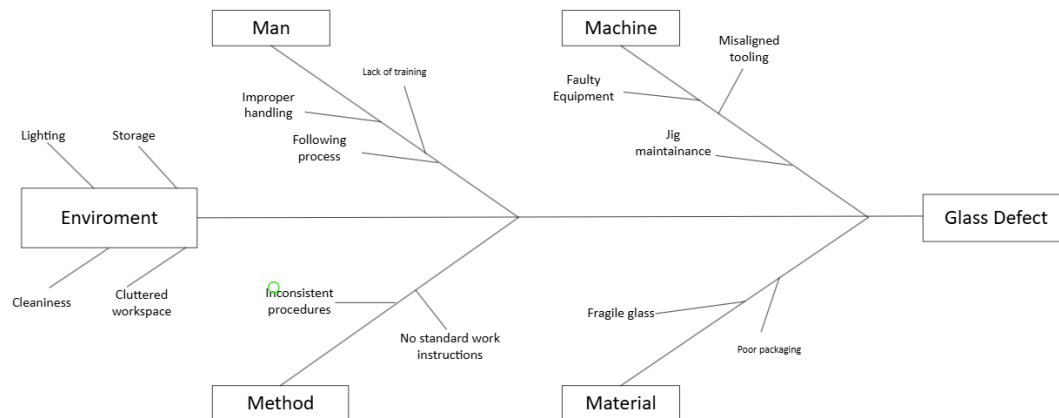
Figure 17: Ishikawa fishbone analysis (Purnell-Whitehead, 2025)

Kaoru Ishikawa introduced seven fundamental quality tools. Among these tools is the cause-and-effect diagram (CED), commonly referred to as “The Fishbone” or “Ishikawa diagram.” Delving into this inquiry can illuminate the initial evidence supporting the claims of Ishikawa that the primary issues faced by companies lie within their processes and possibly, at a deeper level, in some of the essential root causes related to organizational management (Suárez-Barraza & Rodríguez-González, 2019). The Ishikawa fishbone analysis (figure 17) has been carried out. This analysis helps identify and categorize potential root causes of the glass defect.

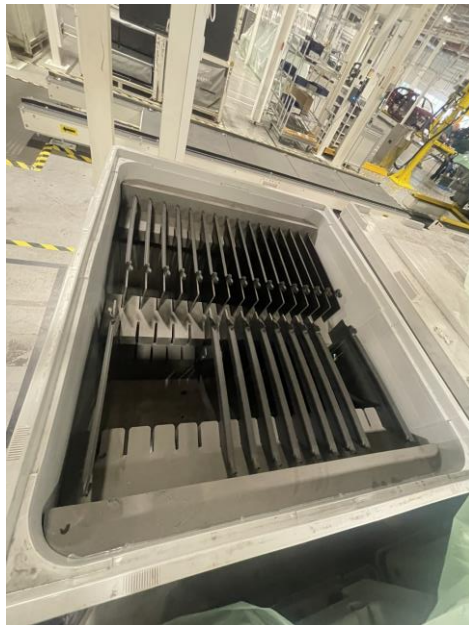
Figure 18: Parts quality standard and image of stillage for glass storage and shipment (Aston Martin, 2025)

Pilkington the glass supplier has a 100% inspection before shipment. Aston Martin supply foam line stillages. The stillages are packaged at suppliers and are not open again until the stillages reach lineside ready for fitment (Figure 18).

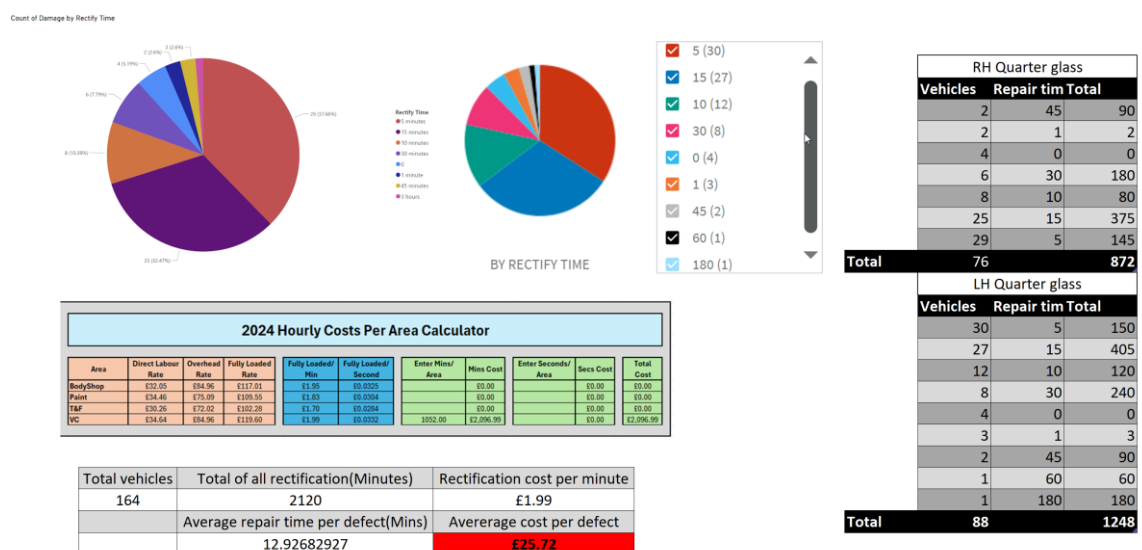
Figure 27: Calculation of rework cost (Purnell-Whitehead, 2025)

Over the six months period in which the data has been gathered. Using the calculations in figure 27 at a cost of £1.99 per minute of rework and a total of 2120 rework time, a total cost of £4218. Giving and average cost of £25.72 per defect.

- **Protective Padding/Guards:** The initial investment in padding and installation was estimated to be low as the covers are made internally by recycling offcuts of leather from the trim shop. Compared to the potential savings from reduced rework and scrap.
- **Reducing rework time-**
