# BUILDING SURVEY REPORT

[13th January 2023]

Woodland Avenue

Building Surveying

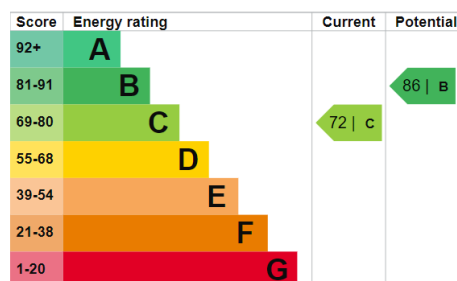
### Energy & Sustainability Performance

Using the information provided on the Energy performance register and similar properties in the area, this property would be considered a 'C' Grade with a potential of a 'B' if necessary, works were to be carried out.
