# Probability of Detection of Floormap Evolution

Presented by Elizabeth May Roberts  
Student No: P147274

Major project dissertation  
BEng Mechanical and Manufacturing Engineering  
Submitted to the University of Wales Trinity Saint David Faculty of Engineering  
In association with Eddyfi technologies.

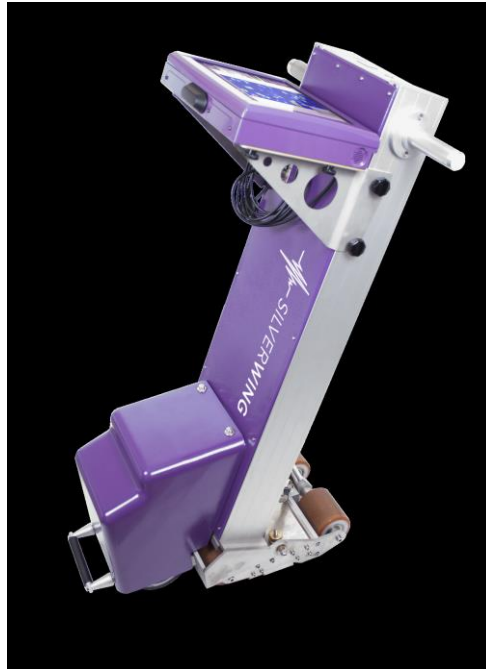
*Figure 1:Image of Floormap 3di [3]*

The FM3Di is Eddyfi's Flagship product. The FM3Di is among one of the most advanced inspection systems on the market with the latest MFL complex mapping capabilities. The system incorporates 20 years of inspection experience and utilise two technologies (MFL and STARS) to provide detailed data on AST floor defects. [2].

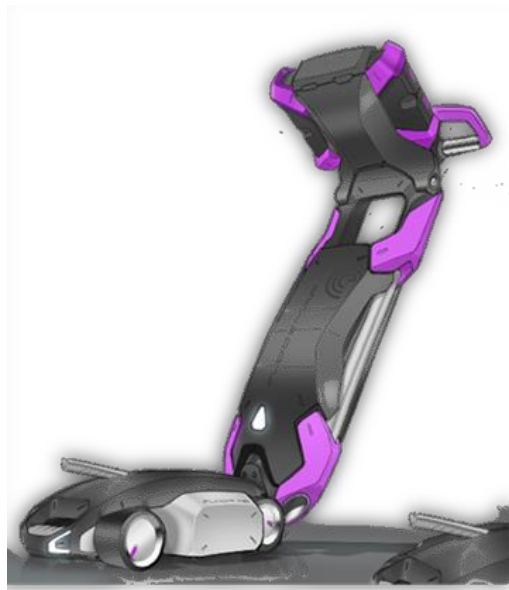
*Figure 2: Image of FMX, [4]*

The FloormapX is currently under development by Eddyfi Technologies and is similar system to the FM3di. The FMX has several system improvements, such as; the ability to scan up to 16mm thick plates, additional STARS sensors, enhanced reporting software, increased lift off to 8mm, motorised adjustable magnets and an enhanced light weight system. The FMX system used in this work is a prototype.

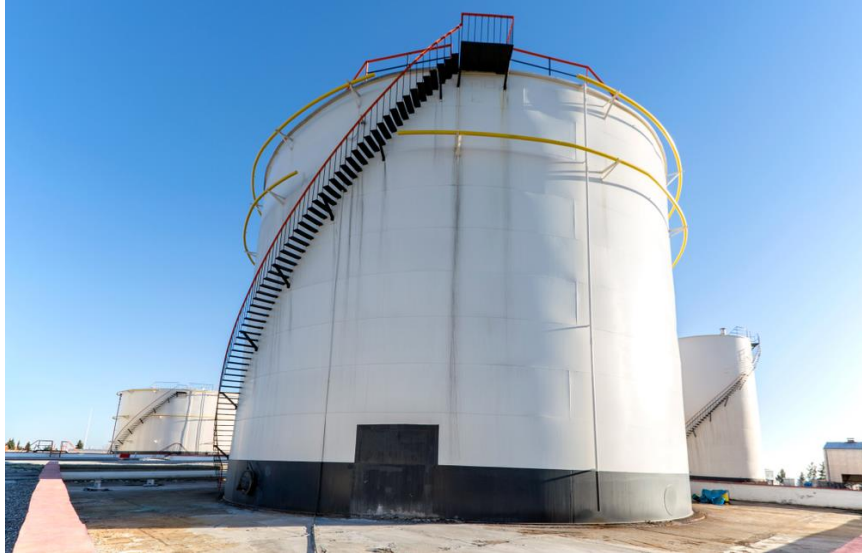
*Figure 3: Above Ground Storage Tank [7]*

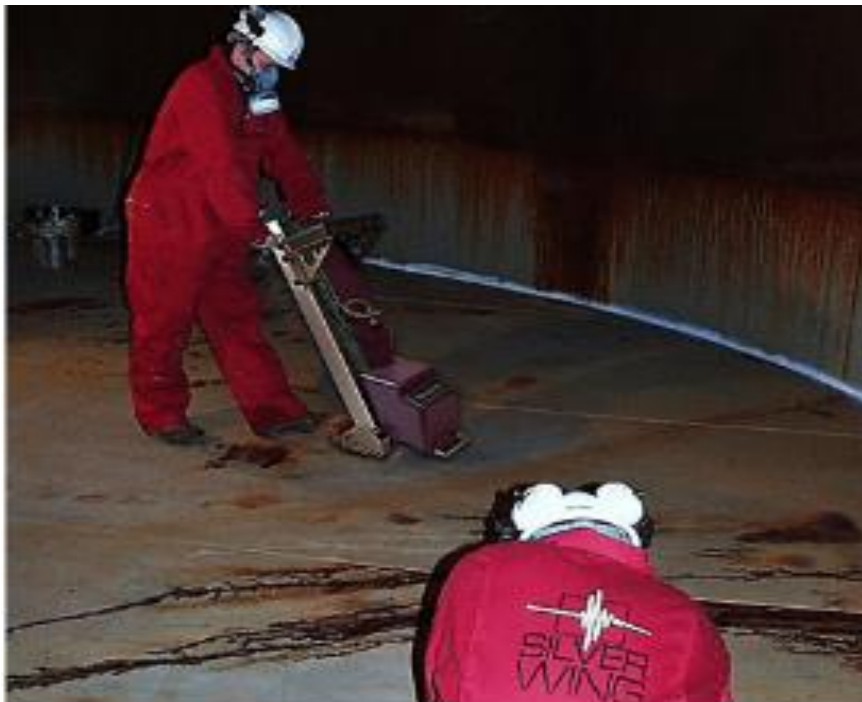
*Figure 4: Out-of-service tank floor inspection with floormap in hazardous tank environment. Image provided by Silverwing (UK) LDT. [8].*

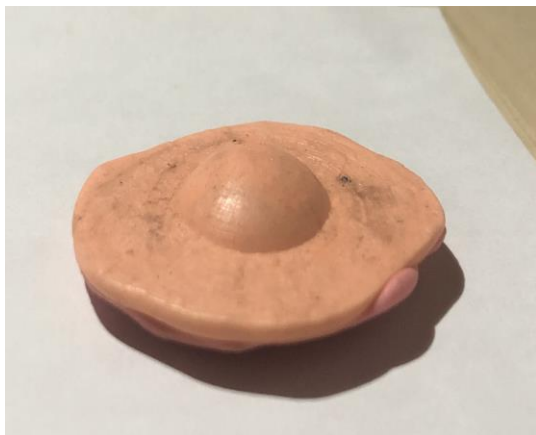
*Figure 11: A mould of an emulated defect, [52].*

To gather realistic data, both emulated and real defects will be used in this project. The emulated defects are holes which have been drilled to a specific size and depth. The emulated defects are characterised as 20%, 40%, 60%, and 80% defects. By using these defects, it enables us to establish the accuracy of the floormap at detecting the depth and size of a defect, as the defect dimensions are already known. Although this is beneficial for laboratory conditions, these types of defects are not beneficial for proving the performance of the floormap within industrial inspection conditions. Therefore, plates with corrosion and natural defects are also scanned with both floormap systems. Some of the plates which were used for this project had been removed from in-service above ground storage tank floors. Using these types of plates allows us to gather realistic data with the floormap, on corroded and pitted defects which could potentially be seen on tank floors. The defects are also manually measured with a pit gauge (Seen in Figure 11) and then verified by creating moulds (seen in Figure 12) of the full defect and manually measuring those defects (seen in Figure 13) for more accurate results. The epoxy mould has the ability to enter areas of the defect which the pit gauge is unable to, this provides more accurate results. The manual results are compared to the data gathered from the floor map scans and enables us to establish whether the floormap is detecting the defects correctly.

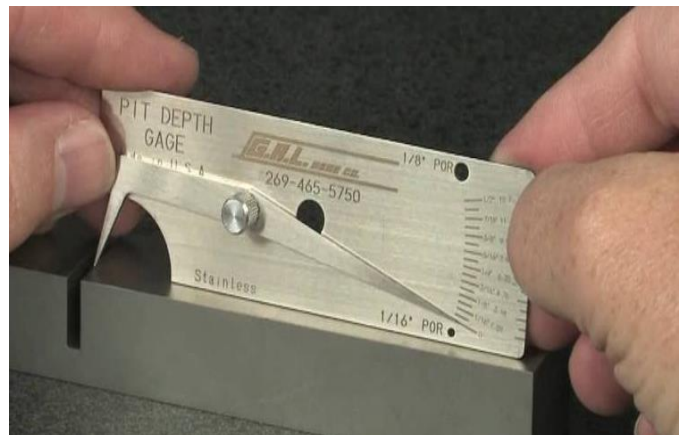
*Figure 12: An example of Pit gauging, [53]*

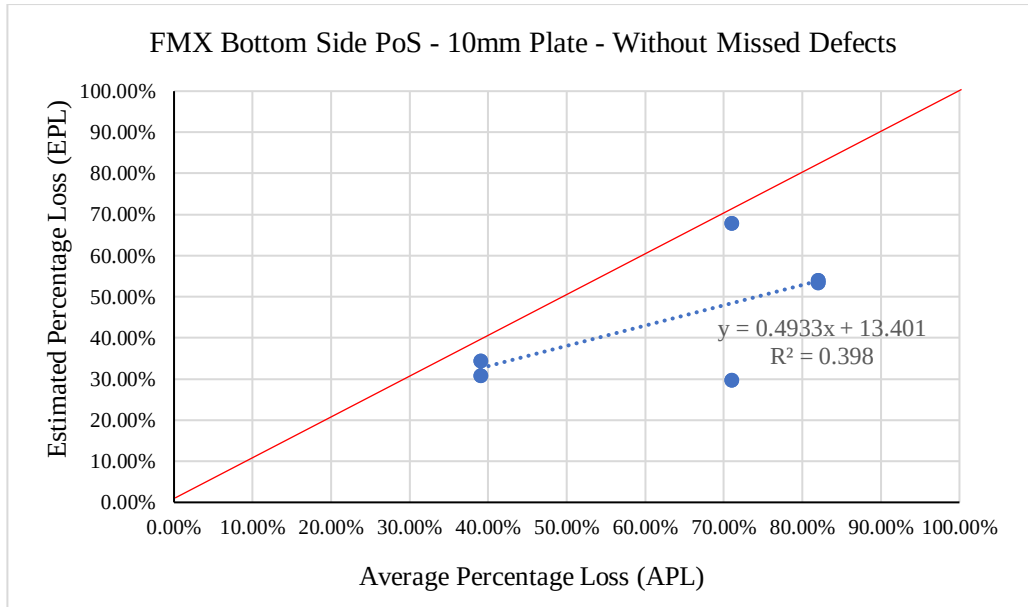
Figure 39: Bottom Side Sizing Capabilities in a 10mm plate, [76].

The above Figure shows a complete under sizing of all defects detected, a gradient of 0.4933, a R2 value of 0.398 and a standard deviation 22.68 is seen. There is little correlation between the data and the trend line which indicates a high-level error could be incurred.
