# Site Investigation Case Study

ACBA4001 Fundamentals of Construction Technology

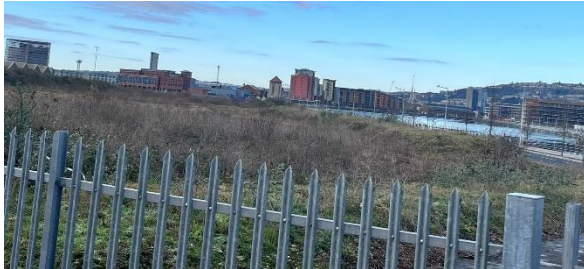
Figure 2 - East perimeter photographed on walkover survey.

Figure 2, taken on the walkover survey shows that there are no existing structures or buildings in situ, the site is slightly elevated with uneven, overgrown ground. Figure 3, dated 2012, shows remnants of rubble remain on site, which may not have been cleared in recent years. There is no indication on site of overhanging or underlying utilities.

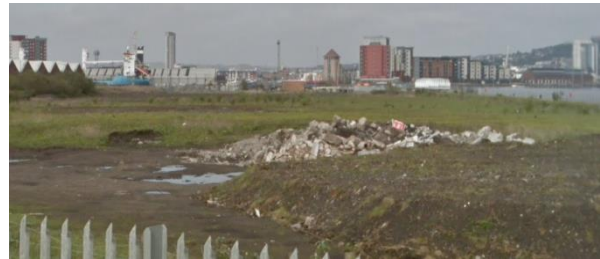
Figure 3 - Google Maps image dated 2012 of East perimeter. (GoogleMaps.com, 2023)

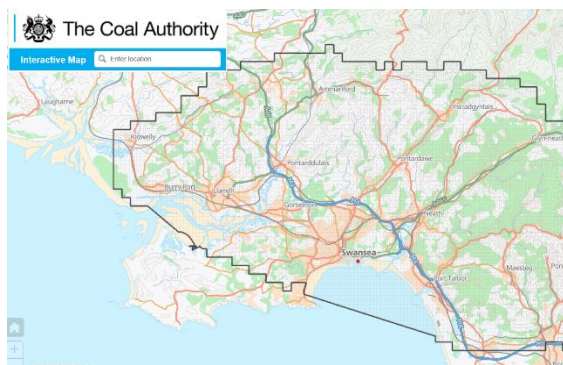
Figure 7 – Map showing Coal Mining Reported Area (The Coal Authority, n.d.)

A search using the Coal Authority interactive map viewer shows that the development site is within a coal mining reported area (Figure 7), however the site does not sit in

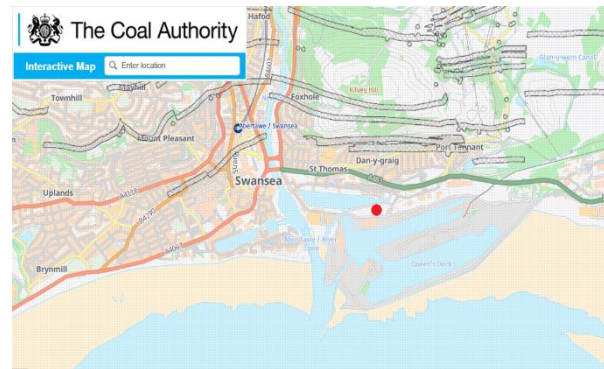
Figure 8 – Map Showing areas of developmental risk hatched in Black and site location marked Red. (The Coal Authority, n.d.).

an area of developmental risk. (Figure 8)

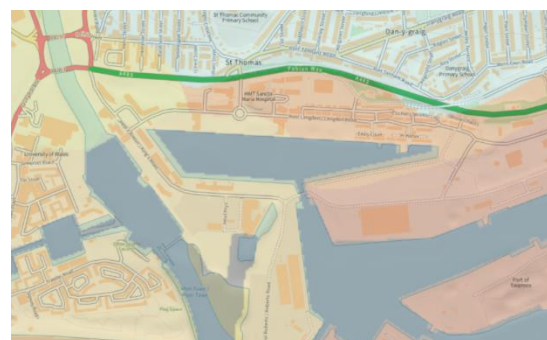
Figure 9 - Extract map from BGS Geology viewer showing the mix of bedrock underlying the site. (British Geological Survey, n.d.)

Research using the British Geological Survey Geology Viewer shows that the underlying bedrock is made up of Mudstone, Sandstone and Siltstone and quotes that the sedimentary bedrock formed between 318 and 309.5 million years ago during the Carboniferous period. The superficial deposits on site are made up of sand and gravel. (British Geological Survey, n.d.)

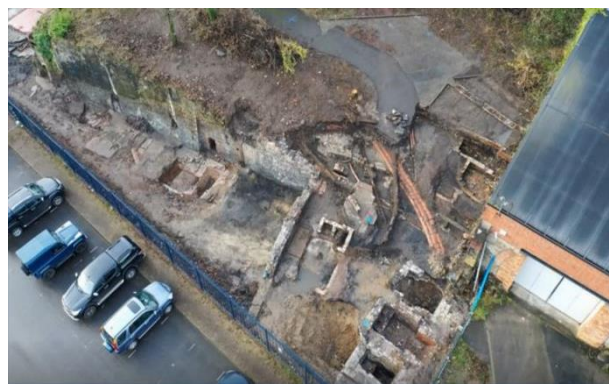
*Figure 11 – Ariel view of a the Hafod-Morfa site showing underlying open cavities. (Nantel, 2023)*

In a bid to regenerate the Kilvey Hill and its surroundings, redevelopment of the area began, back fill was excavated, and the underlying historical site was uncovered. It was discovered that cavities, engine beds, pits had been underlying the site and had not been properly managed, simply filled and covered over. Archaeology teams were
