# The Kyrenia Ship: An Interim Report on its Hull Construction\*

J. RICHARD STEFFY

## Abstract

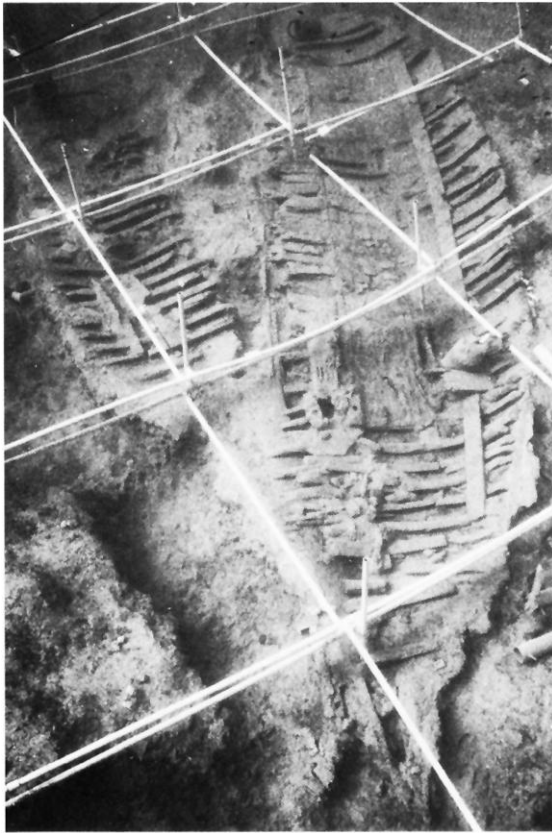
FIG. 1. Kyrenia ship, hull in situ. (Photo John Veltri)

The wreck apparently settled gently on the seabed, coming to rest on its port bottom at a list of about 15 degrees. Its amphora cargo on the port side was hardly disturbed. Both sides of the hull separated from the keel, the starboard side swinging outward at its after end (pl. 21, fig. 1). Internally, most of the port ceiling strakes, a few starboard ceiling pieces, a mast step, two stanchion steps, parts of three cross-beams or planks, and some dunnage survived (ill. 1). Externally, about 60% of the hull area and more than 75% of its representative timbers were preserved (ill. 2). Numerous rigging artifacts, a steering oar blade, and scattered fragments and fastenings provided additional information about portions of the vessel which had disappeared.

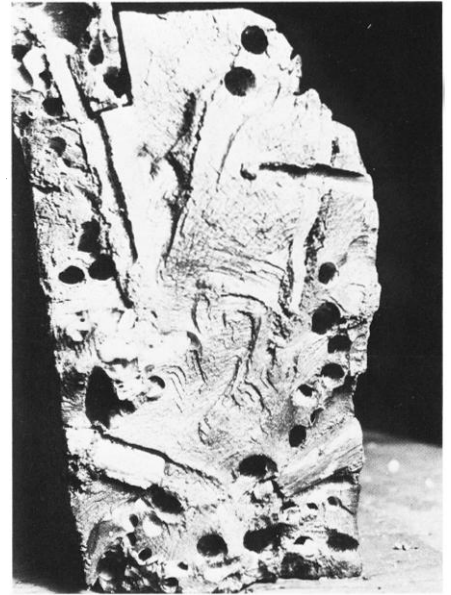
FIG. 2. Kyrenia ship, a lateral break in the keel, showing square side pegs and a fragment of garboard attached to the keel by a mortise-and-tenon joint. (Photo Robin C. M. Piercy)

Tapered square pegs were wedged into round holes in the sides and bottom of the keel. Side pegs (pl. 21, fig. 2) were driven obliquely downward and trimmed even with the sides of the keel. They averaged 1.6 cm. on each side at the keel surface and had no obvious use. They were so obscure and blended so well with the rest of the keel surface that only five of them could be confirmed. A dozen more were suspected in eroded and worm-infested areas.

Three treenails and 62 square pegs or peg remnants were found in the bottom of the keel (pl. 21, fig. 2; ill. 3). Most pegs were about 1.5 cm. on a side at the keel surface and tapered to 1.1 cm. on each side at their inner ends where visible. One penetrated the keel to a depth of 5 cm.; another was 6.2 cm. long. Parts of some of these pegs were found in the false keel which they attached to the bottom surface of the keel. The three treenails were 1.2, 1.3, and 1.5 cm. in diameter; they were cut flush with the bottom surface of the keel.

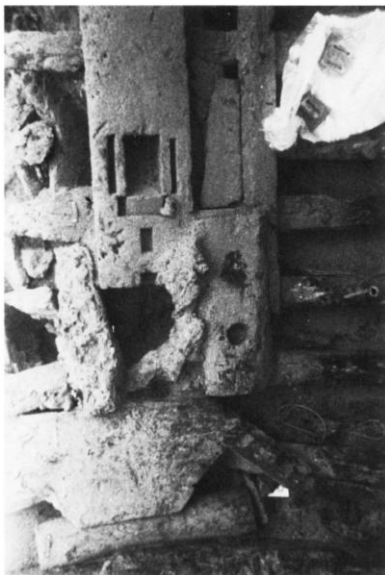
FIG. 4. Kyrenia ship, the mast and stanchion steps before raising; the bilge sump is directly forward of the mast step. (Photo Robin C. M. Piercy)

degree of importance with which ancient ship carpenters regarded frames. Frame 40 was sawed off—not bridged or offset by substitute timbers, but simply eliminated—between the second and third strake seams on either side of the hull (pl. 21, fig. 4). Frame 40 was just aft of the unbolted keel/stem scarf. The entire chock and central floor area then was removed to make room for the sump. The saw marks still remain on the upper edge of port strake 2, where that cut was made (rather clumsily, I feel), and the discoloration and impressions of the once present chock can still be seen. Four frame nails had penetrated the strakes here, and these were removed; tapered wooden plugs wedged with tiny pegs or nail shafts were used to close the holes. The sump (an unwallled opening, really) thus produced was several meters forward of the lowest part of the keel, but with cargo covering the limber boards in the hold, it was as far aft as it could be placed for regular access. A broad piece of scrap-wood was laid across the two frames forward of the sump to serve as a platform for the bilge pump operator who, I assume, used a leather bucket.
