## The 5th-Century BC Shipwreck at Tektaş Burnu, Turkey: evidence for the ship's hull from nail concretions

Wendy van Duivenvoorde

The Tektaş Burnu ship (440–425 BC) sank along a rough and desolate stretch of the Turkish Aegean coast. Archaeological excavation of the shipwreck site by the Institute of Nautical Archaeology at Texas A&M University resulted in the retrieval of hundreds of small fragments from the ship's wooden hull and its metal fasteners. Recent study of this artefact assemblage suggests that the coastal trader was built with pine planks and made-frames, and assembled by a shell-based construction method. Fasteners include pegged mortise-and-tenon joints and double-clenched copper nails, and the ship may have had laced extremities consistent with other contemporaneous shipwrecks.

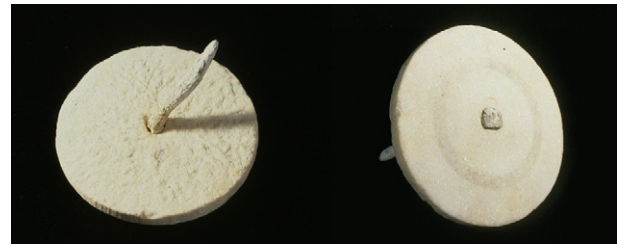
Figure 3. Marble *ophthalmoi*, or the ship's eyes, each measures c.140 mm in diameter. Tektaş Burnu, Turkey. (Photograph: Don Frey, INA)

The *ophthalmoi* are about 140 mm in diameter, retain remnants of the decorative concentric lines that were incised and painted on them, and were fastened to either side of the bow with a lead spike (Figs 2–3) (Nowak, 2001; Carlson, 2003: 594–6; 2009: 354–6). They symbolized the ship's 'eyes', and their location at the upper end of the site indicate the ship's orientation on the sea-bed. This orientation is corroborated by the location of the main assemblage of utilitarian and personal items belonging to the crew, which were found at the opposite end of the site; such items typically are stored in the stern area of the ship (Trego, 2004: 17–9, 21–2, 24–5, 33–8; see also Eiseman and Ridgway, 1987: 26–36; Artzy and Lyon, 2003; Kahanov, 2003: fig. 1; Udell, 2003; Sitry, 2004; and Katzev, 2005: 75–6).

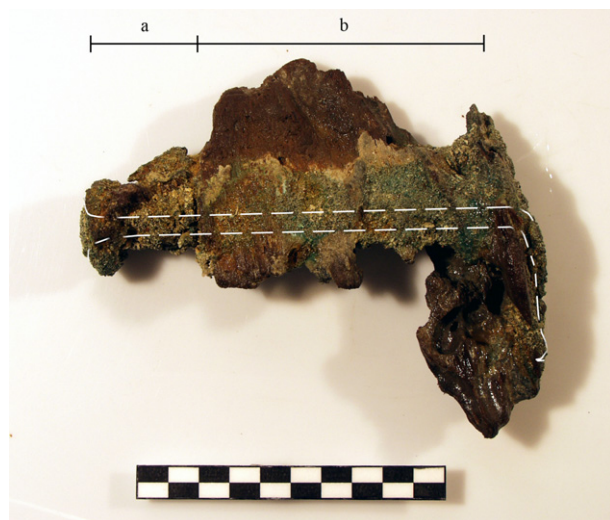
Figure 4. Double-clenched copper nail (white dashed outline) with hull planking (a) and frame wood (b) preserved around its shaft, lot number 881. Tektaş Burnu, Turkey. (Photograph: Wendy van Duivenvoorde)

be positively identified as hull planking and frame wood (Fig. 4). Although the wood remains represent only the vestiges of the actual planks and frames, they provide useful information about the ship's hull, such as planking thickness, moulded dimensions of the frames, and the types of wood from which these components were fashioned.

Several frame fragments of the Tektaş Burnu ship indicate the use of made-frames. These small fragments of timber suggest rounded frame tops and floor-to-futtock scarfs with square treenails (Fig. 17). In using copper nails to join made-frames to planking, the Tektaş Burnu ship most closely resembles the Jules-Verne 7, César 1, Grand Ribaud F and Ma'agan Mikhael ships, and therefore, like these hulls, may also have had laced extremities (Kahanov and Pomey, 2004: 6–19, 21–2). Moulded dimensions of frame fragments from Tektaş Burnu were measured on 25 double-clenched nail/wood concretions; they vary from 57 mm to 140 mm, and average 91 mm (Fig. 4).

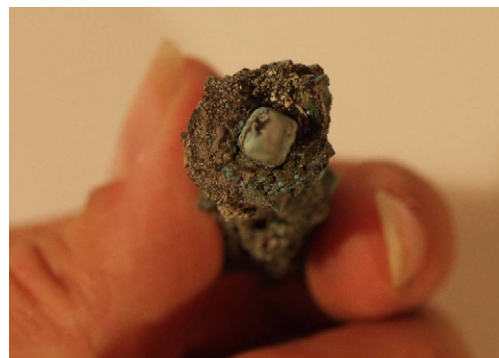
Figure 6. Square cross-section of copper nail shaft with concretion layer around it, lot number 515 (shaft 5 × 5 mm). (Photograph: Wendy van Duivenvoorde)

measurable nail shafts have an average thickness of 6 mm and were originally square in cross-section (Fig. 6). Generally, the first 20 to 30 mm directly beneath the nail-heads are circular in section and range in diameter from 7 to 12 mm (averaging 9 mm). The tips of the nails taper to a fine point. The nail-heads, mostly circular with rounded tops, have an average diameter of 22 mm.

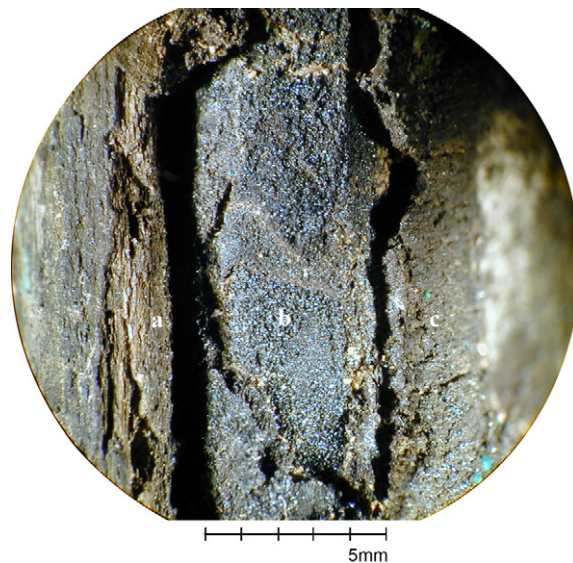
Figure 13. Double-clenched copper nail driven through treenail, lot number 881.02. Treenail (a) visible only on left side of nail shaft (b), as revealed by wood grain running parallel to nail shaft, whereas wood of frame (c) on the right side of nail runs perpendicular to shaft. Tektaş Burnu, Turkey. Dissecting microscope, magnification  $\times 120$ . (Micrograph: Wendy van Duivenvoorde)

The treenails are only just visible as a thin layer of copper-impregnated wood around the nail, with wood grain running parallel to the nail shaft (Figs 13–14). Unlike the Kyrenia ship, where the treenails have a maximum diameter of 13 mm, the pre-drilled nail holes and treenails of the Tektaş Burnu ship range from 8 to

11 mm. These treenails, therefore, are only a few millimetres larger in diameter than the nails, and are hardly visible to the untrained or un-aided eye. An additional complicating factor is that the nails are not always driven straight through the centre of the treenails. Several nails had treenail wood on only one side, indicating that the nail had diverged to the side of the treenail when it was hammered through (Fig. 13). In some cases, the treenail was split as a result of hammering the nail.

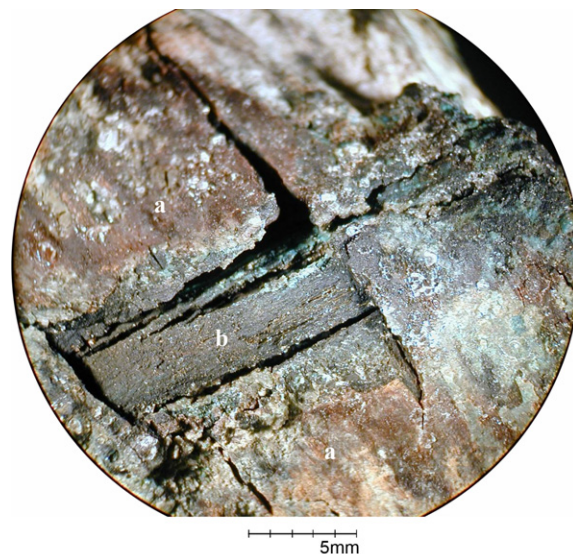
Figure 14. Frame wood (a) containing treenail (b), through which double-clenched nail is driven, lot number 810.01. Nail shaft is located underneath the treenail and, thus, not visible in this micrograph. Tektaş Burnu, Turkey. Dissecting microscope, magnification  $\times 60$ . (Micrograph: Wendy van Duivenvoorde)
