## Report No. 1

# **The 4th century wreck at Yassi Ada An interim report on the hull**

**Frederick H. van Doorninck, Jr.**

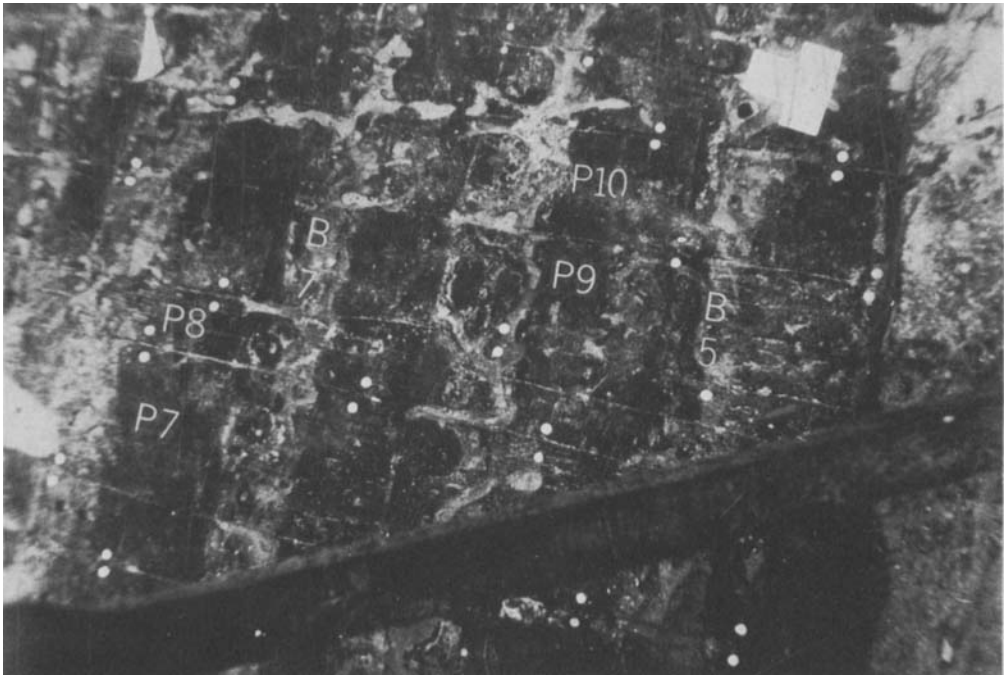
Figure 2. Close-up photograph of planking. Frame remnant of B-4 appears *in situ* along right edge of photograph. White T and triangle are targets used in photogrammetric mapping of hull remains.

show up clearly in both close-up and stereo-photographs (Fig. 2). All surviving planking forward of B-14 was uncovered, thoroughly cleaned, thumbtacked and photographed during the 1969 season. A series of maps of most of this planking was made on plastic sheets for underwater use at the outset of the 1974 season. A mark was made at every point on the maps where there appeared to be any likelihood that a peg or pair of pegs had escaped detection in 1969. After the planking had been uncovered, cleaned again and labelled for easy orientation, divers methodically re-examined the planking with maps in hand, thumbtacked any additional pegs detected, and recorded their locations on the maps. A second series of close-up photographs of the planking was then made. We managed to complete a re-examination of P-2 through P-19 from A-3 to B-14 in this way during the few weeks of the 1974 season and have every confidence that the number of pegs that have escaped notice within this area of planking are very few indeed. Forward of A-3 and aft of B-14, the planking has been thumbtacked and photographed but once. In these areas, then, a greater number of pegs have gone undetected.

A layer of pitch was found adhering to the inner face of the planking where each frame had been set. The original outer edges of these deposits were quite straight and occurred precisely where the side faces of frames had been located (Fig. 2). In view of this exact correspondence, it would appear that pitch was applied to the under face of each frame section just before its final installation. Admittedly, only an occasional trace of pitch was found on the under faces of the frame remnants. However, the frames had tilted over on their sides to varying degrees during the process of wreck formation, and their under faces without exception had been well scoured by the action of currents and sand.

The straight outer edges of the pitch deposits often appeared as thin, white lines in photographs taken of the planking (Fig. 2). At first, I wrongly supposed many of these edges to be score lines and unfortunately stated that score lines showing where frames were to be set were abundant on the inner face of the planking (Bass & van Doorninck, 1971: 31). Although there were indeed many random and irregular scratches on the inner face of the planking, I was able to find and carefully examine in 1974 only one long, straight, incisive scratch located where a frame edge had been set (Fig. 10). This scratch, occurring on P-7 to 9 where the after side of B-1 was located, had every appearance of being a score line and has been indicated on Fig. 1 with the label SL.

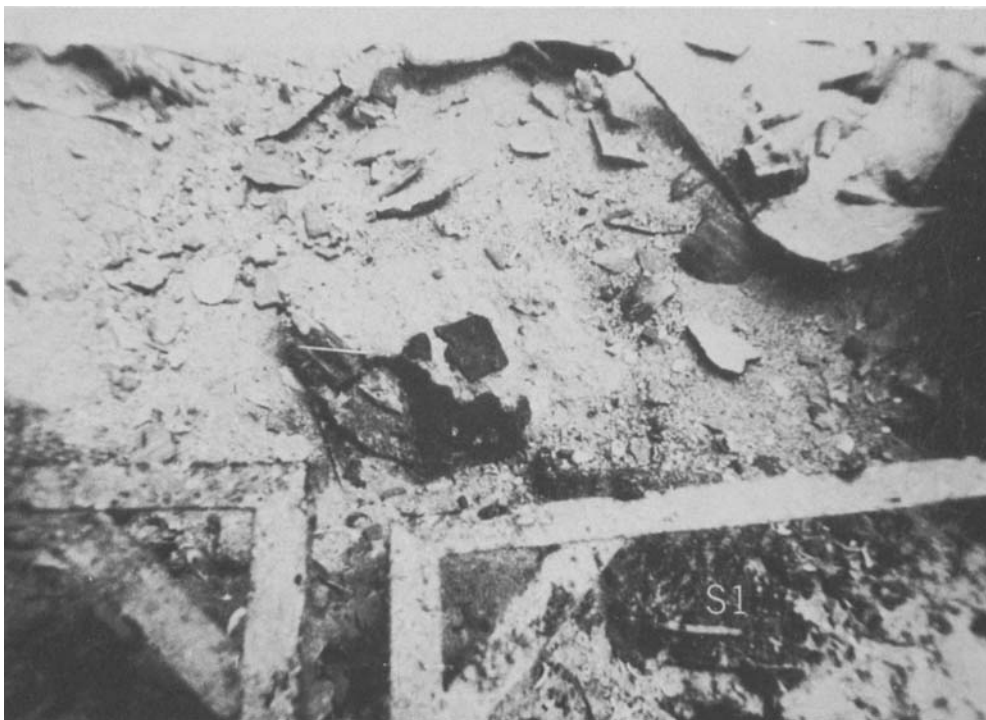
Figure 11. Lead patch *in situ* next to starboard garboard (S-1). Wood fragment overlies left-hand portion of patch. Notice that patch's two visible corners are rounded. Some of the tack holes running along patch's four edges are faintly visible in photograph.

the sheets are known and are indicated on Fig. 1 by the label L: one was found lying against the keel remnant at A-5; the other (Fig. 11), underlying a small fragment of wood immediately to starboard of S-1 at A-3. The approximate find spots of two of the other sheets are known: one of these was found beneath the sternpost where the after ends of P and S-2 were attached to it; the other, somewhere around A-9 to 10 about 11 strakes out from the stem on the port side. The fifth sheet was found somewhere between A-11 and 16 within c. 1 m to port of the stem.

The sheets were generally about 0.001 m thick. Surviving corners were rounded. One of the corners of the sheet found next to S-1 appears clearly in Fig. 11. The sheets varied in size. The largest one, found underneath the sternpost, measured 0.265 × 0.17 m; the ones found forward of A-11 and around A-9 to 10, 0.175 × 0.149 m and 0.174 × 0.121 m respectively. The smallest sheet was the one found next to S-1. Its measurements are not available to me at the moment, but the sheet appears in

Fig. 11 along with the corners of two angle iron frames of known dimensions. I estimate on this basis that the sheet measured c. 0.149 X 0.101 m.
