Course: BSc (Hons) Electrical & Electronic Engineering  
Module: SGEL6000 Independent Project  
Assignment: 2. Project Design, Implementation and Evaluation  
Name: Jonathon Williams  
University Number: 1708159  
Date Submitted: 06/05/2022  
Word Count: 5823

| 8.2 Appendix B- Interface Electrical Schematics..... | 24 |

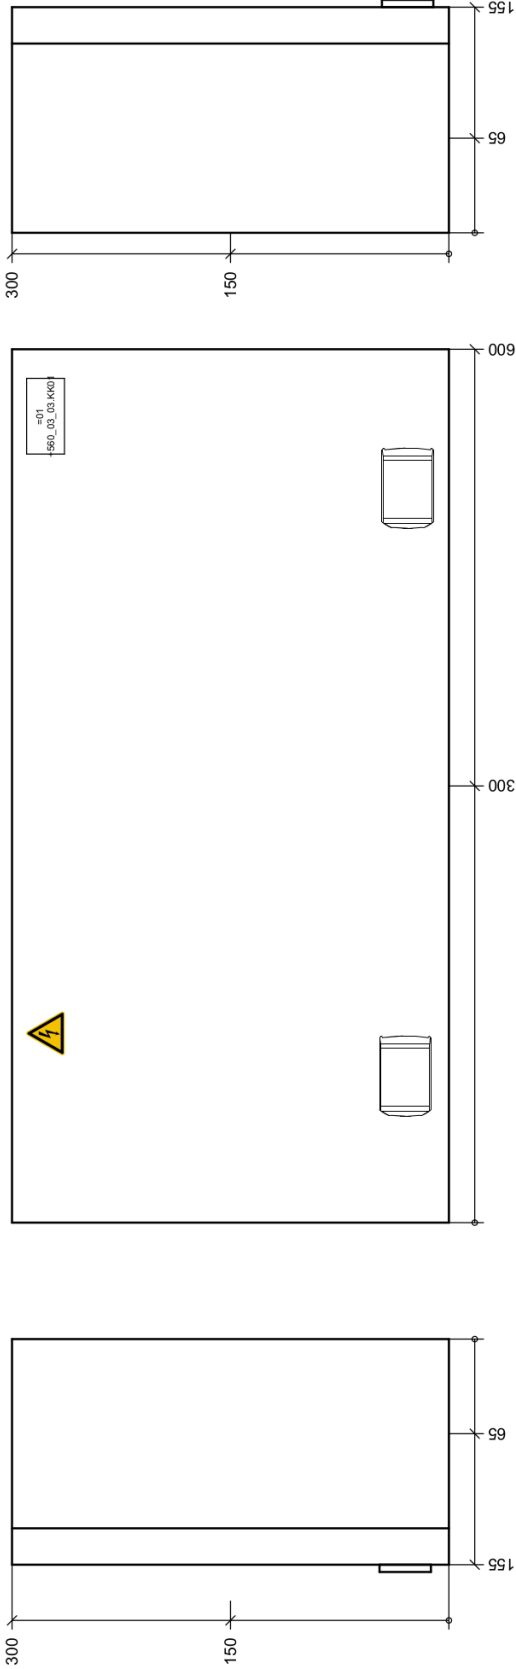
## 8.2 APPENDIX B—INTERFACE ELECTRICAL SCHEMATICS

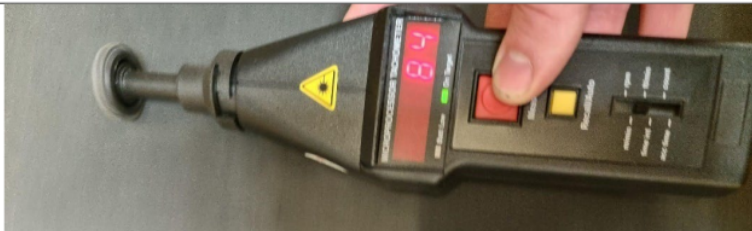
| Test | Evidence | | | | | | | | | | | | | | | | | | | | | | | | | | | | | | | | | | | | | | | | | | | | | | | | | | | | | | | | |
|---|---|---|---|---|---|---|---|---|---|---|---|---|---|---|---|---|---|---|---|---|---|---|---|--|---|---|---|---|---|---|---|---|---|---|---|---|---|---|---|---|---|---|---|---|---|---|---|---|---|---|---|---|---|---|---|---|---|
| 9 | <p>Figure 10 - Belt runs at 84 ft/min</p> | | | | | | | | | | | | | | | | | | | | | | | | | | | | | | | | | | | | | | | | | | | | | | | | | | | | | | | | |

| 9 | P1.2 | Measure belt speed using tachometer | Speed is between 80±5 ft/min | Speed is 84ft/min Figure 10 | Pass |

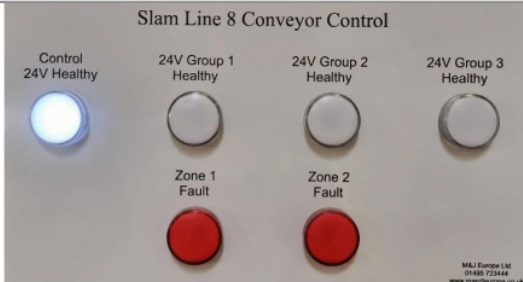
Figure 13- E-stop activated and all power supplies have disconnected

| 14 | S1 | Activate emergency stop | On activation of E-stop, the line will stop and energy will disconnect. | Line stopped and energy disconnected. Figure 13 | Pass |

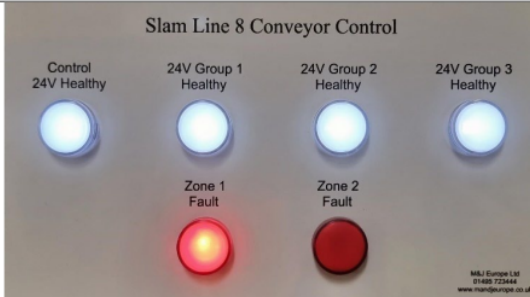
Figure 14 - PLC panel pilot light showing fault

| 15 | P2/P5 | Place fault on line by blocking sensors, | Fault light displays on panel and sends fault condition signal to PLC01 | Fault light show on PLC panel and sends signal to PLC01 Figure 14 and Figure 15 | Pass |

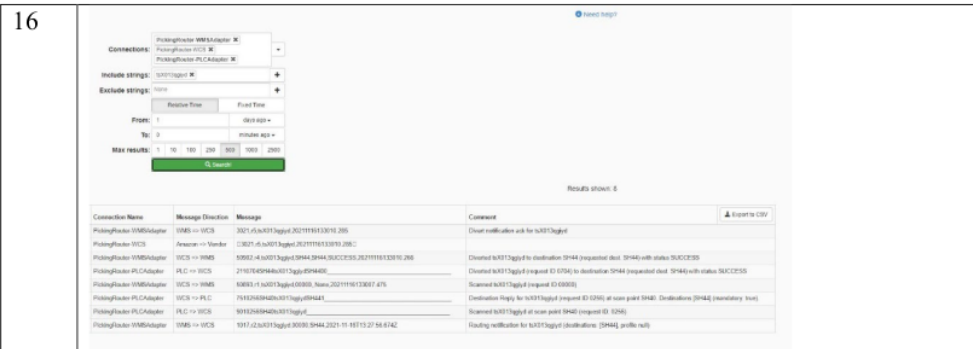
Figure 16 - Successful telegram message

| 16 | P4 | Route tote to line using operations interface and check telegram status | Tote routes correctly and send a successful telegram | Totes route correctly using operations interface and sends a successful telegram Figure 16 | Pass |
