# BRE: Post Installation Performance of Cavity and Why it Fails

Colin King

Part of the BRE Trust

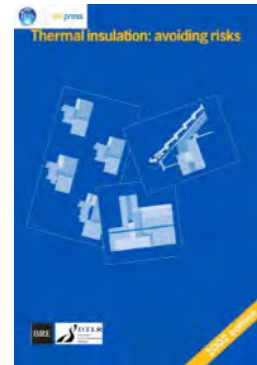
- Moisture ingress as a result of wind driven rain a significant risk
- General guidance given in BR 262 based on maps of exposure and tables of tolerance for various wall finishes
- Zones from 1 to 4, from sheltered to very severe

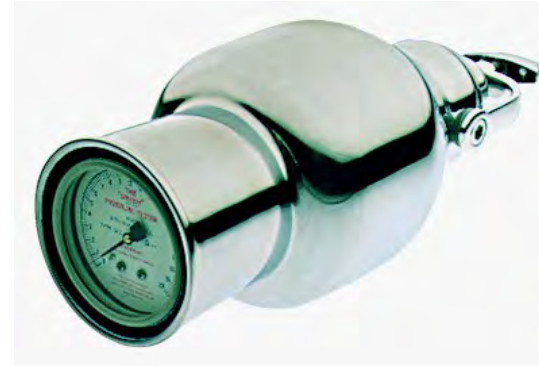
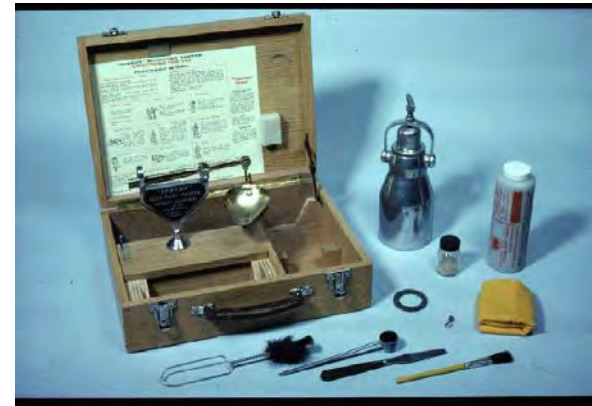
## Ashworth Speedy Tester

Portable %mc  
measurement capability

6 step test procedure

Calcium carbide reagent  
Approved by ASTM4944,  
ASSHTO T217 and  
DIN18365

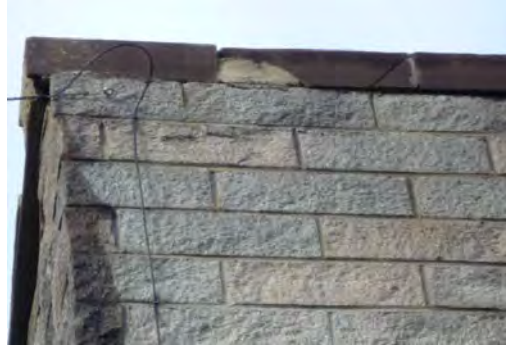
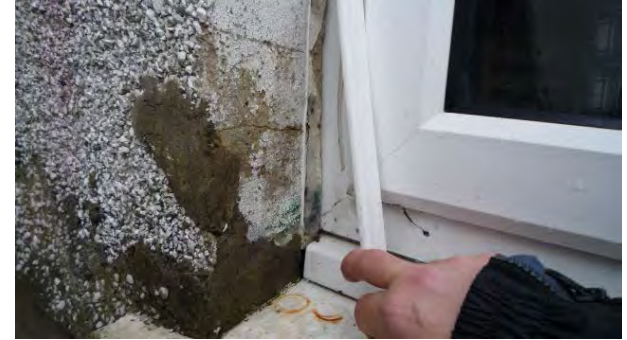
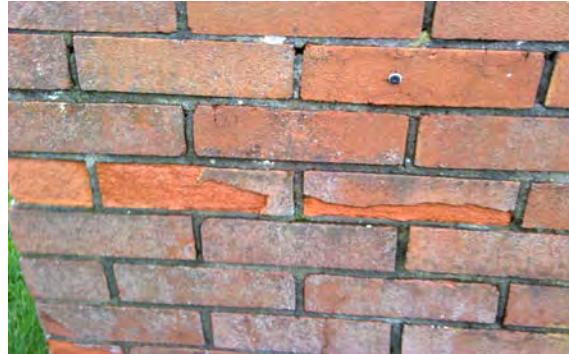
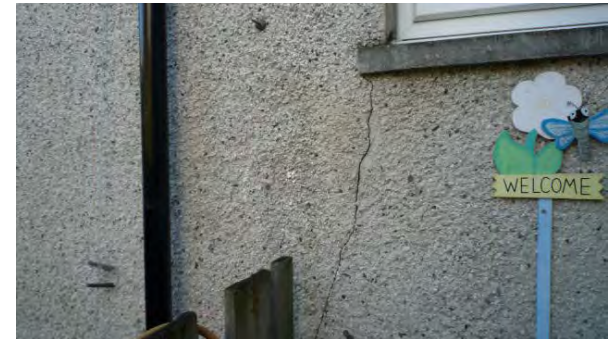
- Cracks in Render
- Missing DPC
- Windows not sealed
- Leaking gutters
- Spalled brickwork

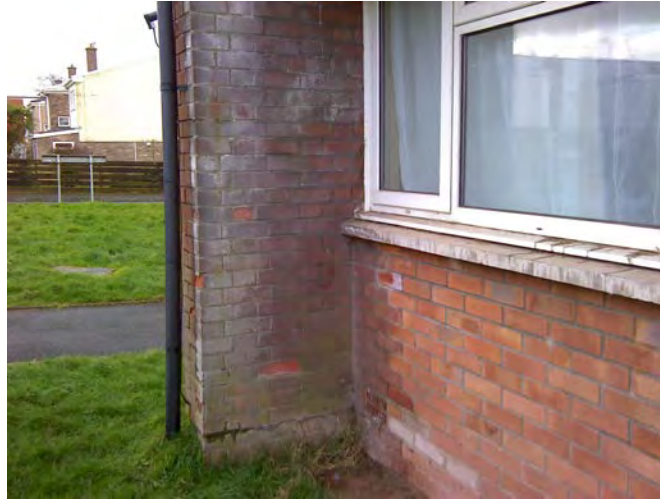
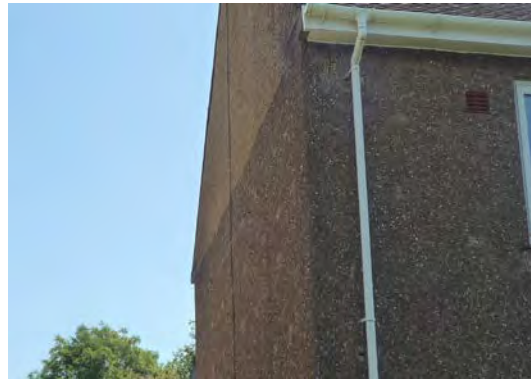
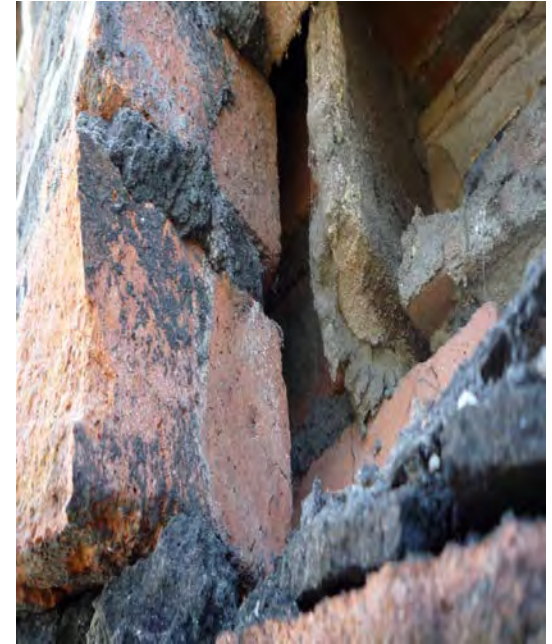
- Cavities not closed
- Bad or partial repairs
- Poor gutter alignment

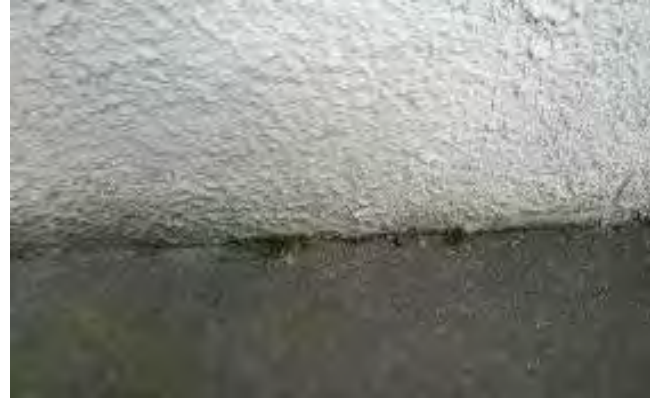
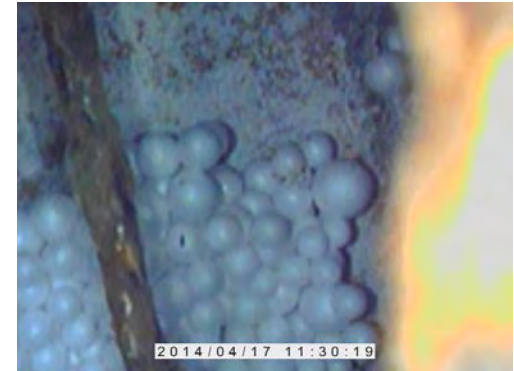
- Incomplete fill – does not achieve density
- Base of cavity not fully cleared
- Insufficient width of cavity
- Wrong material choice

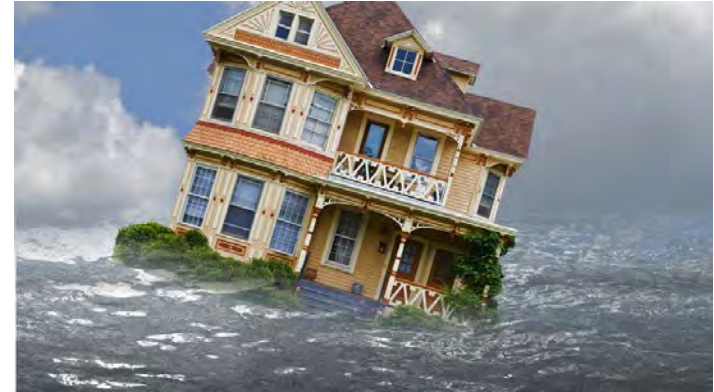
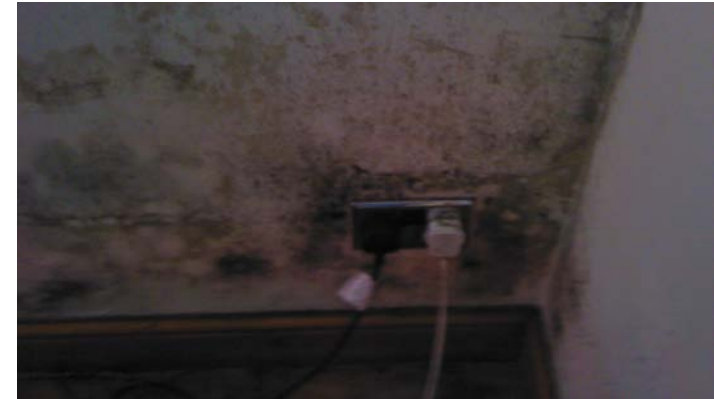
- Initial survey to ascertain context
  - Location
  - Construction – Ground levels etc
  - Defects
  - Preliminary Investigations IR, Moisture readings

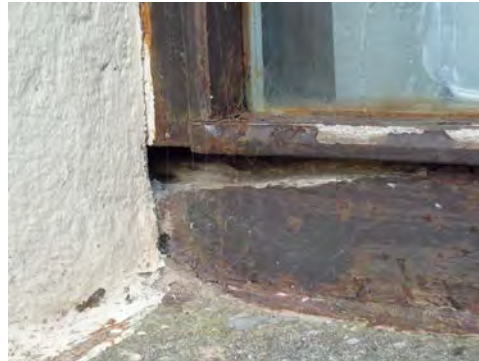
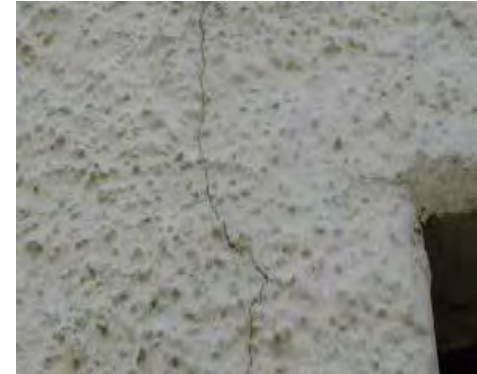
- No protection from local features
- Lack of maintenance and repair
- Probable missing insulation and or wet insulation
- Narrow cavities

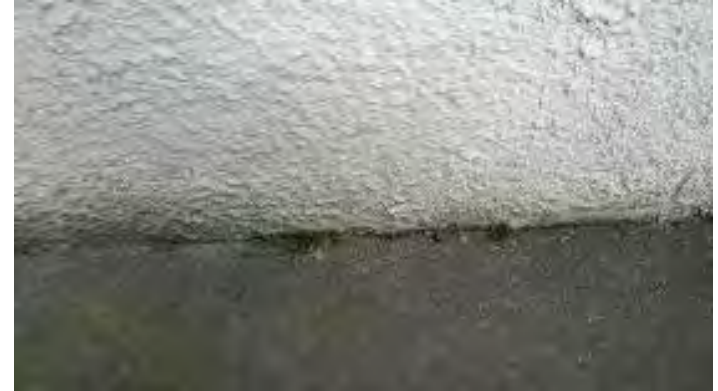
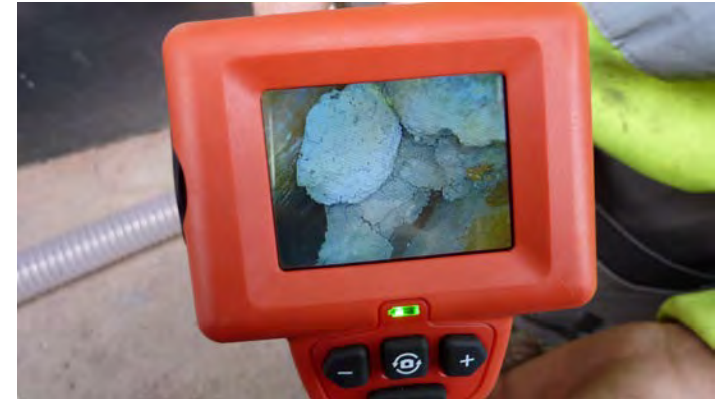
- Blocked cavities or partially filled
- Installation, outside certification
- Render to ground level
