# Condition & Retrofit Assessment Report

LOUIS KING (2320088)

RETROFIT CO-ORDINATION AND MANAGEMENT (ACBA5026)

ECO-RETRO SOLUTIONS LTD

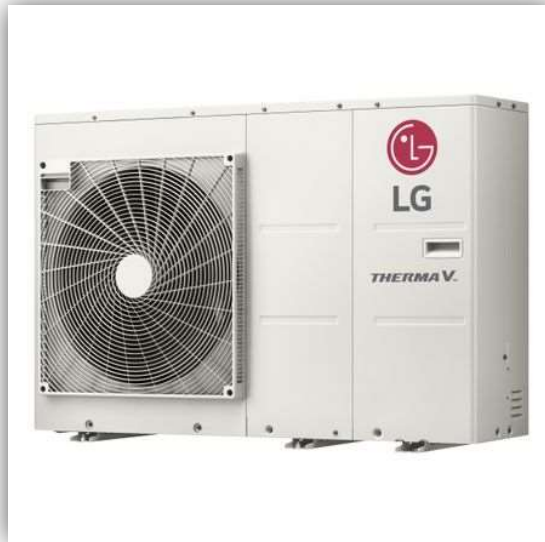
(Fig A)(*LG Therma V 5KW R32 Monobloc S Heat Pump*, n.d.)

The existing Ideal Logic gas combi-boiler is graded as condition 2 and represents the primary source of operational carbon emissions. In line with PAS 2035 guidance, the system is proposed to be replaced with a 5 kW Air Source Heat Pump (ASHP) following completion of fabric improvements such as this LG Therma V 5kW R32 Monobloc S Heat Pump (BSI, 2023).

The current heating system utilizes 15 mm copper distribution pipework designed for high-temperature operation, which is unsuitable for efficient low-temperature heat pump performance (CIBSE, 2016). To support the proposed 5 kW Air Source Heat Pump (ASHP), upgraded pipework, appropriately sized heat emitters and an unvented hot water cylinder are required to ensure efficient operation at reduced flow temperatures and maintain occupant comfort (MCS, 2017).

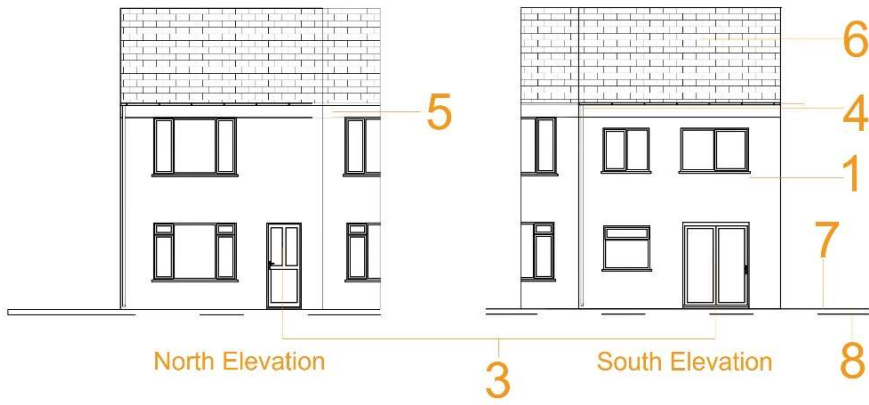
West Elevation Section

- Face brick outer leaf
- PVC Window
- PVC Door
- Plastic rainwater goods
- PVC Facias
- Concrete roof tiles
- Finish floor level
- Ground level
