# *SWANSEA MUMBLES ROAD DEVELOPMENT*

*PHASE 1 PRELIMINARY STUDY*

*Fundamentals of Construction Technology*

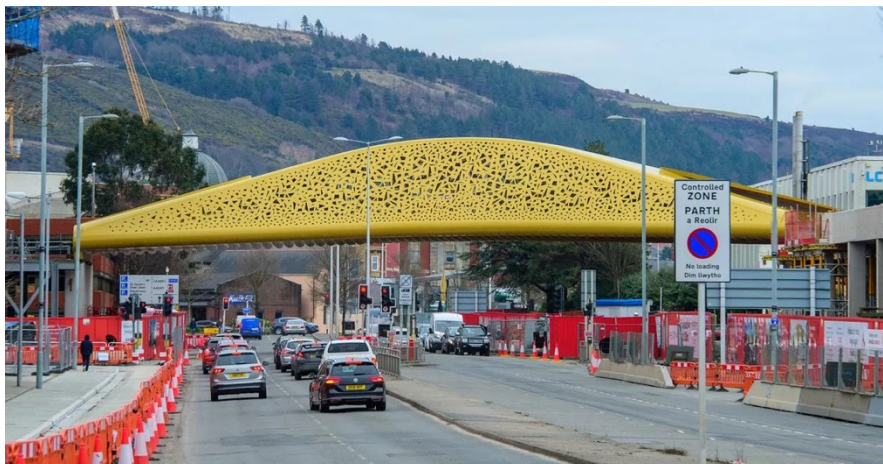
It is important to note that the Copr Bay Bridge, which extends over Oystermouth Road at an elevation of approximately 7.5 meters, may present a potential obstruction for certain types of vehicles accessing the site. A detailed analysis of this bridge and its potential impact on the development will be necessary. Figure 2 refers.

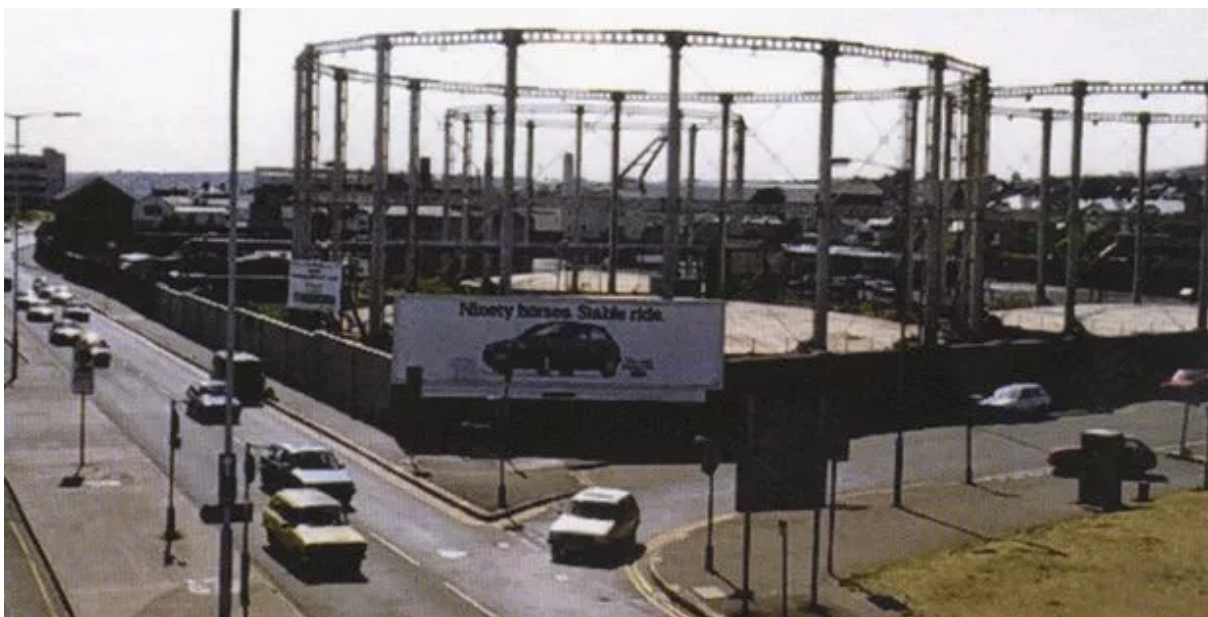
Figure 4 – shows the structure of the gas holders still in place in July 1989.

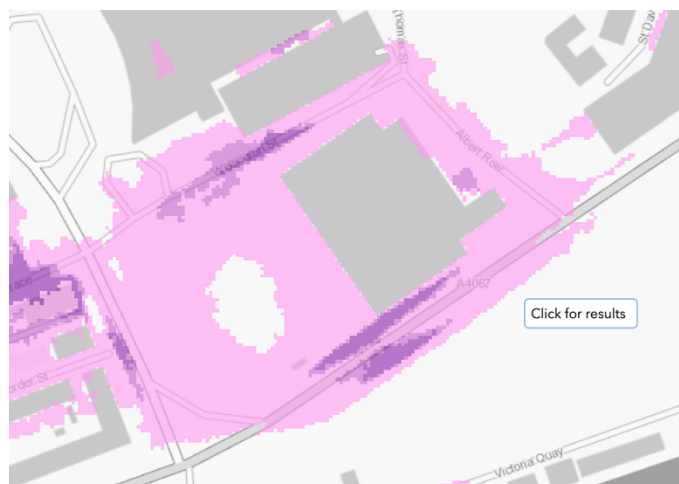
See figures 10 and 11 below:

An assessment of flood risk was conducted using the Flood and Coastal Erosion Risk Map published by Natural Resources Wales (NRW). This analysis shows that portions of the site are classified as being at medium to high risk of flooding. These raised flood risks range from potential flood by surface water runoff and overflow from nearby small watercourses during periods of heavy rainfall.

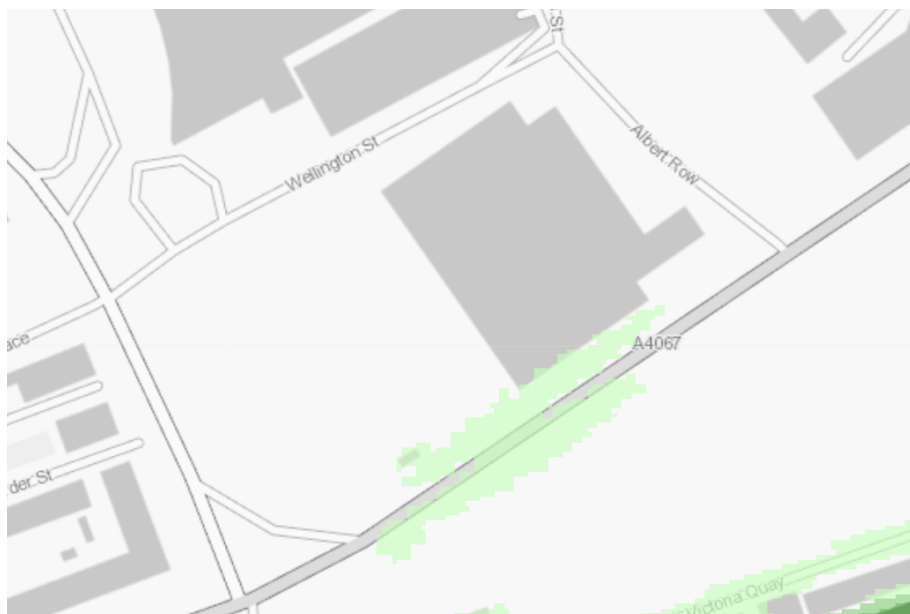
See figures 12 and 13 below:

**The NRW Flood risk map confirms that the site is not at risk from flooding from rivers.**
