BEng (Hons) Mechanical and M

# Condition of The Cross Haven

# Pipelines

Reinstatement of historic Submarine pipelines between Valero Pembroke-shire Oil Terminal and Valero Pembroke Refinery.

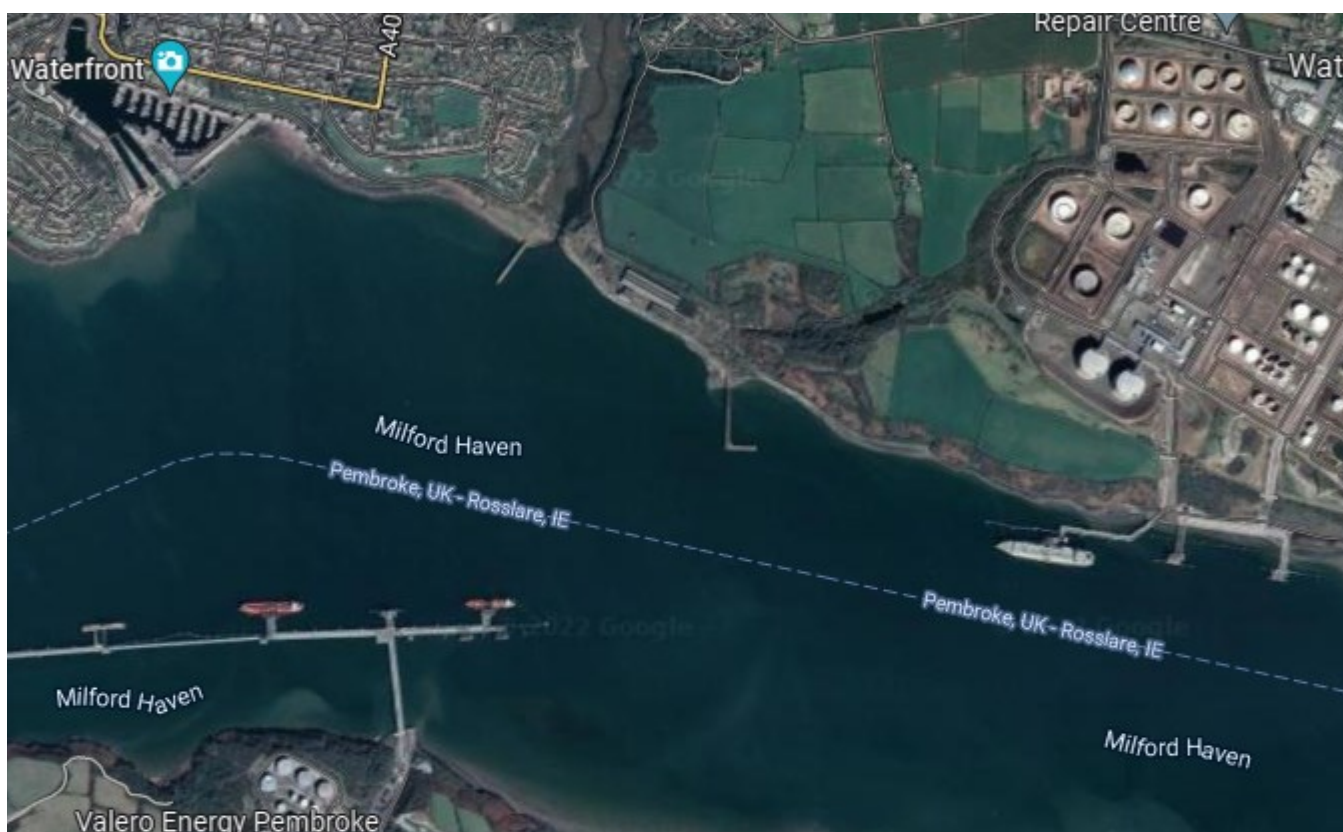
5.7KM of above ground, submarine and underground pipework, previously used for the Transfer of Petrochemicals between sites.

Lines were intelligently pigged, and left water filled in 2002. 2018 saw the investigative works commence.

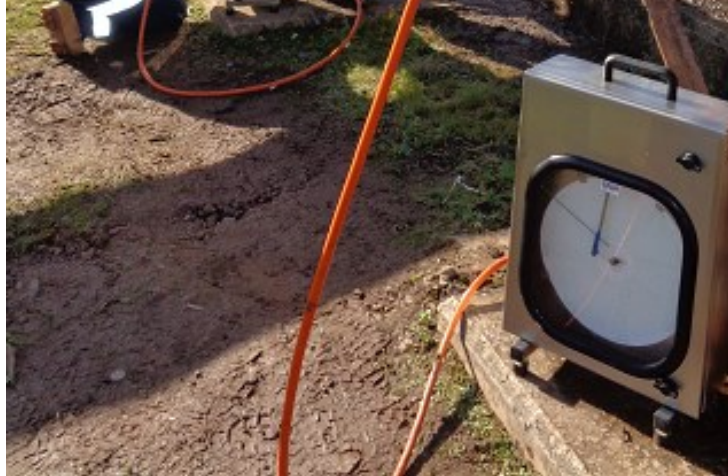
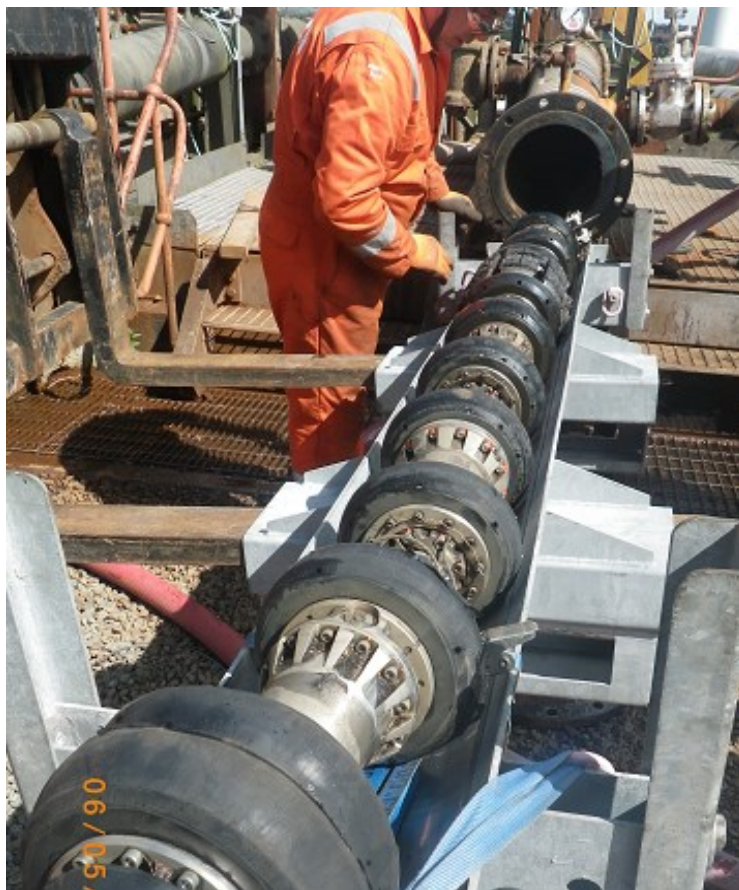
## 12" Line Results

- . A total of 1513 metal loss anomalies were found
- . 655 external corrosion anomalies
- . 322 internal corrosion anomalies
- . 536 internal pipe mill anomalies

ROSEN reports state that there is 1 repair per an ERF over 1. However, using the Valero standard ERF of 0.95, 19 repairs are needed.

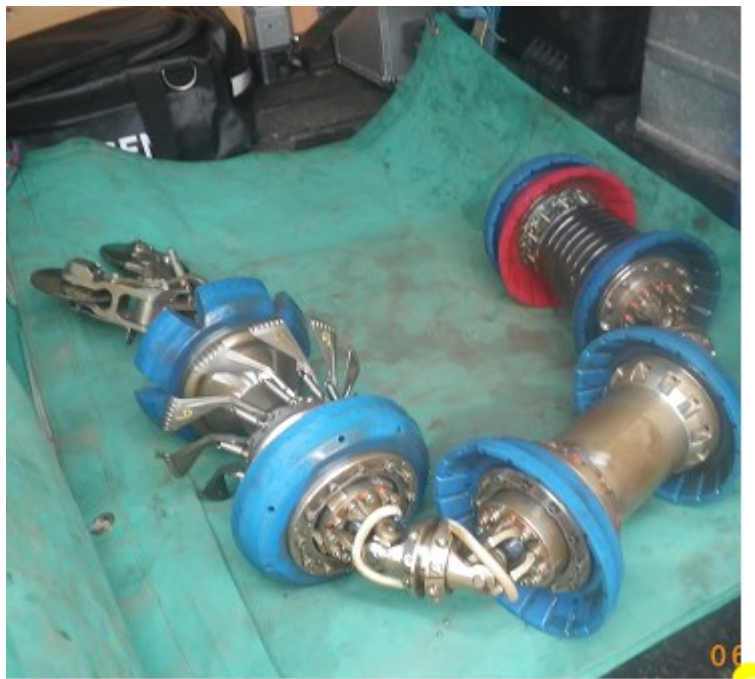
## 8" Line Re

A total of 273 m  
ceeding the re  
This included;

- 37 external c
- No internal c
- 229 internal
- 7 external p

metal loss anomalies were found ex-  
porting threshold of 10%
