## Hazardous and deleterious building materials

This note offers a first point of reference and practical guidance to the identification and treatment of problems associated with some types of building materials. Bringing together the essentials of a wide range of different materials and forms of construction over the years that may have been found to be hazardous to persons or to the environment, may have been considered to be deleterious, might have been regarded as being problematical in some way, or would probably be labeled as deleterious if they had their chance again.

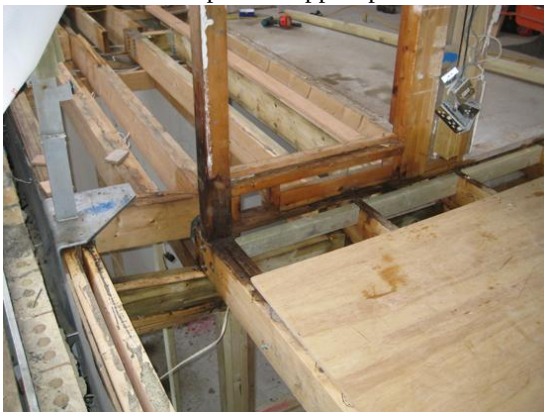
**Figure 1: Remedial work in progress to a TF building. The vertical load from the post in the centre of the picture was supposed to be transferred by a set of site-fixed studs below (now installed) but these were originally missing. The resultant distortion of the frame led to severe water penetration from a balcony. (© Watts Group/Trevor Rushton)** The design was fully detailed by designers and required 'loose studs' to be inserted within certain internal wall panels to increase the load-bearing capacity of the panels to support point loads from the roof structure. The building was clad in brickwork.

For example, we are currently involved with repairs to a recently constructed block of 15 flats arranged over four floors. The building is of platform construction whereby the external walls are constructed of prefabricated timber panels bolted together on site. The timber panels support prefabricated floor and ceiling 'cassettes'.

Fairly soon after construction, residents were alarmed by distortion that began to occur in the building, windows no longer fitted and floors became uneven - in the most severe cases, differences in level developed of up to 75mm across a single room. The downward motion of the floors caused the external balconies to distort, with the result that water flowed back into the building.
