# ANALYSIS OF DEBRIS EFFECT ON HEAT EXCHANGERS

School of Engineering

Mechanical Engineering BEng

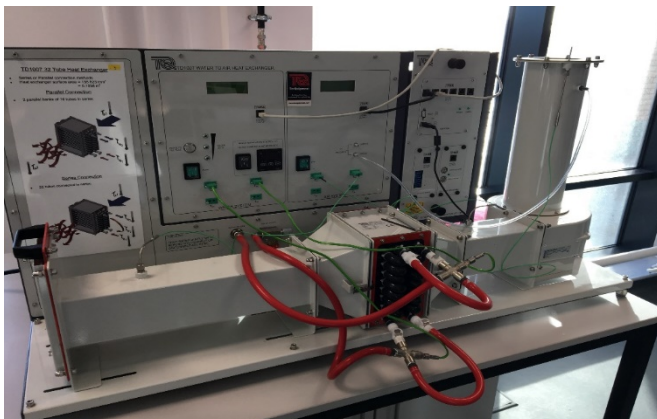
*Figure 1 – The TD1007 Testing apparatus.*

The testing apparatus being used is the TecQuipment TD1007 water to air heat exchanger. This the university's own equipment so is always available for use. This equipment will be the main equipment in this investigation.

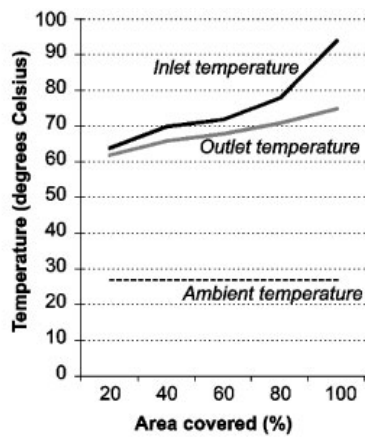
: Variation of temperature with the area  
of radiator covered with the mud

*Figure 2 – Temperature change taken from the Dirt analysis research document.*

As can be seen in figure 2 below taken from the document, as the area covered as a percentage increases so does the inlet and outlet temperatures. The coolant temperature at the inlet increases due to the outlet not being cold enough and then repassing through the engine again. This process slowly builds the inlet temperature to dangerous levels.

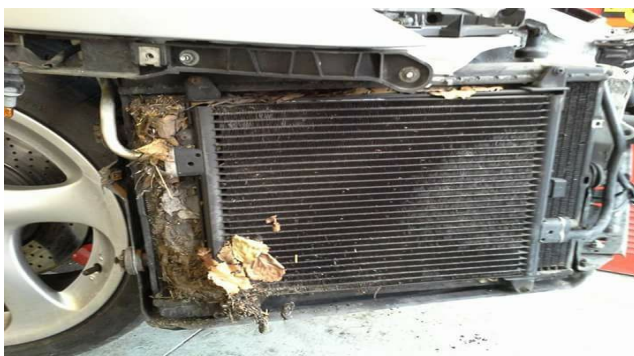
*Figure 3 – A design error by Porsche allowing debris to enter through bumper.*

As shown in figure (3) below a Porsche 911, which has its radiators and condenser positioned in the side of the bumpers, a problem occurred when large quantities of debris were getting in through the gaps and depositing themselves in and around the main engine cooling HX and the aircon condenser. This was seen to influence the HX, but through this dissertation, a number can be put on just how much of an effect can be caused by debris.

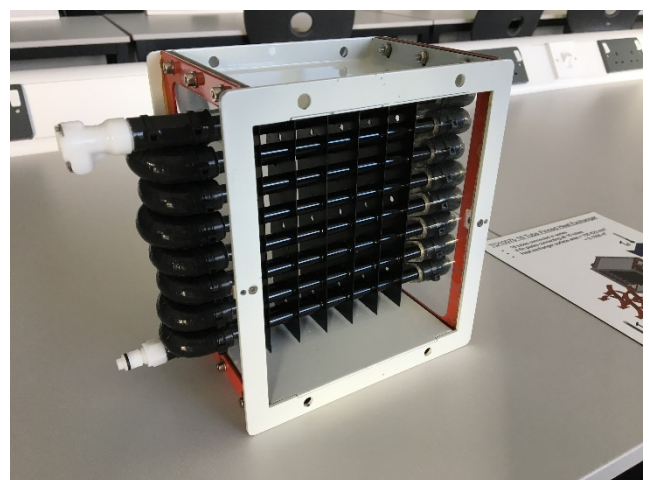
*Figure 4 - 16 tube finned design heat exchanger designed by TecQuipment.*

In figure (4) below the 16-tube finned design HX that is in the TecQuipment apparatus kit, these fins aid in heat transfer as seen the Porsche's radiators also incorporate a finned design.

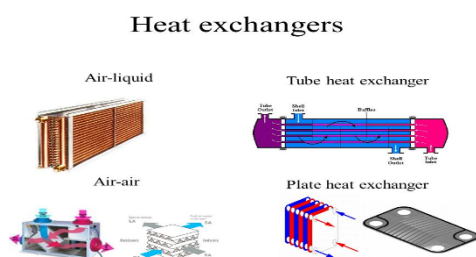
*Figure 5 – Different types of heat exchangers.*

However, there are many different types of layout such as concentric, plate, shell and tube to name just a few. Then there is flow configurations such as cross flow spoken about previously as well as parallel flow and counter flow. Choosing the correct configuration is vital for efficiency, for example a shell and tube heat exchanger would not be right for a car because it would not take advantage of the flowing air provided by the car's movement. Where as a plate/fin design on a motorbike works as there is less heat produced and air passing provides efficient cooling to the smaller engine. A few different types of heat exchangers can be seen in figure 5 below.

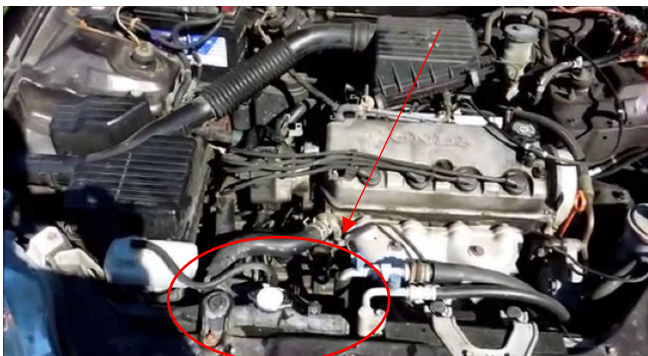
*Figure 6 – Location of Honda civic small radiator.*

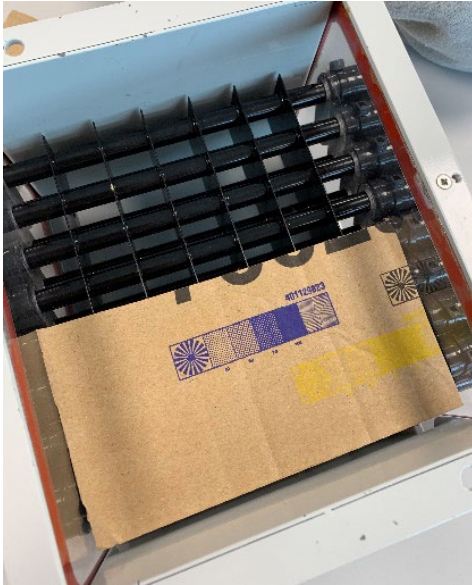
*Figure 7 - Corrugated cardbaord.*

Progressing onto the corrugated cardboard at 25% coverage, the thickness change was obvious to see figure 7. Again, with the same parameters set of 60 degrees C, 0.5 L/minute and left for 5 minutes to allow changes to take place. An increase of 1.2 degrees C was observed, nearly a whole degree above that of the thin coverage of the same area.

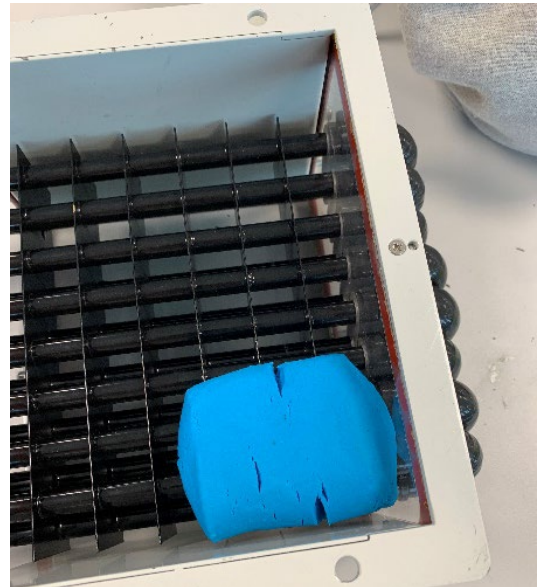
*Figure 8 - Clay to simualte insulated derbis.*

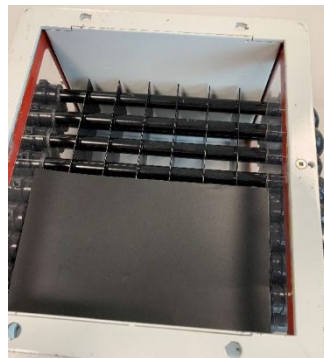
*Figure 9 – 50% Coverage Displayed.*

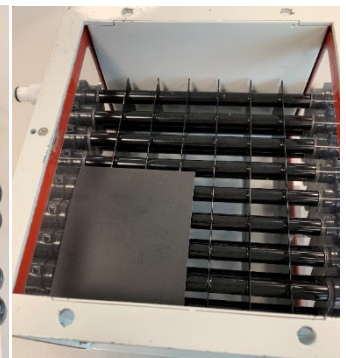
*Figure 10 - 25% Coverage Displayed*

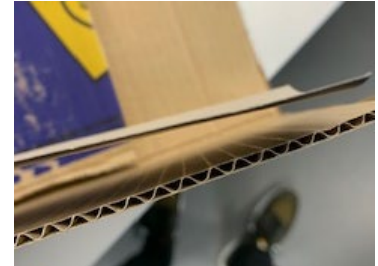
*Figure 11 - Thickness difference between cardboard.*

Demonstrated in figure 11, the difference in thickness of thick and thin cardboard.

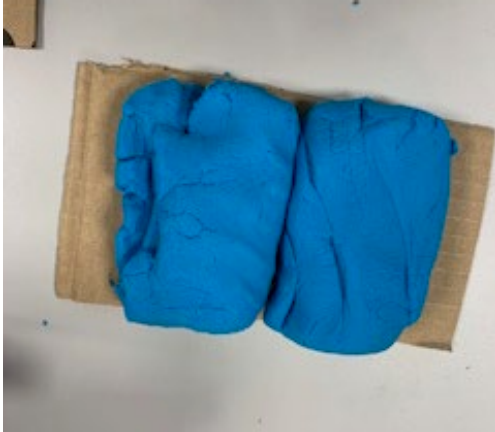
*Figure 12 - Clay used in conjunction with cardboard.*

To simulate the insulated coverage, it was decided that a 50% piece of corrugated cardboard would be used in conjunction with 224g of clay. See figure (12) below. Unfortunately, the affect seen by the clay was less than expected causing a total increase of 4.2° C. Increase of 2.4° C of that of 50% on its own.

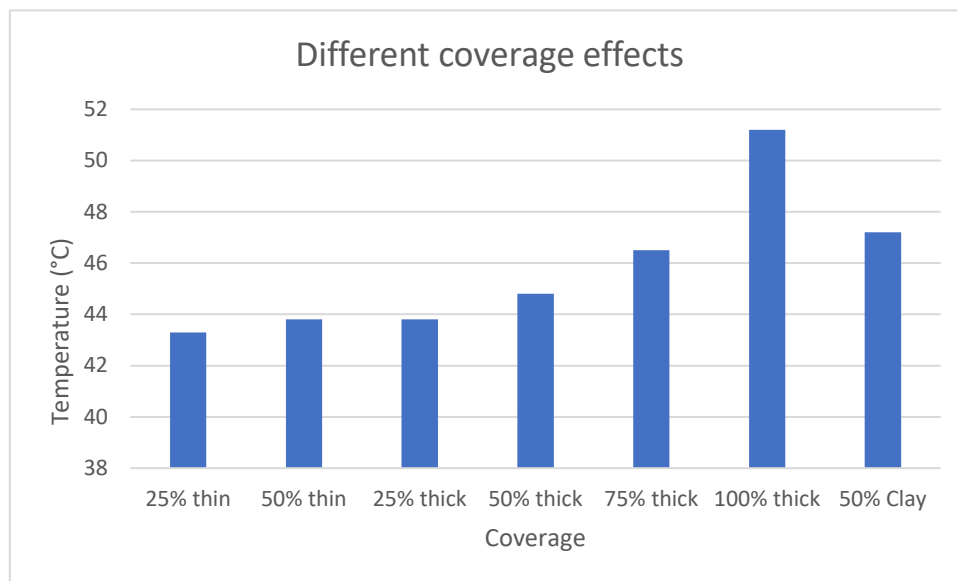
Figure 12, Comparison of coverage effects bar chart.

From the graph above the different coverages and their recorded temperatures can be seen, this graph goes to show not only an illustrative insight but also on how they compare against each other. From this the difference between 75% and 100% is a lot greater than that of the difference between 25% and 50%. This could be down to the fact that 100% coverage would not let any exposed surface from the heat exchanger become sufficient in cooling as there is no exposed surface area, apart from behind the coverage where the heat exchanger will dissipate heat into the moving and ambient air.
