| 1 | First Issue | AA | 04 | 04/24 | Thomas McGaw | SA1 CAMPUS | ALT Surveying |
| | | | | | Digital Surveying Assignment 2 | | |

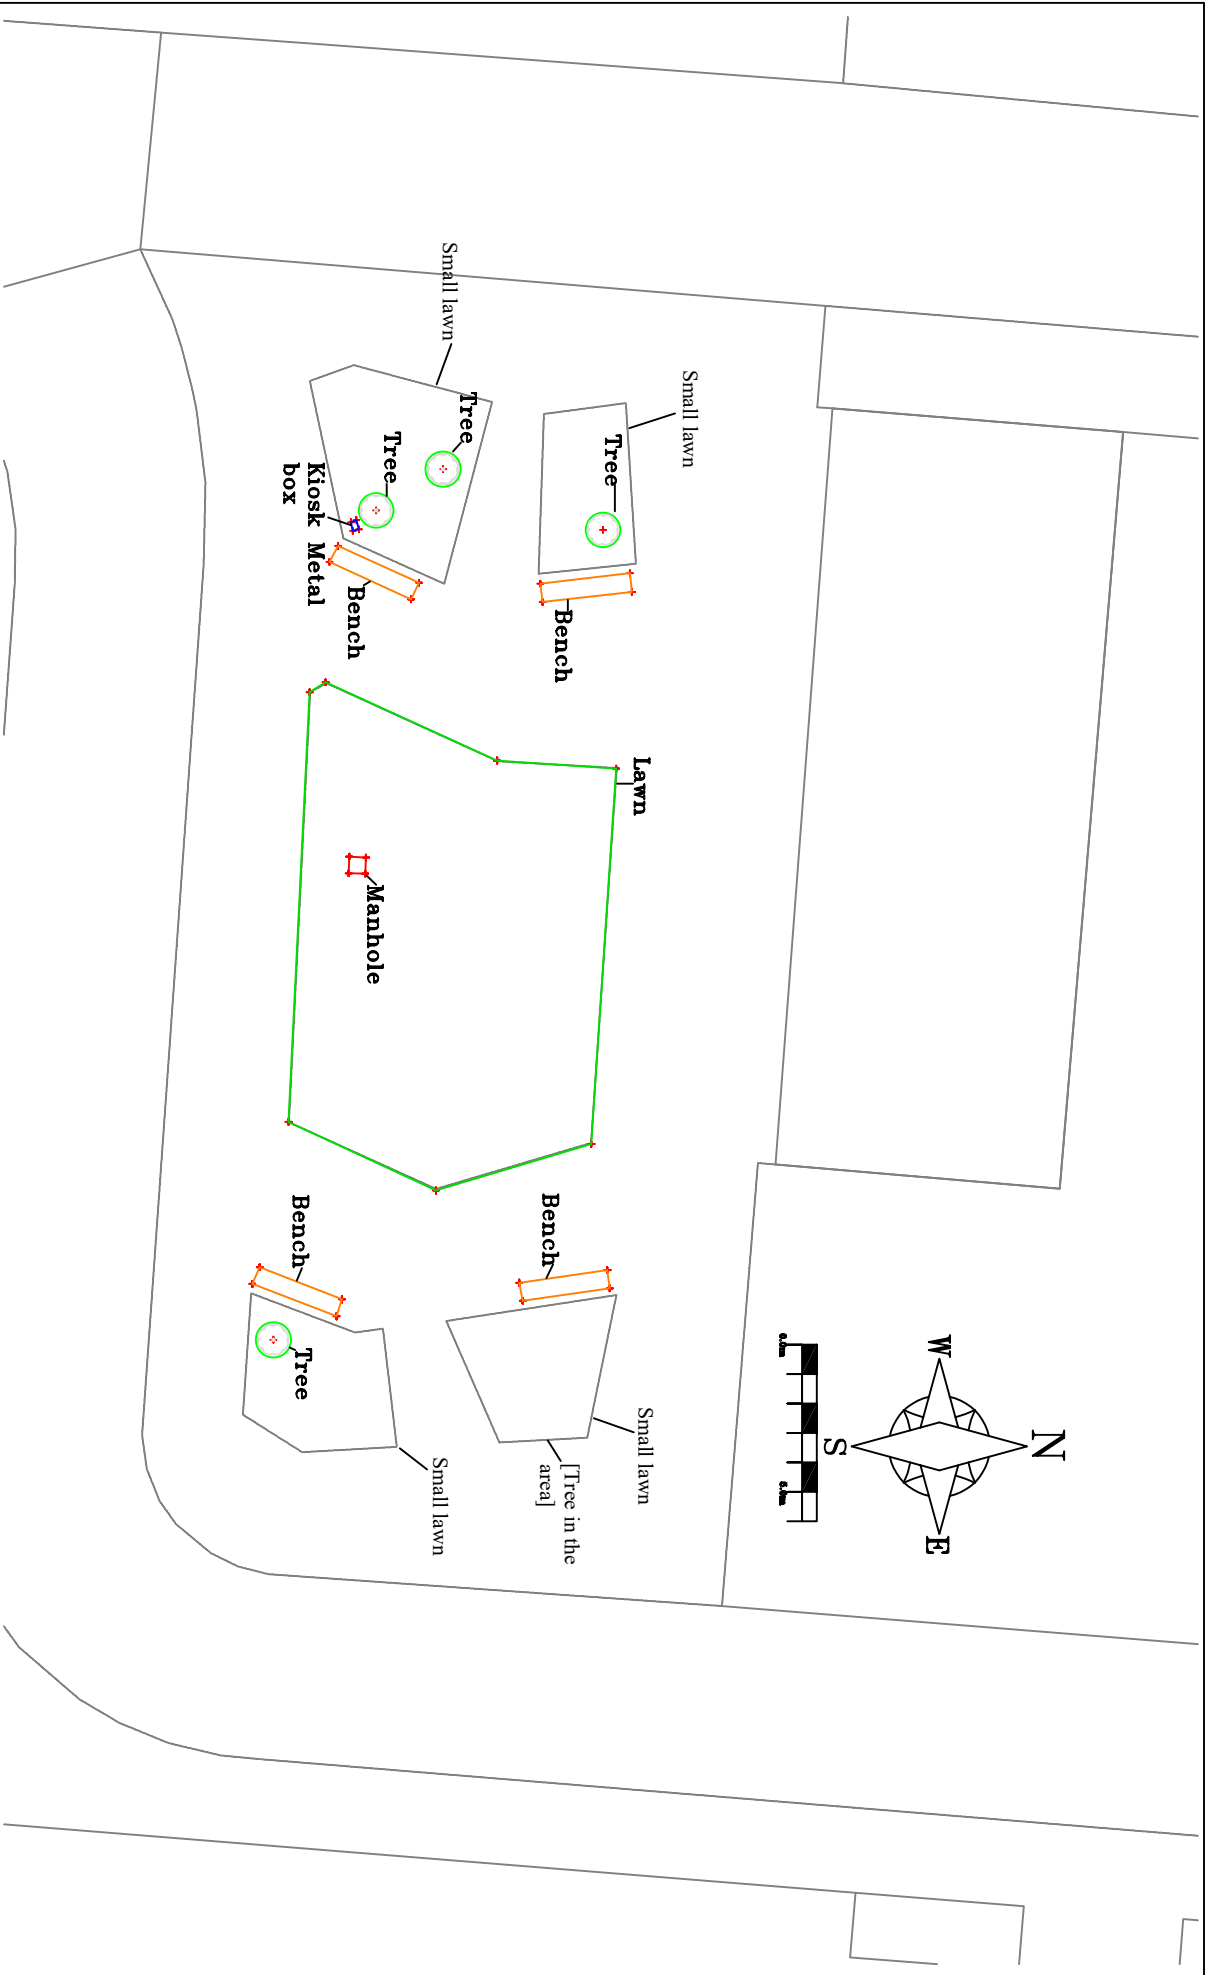
Notes:  
For this GNSS survey of the area adjacent to the IO Building at the UWTSD Waterfront Campus, all trees, benches, manholes, lawn areas and a kiosk metal box are shown, distinguished by the following colours:  
Tree - ■  
Bench - ■  
Kiosk Metal Box - ■  
Lawn - ■  
While coordinates were taken for the entire lawn area, we were directed by the instructor not to attempt to do the same for the four small lawns shown. The OS map shows the location of the four small lawns. Due to the orientation of the building under construction to the north, we were unable to establish the coordinates of a tree located in the north-east small lawn area but its presence is indicated in square brackets.
