## The Yenikapı Byzantine-Era Shipwrecks, Istanbul, Turkey: a preliminary report and inventory of the 27 wrecks studied by Istanbul University

Ufuk Kocabaş

*Istanbul University, Department of Conservation of Marine Archaeological Objects, Ordu Cad. Laleli, Fatih, Istanbul, Turkey. ufukkocabas@gmail.com*

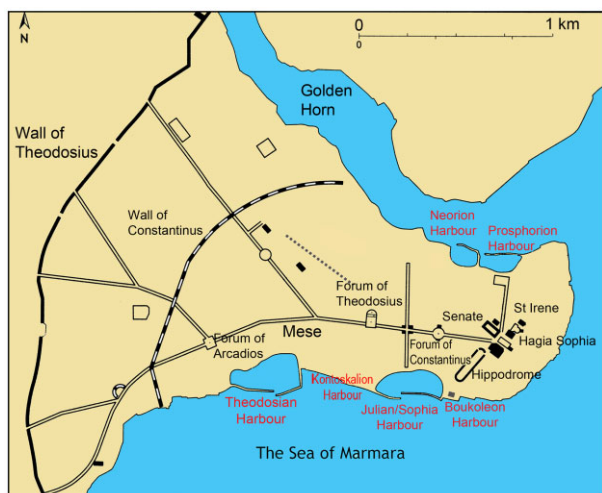
Figure 3. Harbours of Constantinople (after Haldon, 2006: 72)

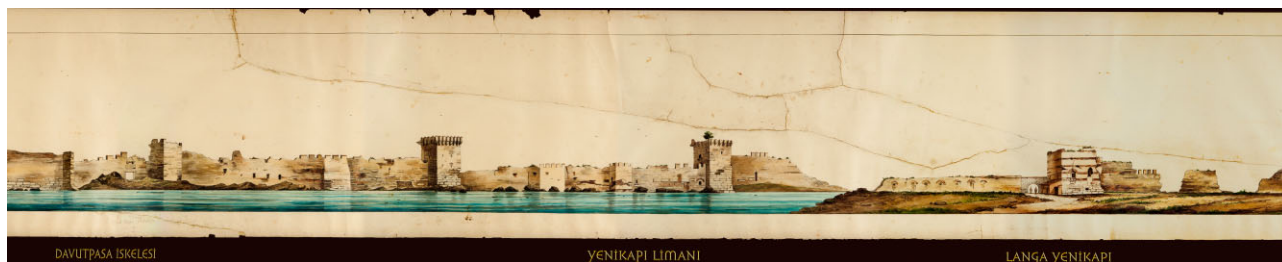
Figure 4. Detail showing the Yenikapı area in a 28 m-long drawing of the sea-walls of Istanbul by engineer Dimitriadis Effendi in 1873. (Istanbul Archaeological Museums Library)

The Theodosian Harbour declined in activity in the mid 7th century when the grain imports from Egypt halted, yet it continued to serve as a harbour, as evinced by the ships uncovered dated to the 7th–11th centuries (Asal, 2007; Asal, 2010; Asal, 2013). It is thought that the Lycus Stream flowing into the Marmara at Yenikapı silted the western part of the harbour first. When this part, known as the inner harbour, became unusable, activities shifted eastward; as silting progressed the remaining harbour filled up from the north southward. In its last years it served only coastal traders and fishing boats. The harbour was abandoned as a result of silting after the 12th century, when it became a dumping ground for rubble from the surrounding area, as is shown by the remains of a church from the 12th–13th centuries uncovered in the harbour basin (İnciyan, 1976: 4–5). After 1261, Jews were settled in this area, which came to be known as Vlanga, where they worked primarily in leather tanning (Fig. 4).
