# An Analysis of Protective Coatings for Automobile Exhausts

## 5 Analysis of a failed exhaust system

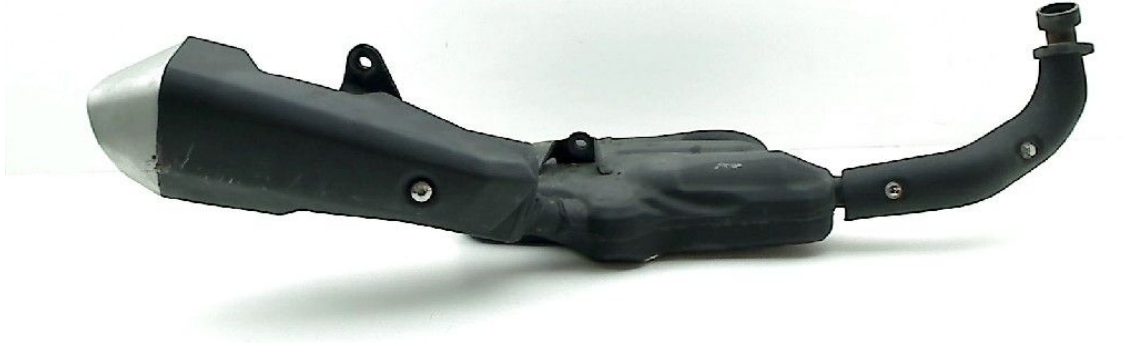
Figure 1: 2019 MSX 125 exhaust system

In order to analyse the value of coatings I will be using an the old exhaust system from a 2019 Honda MSX125 which has fractured, likely due to temperature, corrosion and fatigue. The exhaust system was in use on the motorcycle for three and a half years and the motorcycle has been used in all weather conditions, mostly away from coastal areas, in a temperate environment and both on and off-road. The exhaust system has been externally coated with a high temperature ceramic paint. The exhaust system is attached to the motorcycle via three bolts, two connecting to the engine housing and one on the muffler connecting to the frame of the bike. Figure 1 shows the exhaust system as a whole piece.

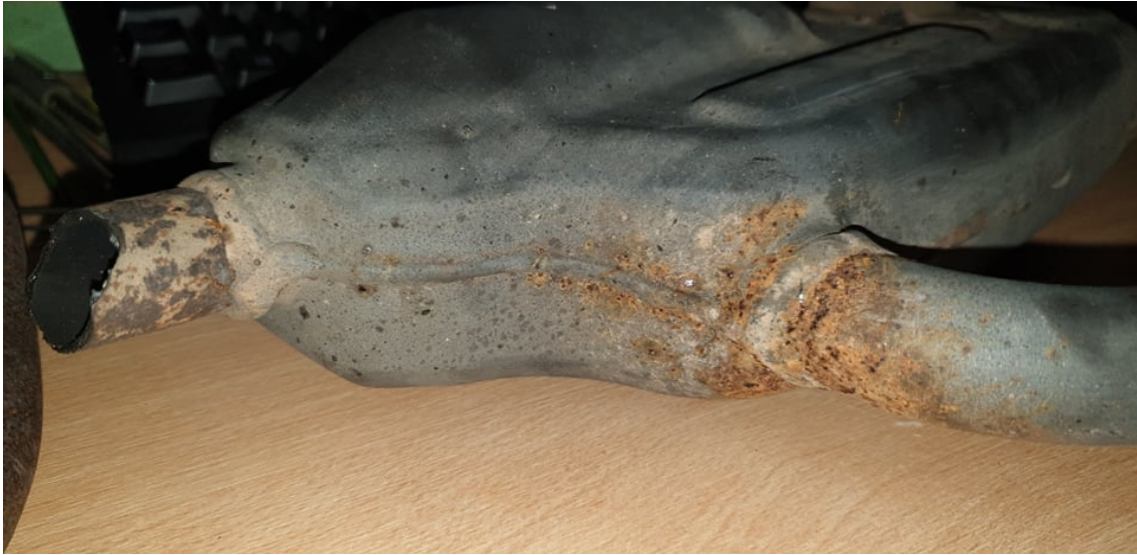
Figure 2: Catalytic converter and broken header pipe.

Due to temperature, corrosion and fatigue a crack developed in the exhaust header, just before the catalytic converter which eventually led to catastrophic failure of the exhaust system, detaching the catalytic convert and muffler from the header.

Figure 2 shows how the protective coating has clearly been compromised on both the header pipe and the catalytic converter. The corrosion near the sharp turns in the components and on the header pipe itself are likely to have occurred due to extreme heat build up in these areas compared to other sections, however it could also be because these are the most exposed sections. Additionally rust is also prevalent around the welds in the catalytic converter, this is likely due to imperfections in the metal causing the coating to no apply as well to these areas. By cleaning off the red rust and whats left of the coating we can also see signs of pitting occurring in these areas, as shown in Figure 3.

This particular exhaust shows that even with ceramic coatings if the exhaust system experiences an environment that can cause damage to the coating and substrate it is important to perform the rudimentary maintenance of cleaning exposed areas and reapplying the coating so as to prolong the lifetime of the part. From an economic standpoint a new stock exhaust system costs over £350 [11] which, compared to the cost of cleaning the motorcycle regularly and applying a coat of high-temperature exhaust paint annually, is significantly more expensive.

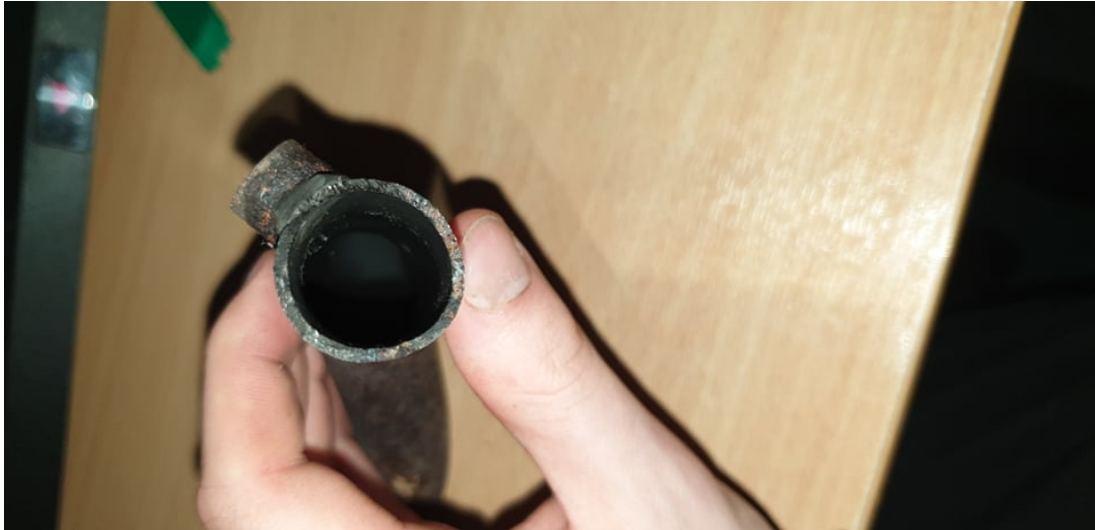
Figure 4: Cross section of the header pipe

Figure 4 shows the cross section of the pipe and the internal coating of the pipe. We can see from this that corrosion penetrated fully through the walls of the pipe in this section, compromising the integrity of pipe such that, under normal operating procedure it could no longer sustain the weight of the catalytic convert and fractured. In order to inspect the condition of the internal coating the interior has been cleaned however there is still a large build up of soot deep in the pipe. No signs of corrosion has been found in the interior of the header pipe suggesting that the internal coating as outperformed the exterior coating. This is to be expected as the internal coating is not attacked as often physically or has as much exposure to oxidation. The internal layer of soot may also serve to protect the interior from contaminants in the fuel. It is however possible that the crack was formed purely due to fatigue in the metal and it later rusted prior to the failure.
